RADIAL TIRE CONDITIONS ANALYSIS GUIDE

**A Comprehensive
Review of Tread Wear
And Tire Conditions**

© Copyright 1994 The Maintenance Council
Printed in U.S.A.

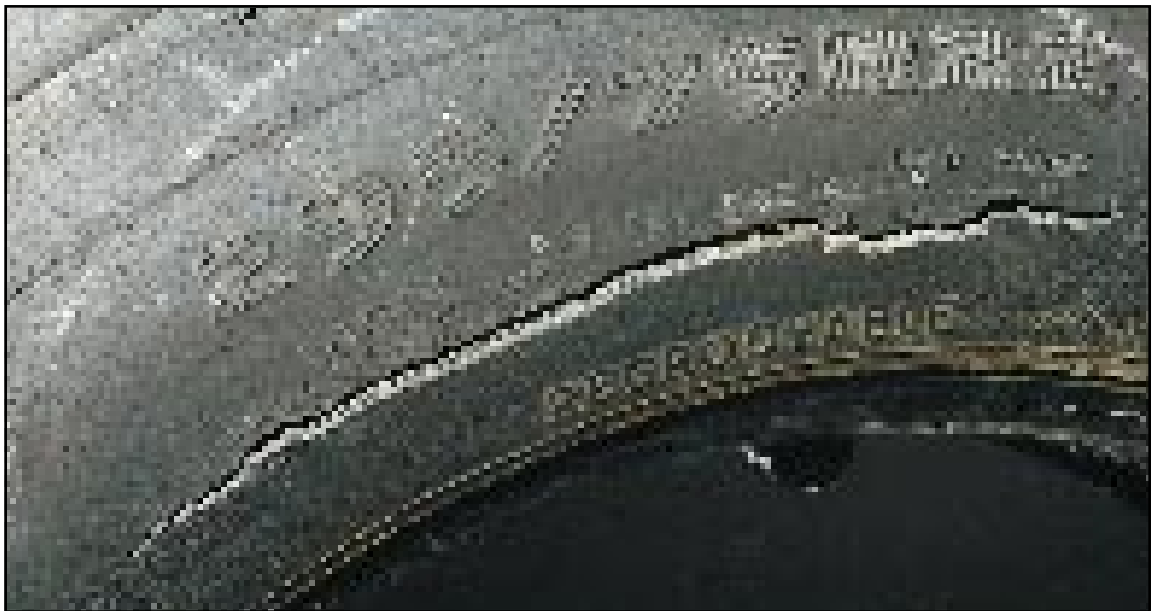
Circumferential cracks above bead flange area with cord material exposed.

Improper bead seating, improper rim size, overload condition, underinflation, impact or possible manufacturing condition.

Remove from service and consult tire manufacturer.
