RADIAL TIRE CONDITIONS ANALYSIS GUIDE

**A Comprehensive
Review of Tread Wear
And Tire Conditions**

© Copyright 1994 The Maintenance Council
Printed in U.S.A.

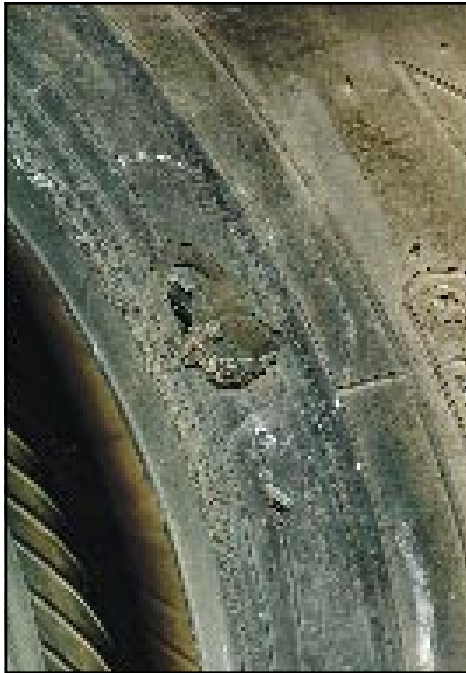
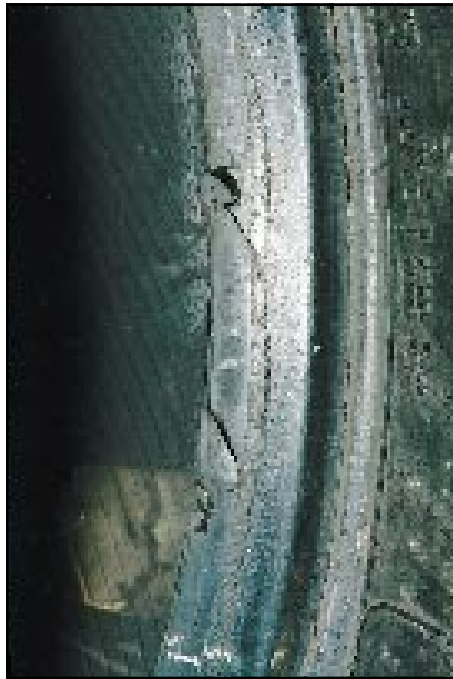
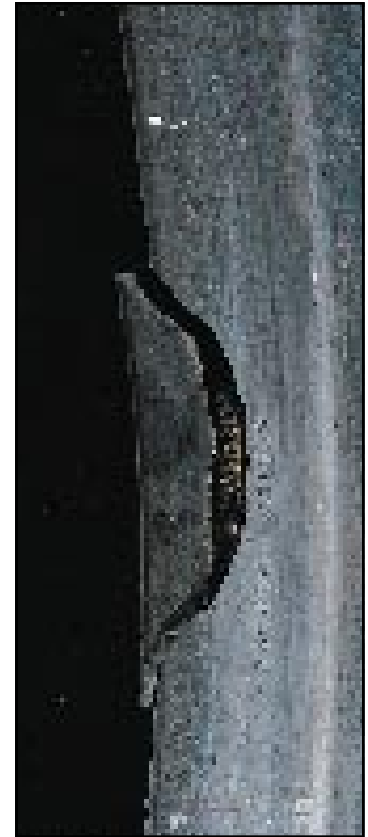
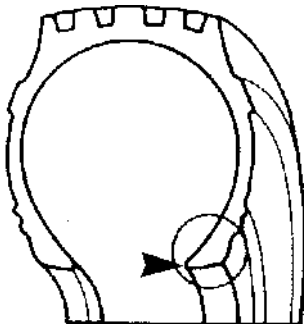
APPEARANCE	Bead toe rubber is torn or cut exposing the wire or fabric.
PROBABLE CAUSE(S)	Poor mounting/demounting techniques with tire tools and/or poor lubrication, forklift damage and poor tire handling procedures.

TIRE	If no rust on the wire is evident, repair and return to service. If wire is rusty, gouged, kinked or broken, loose or separated, contact your tire supplier/retreader to determine reparability; otherwise, scrap tire.
VEHICLE	None
OPERATIONS	Review mounting/demounting procedures and tire tools. Ensure the tire beads are well lubricated. Also check new tire handling procedures.

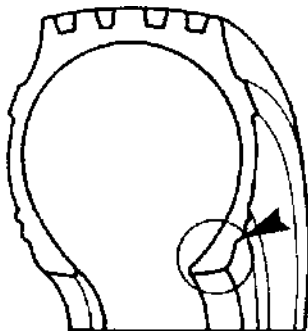
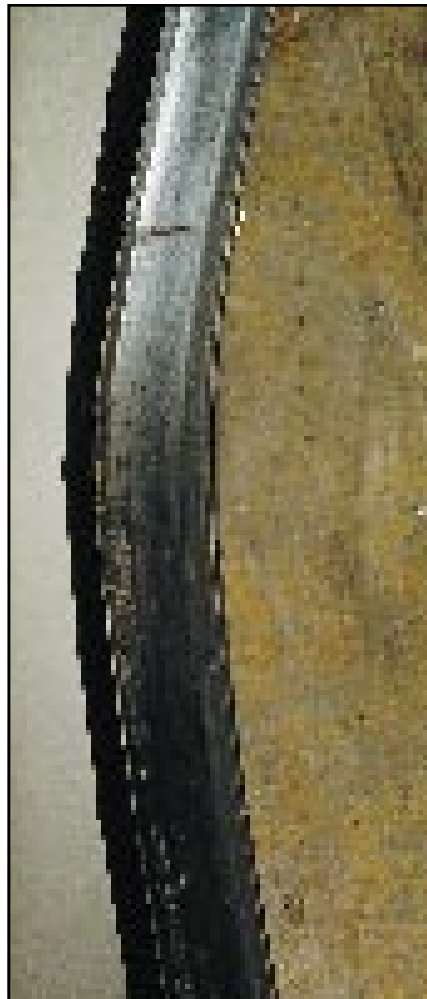
APPEARANCE	Local areas of distortion in the bead seat area.
PROBABLE CAUSE(S)	Improper use of tools, or incorrect techniques used when mounting the tire; shipping/handling damage.

TIRE	Scrap tire.
VEHICLE	None
OPERATIONS	Review mounting/dismounting procedures and tire tools. Ensure the tire beads are lubricated.

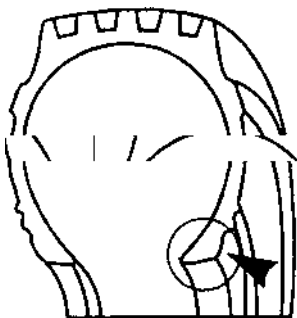
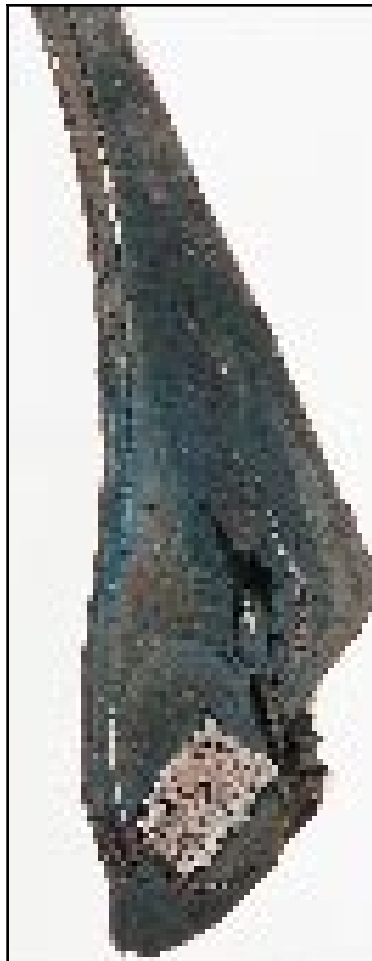
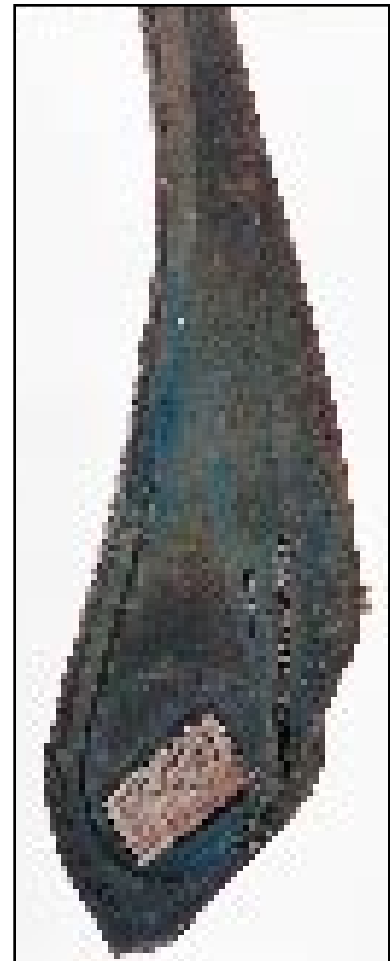
Rusty rims, improper bead/rim lubrication, and bent or damaged rims which result in improper bead seating. Excessive heat in the bead area.

If wires are visible, scrap the tire. If only the rubber is distorted, return to service on other than the steer axle.

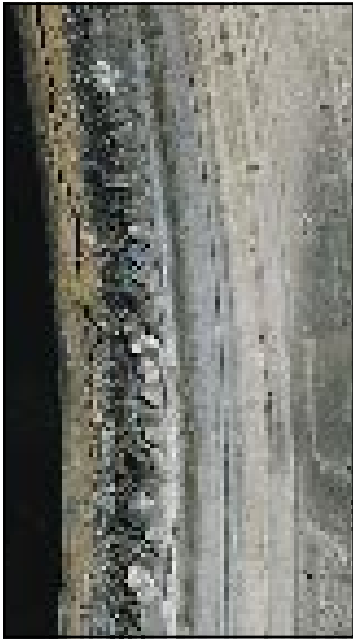
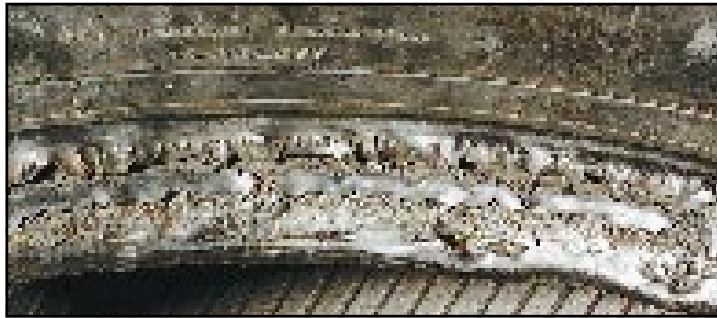
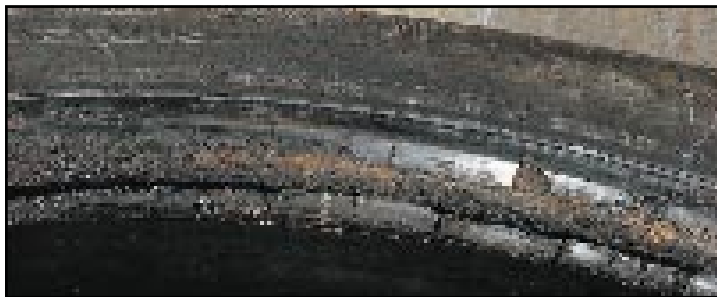
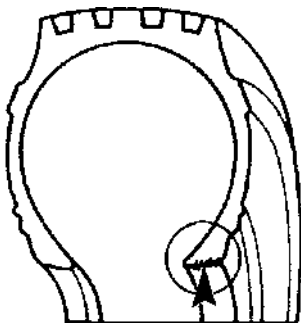
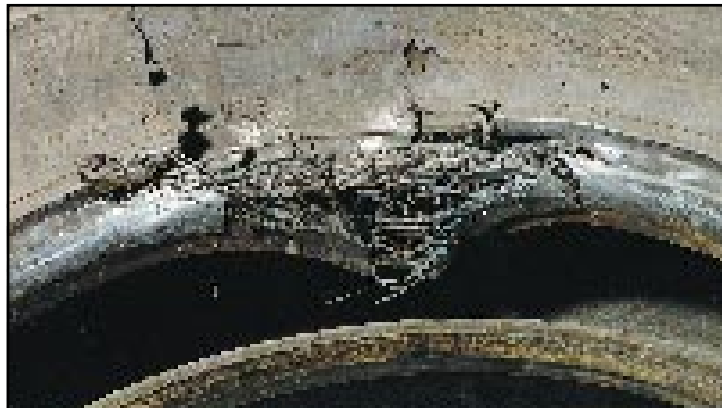
Burned Beads

APPEARANCE	Rough, brittle, distorted and/or discolored hard surface in the bead area.
PROBABLE CAUSE(S)	Excessive heat exposure caused by frequent hard braking; improperly adjusted brakes; faulty braking system; insufficient air flow around the brakes.

TIRE	Scrap tire.
VEHICLE	None
OPERATIONS	Determine the source of excessive heat and correct the braking condition.

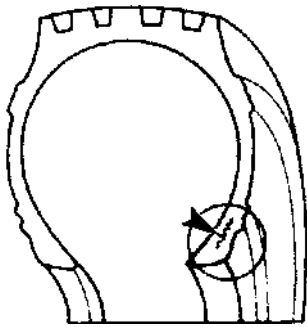
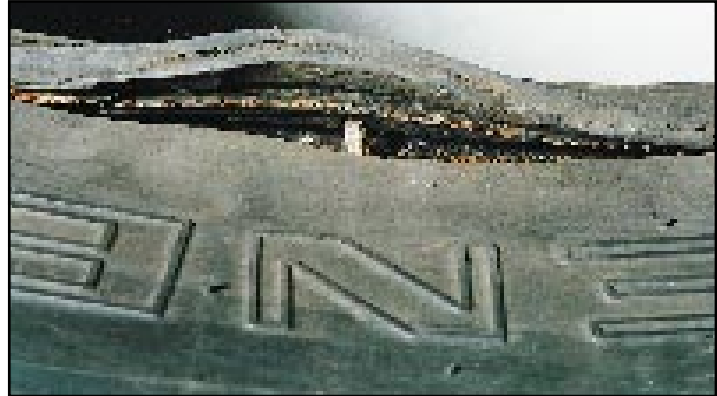
Circumferential cracks above bead flange area with cord material exposed.

Improper bead seating, improper rim size, overload condition, underinflation, impact or possible manufacturing condition.

Remove from service and consult tire manufacturer.

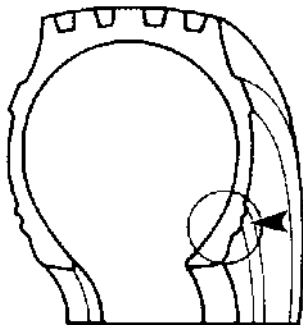
Petro/Lubricant Damage

APPEARANCE	Rubber exhibits blistering, swelling, or spongy condition in the bead area. In later stages the bead may appear dry and brittle. Petroleum odor may be evident.
PROBABLE CAUSE(S)	Use of petroleum-based products such as a lubricant, i.e., oil, diesel fuel and antifreeze.

TIRE	Scrap tire.
VEHICLE	None
OPERATIONS	Use of proper non-petroleum-based tire lubricants.

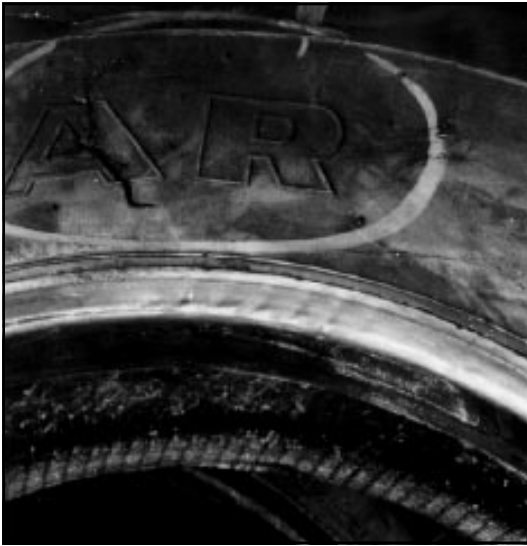
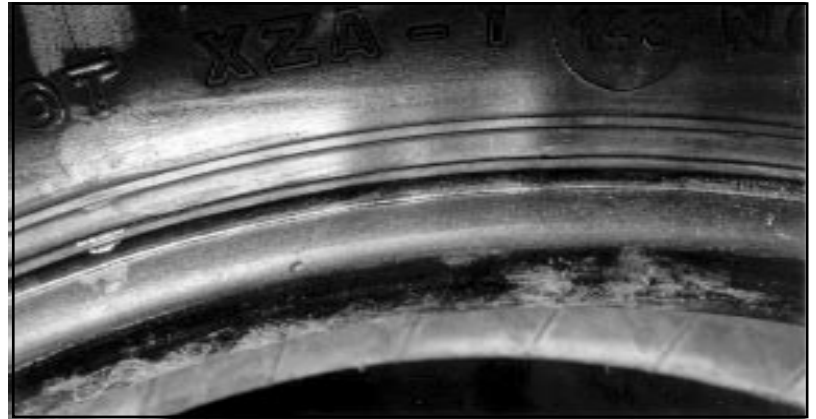
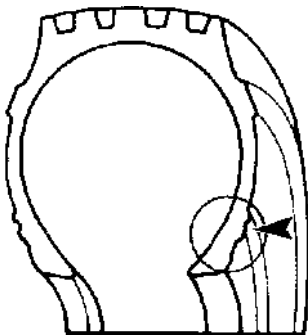
Bead Damage from Curbing

Curbing.

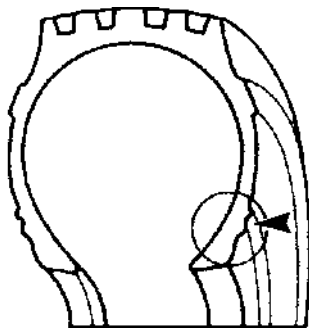
Bead Area Flow Crack

APPEARANCE	Circumferential crack above the bead with no wire exposed.
PROBABLE CAUSE(S)	Improper rubber flow during the manufacturing process.

TIRE	Remove from service and contact the tire manufacturer.
VEHICLE	None
OPERATIONS	None

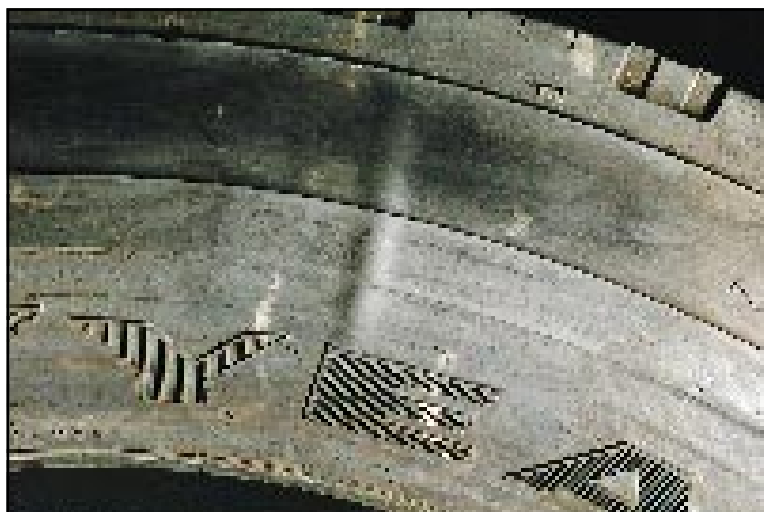
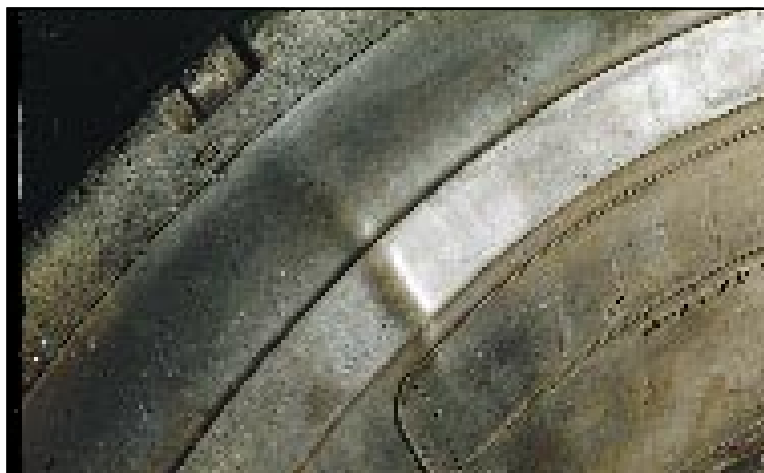
Spread/Damaged Cord

APPEARANCE	Radial, pencil shaped bulge in the sidewall of a radial tire.
PROBABLE CAUSE(S)	Wider than normal wire spacing. A tire with a repair may show this condition soon after being repaired, or the condition may arise somewhere along a body ply that has been damaged — not necessarily in the repair area.

TIRE	Determine the cause of the bulge. Repaired tires can often be returned to service on dual positions unless the bulge height exceeds 3/8" when inflated. If the cause of the bulge is not a repair or damage, contact the tire manufacturer.
VEHICLE	None
OPERATIONS

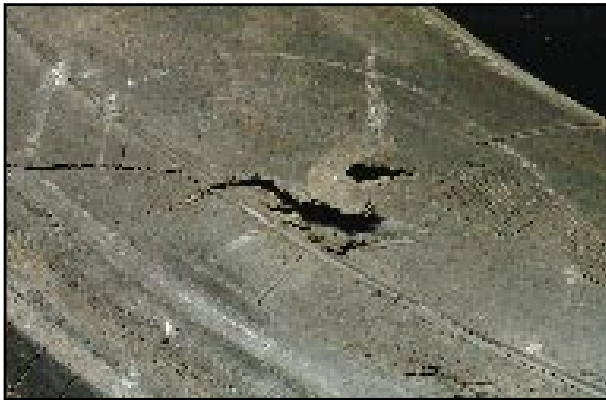
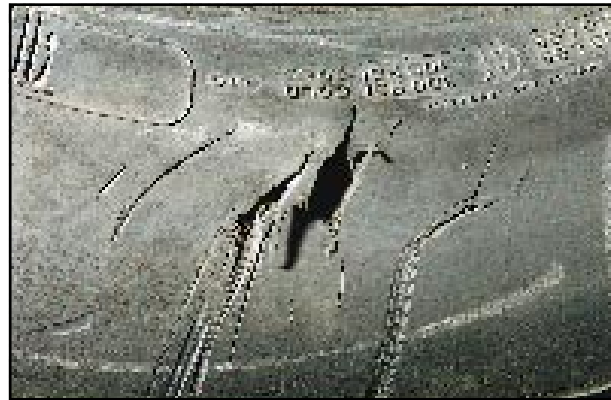
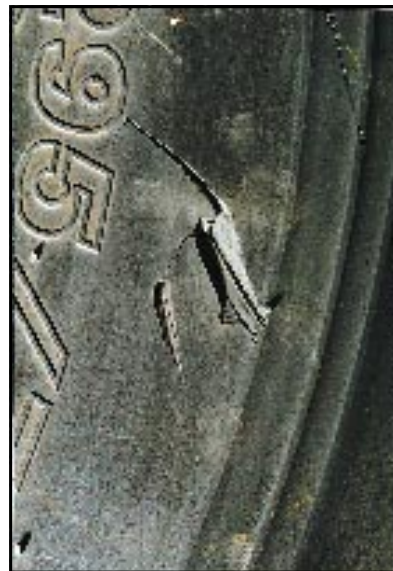
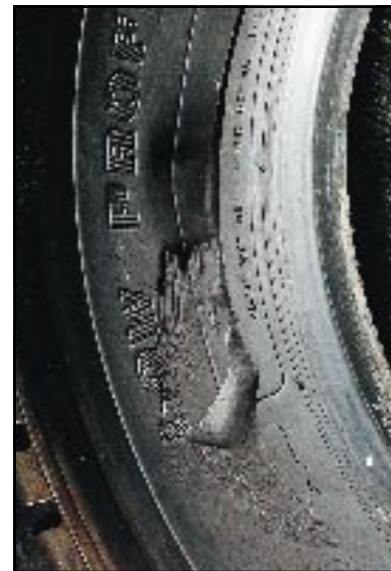
APPEARANCE	Scrapes, gouges or cuts in the sidewall.
PROBABLE CAUSE(S)	Road hazard, curbing, equipment damage, wash rack rails, pit rails, vandalism, etc.

TIRE	If damage has not exposed ply cords, tire may be run out on dual positions. If the cords are visible, repair the tire if damage to the cords is within repair limits and return to service; otherwise scrap tire.
VEHICLE	Ensure the tire does not come in contact with vehicle hardware.
OPERATIONS	If similar damage occurs on several tires, investigate vehicle operations to determine the cause of the damage.

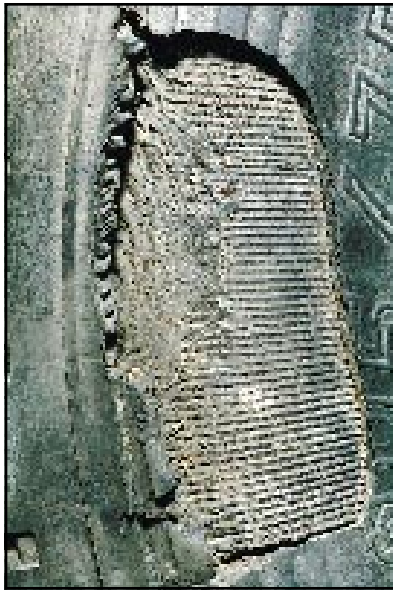
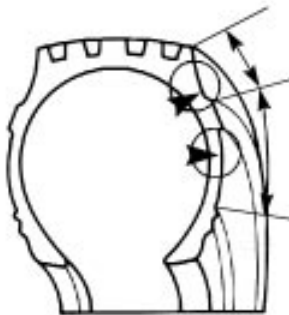
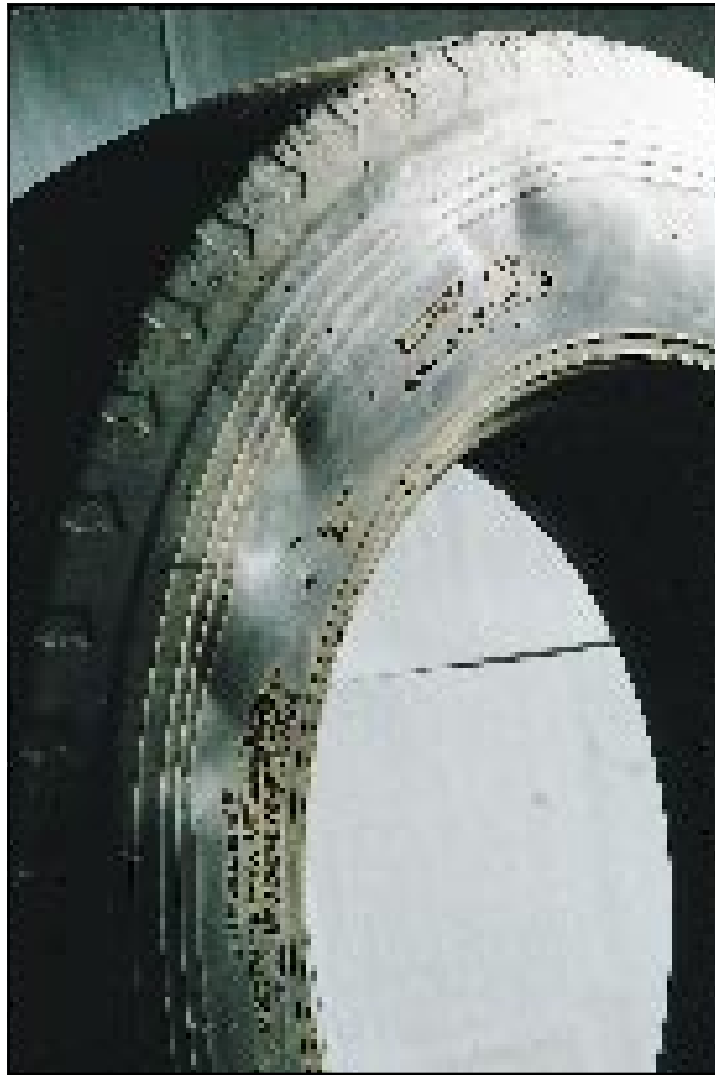
APPEARANCE	Irregular shaped bulge in mid/upper sidewall area; may progress to complete separation of sidewall rubber from the casing exposing the ply cords. No repairs, breaks or punctures in the casing are evident.
PROBABLE CAUSE(S)	Loss of adhesion between the sidewall rubber and the body ply.

TIRE	Remove the tire from service and contact your tire manufacturer.
VEHICLE	None
OPERATIONS	None

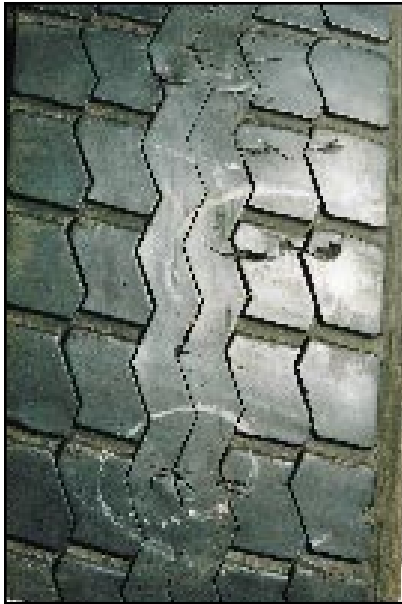
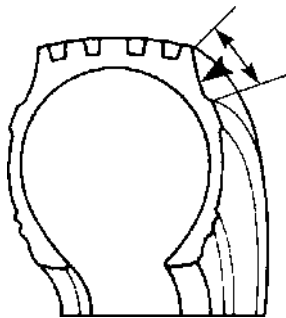
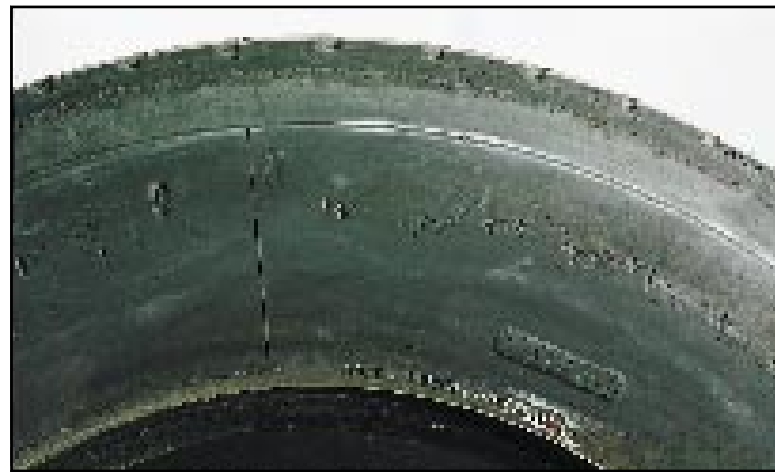
Chain Damage

APPEARANCE	Numerous pock marks around the tire on the mid to upper sidewall and crown area.
PROBABLE CAUSE(S)	Chain abrasion often due to loose or improperly sized chains or extended chain use on dry surfaces.

TIRE	Run out the tire on a dual position unless damage extends to the ply cord. If ply cords are visible, consult your tire repair facility for the possibility of repair.
VEHICLE	None
OPERATIONS	Select the proper chain size. Correct the installation procedures and enforce chain removal when conditions warrant.

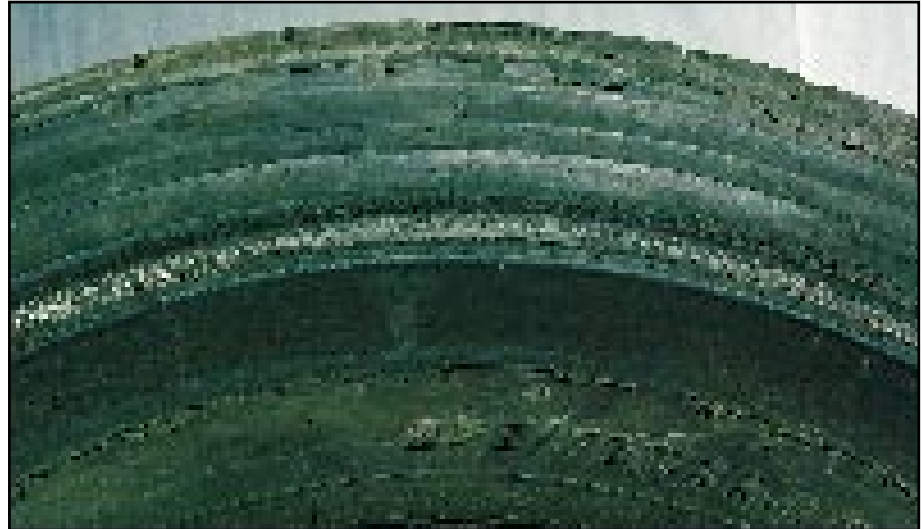
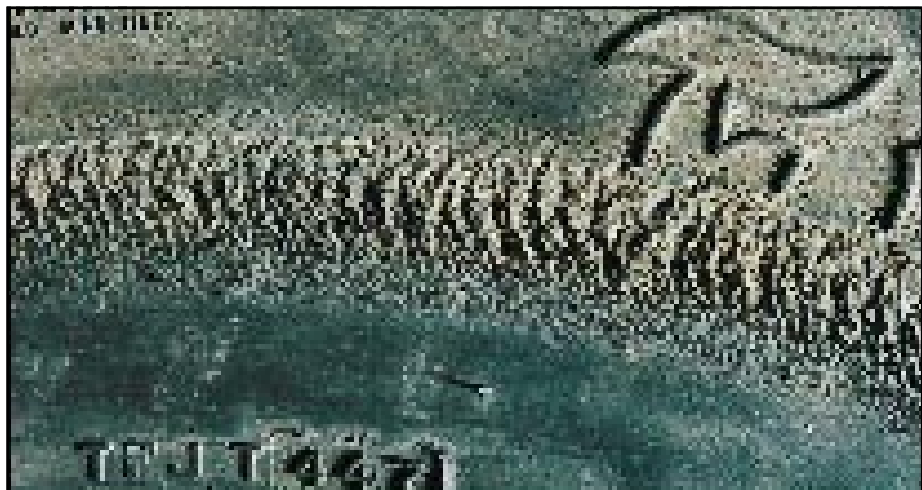
Vehicle/Equipment Damage

Contact with vehicle hardware, such as loose U-bolts, slipped spring clips, restraining bolts, loose fenders, flap hangers and trailer wheel house molding, etc. Can also be caused by objects trapped between the duals.

Return the tire to service on a dual position unless abrasion extends to the ply cords. If the cords are exposed, consult your tire repair facility for the possibility of repair.

Analyze cause of the condition and correct.

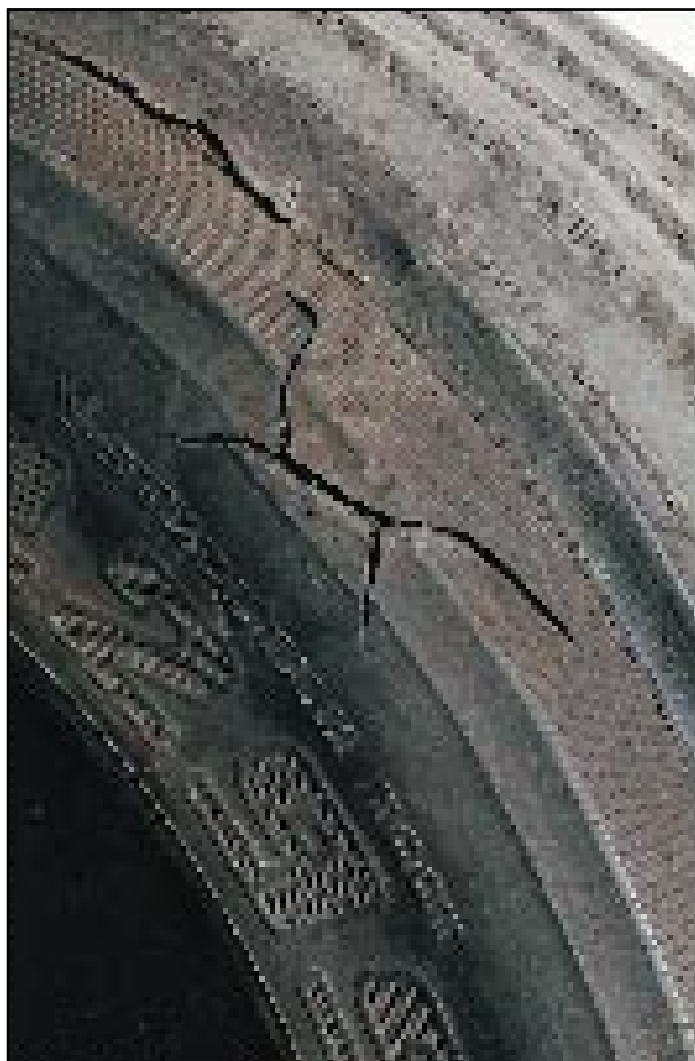
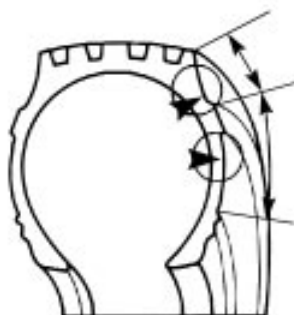
Damage Induced Sidewall Separation

APPEARANCE	Irregular shaped bulge in the mid/upper sidewall area; may progress to complete separation of the sidewall rubber from the casing, exposing the ply cords. Breaks in the liner, a puncture or damage to the casing is evident.
PROBABLE CAUSE(S)	A puncture, impact, inner liner damage or bead damage.

TIRE	Scrap tire.
VEHICLE	None
OPERATIONS	Determine the cause and take appropriate corrective action.

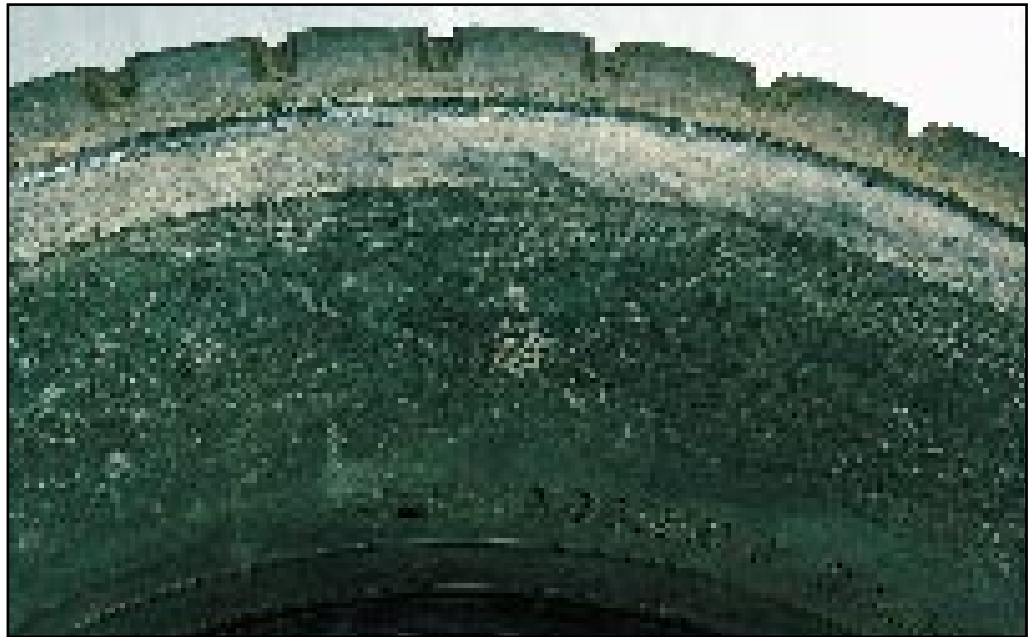
Sidewall Abrasion/Scuff Damage

Rubbing against curb or guide rails. Most often seen in city delivery service.

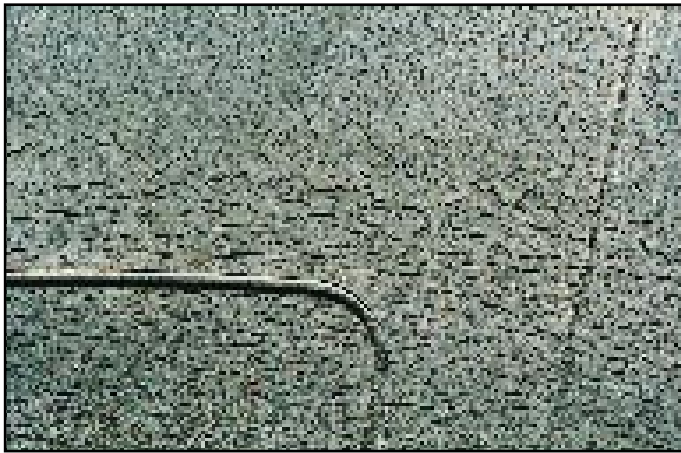
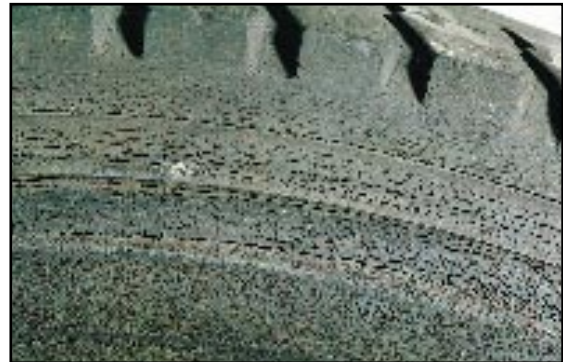
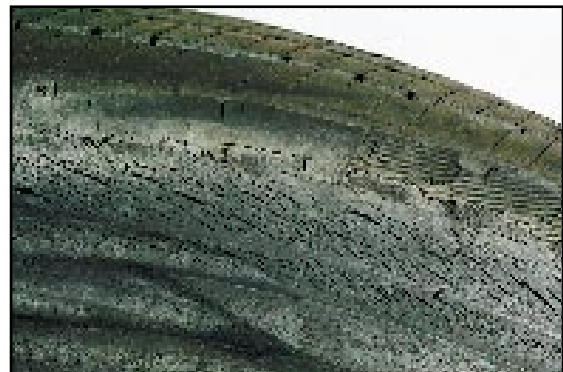
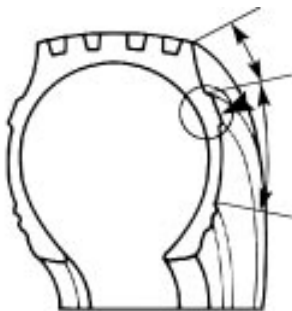
APPEARANCE	Numerous tiny cracks in the rubber surface, most often 360° around the tire.
PROBABLE CAUSE(S)	Rubber surface exposure to environmental elements. Aggravated by long periods of parking and high concentrations of ozone.

TIRE	All tires may eventually exhibit this condition in late service-life stage. Tires can be run out on the steer axle if weathering is minor; on dual positions if weathering is moderate. Severe weathering may require removal from service.
VEHICLE	None
OPERATIONS	Weather protection materials compounded into the tire are more effective when the tire is exercised. Therefore, minimize parked vehicle time. Consult your tire manufacturer if long periods of parking are expected.

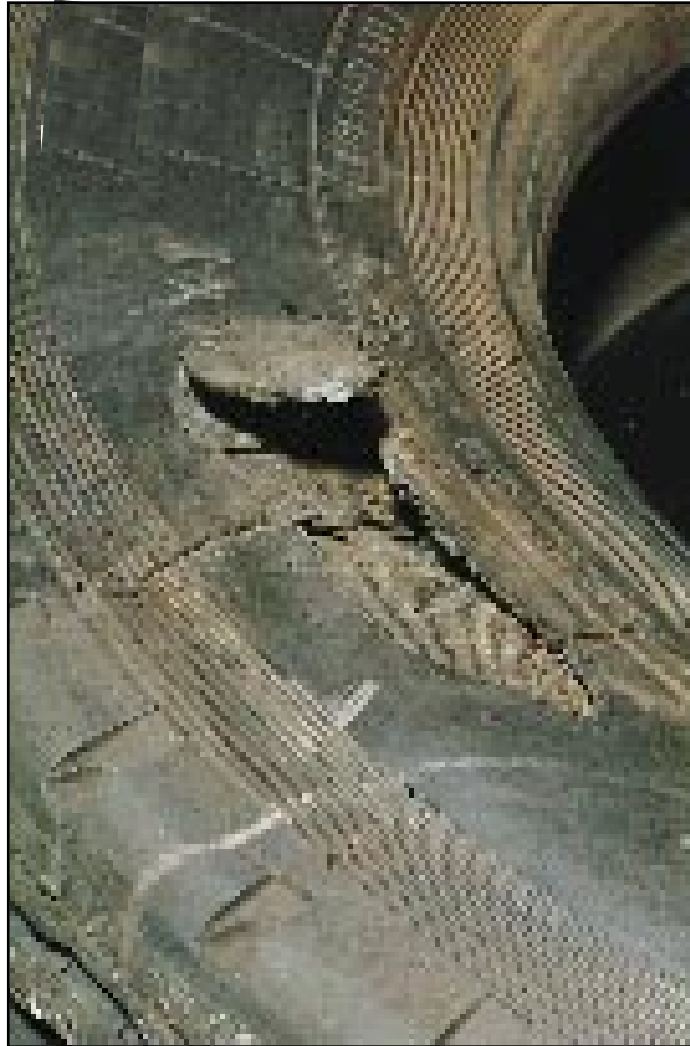
Break in the sidewall through the casing. This condition will usually deteriorate quickly to a radial runflat appearance.

Caused by a sudden impact with a road hazard or a chuck hole. Aggravated by overinflation.

Consult your tire repair facility for the possibility of repair or scrap tire.

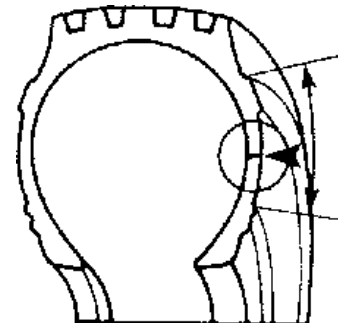
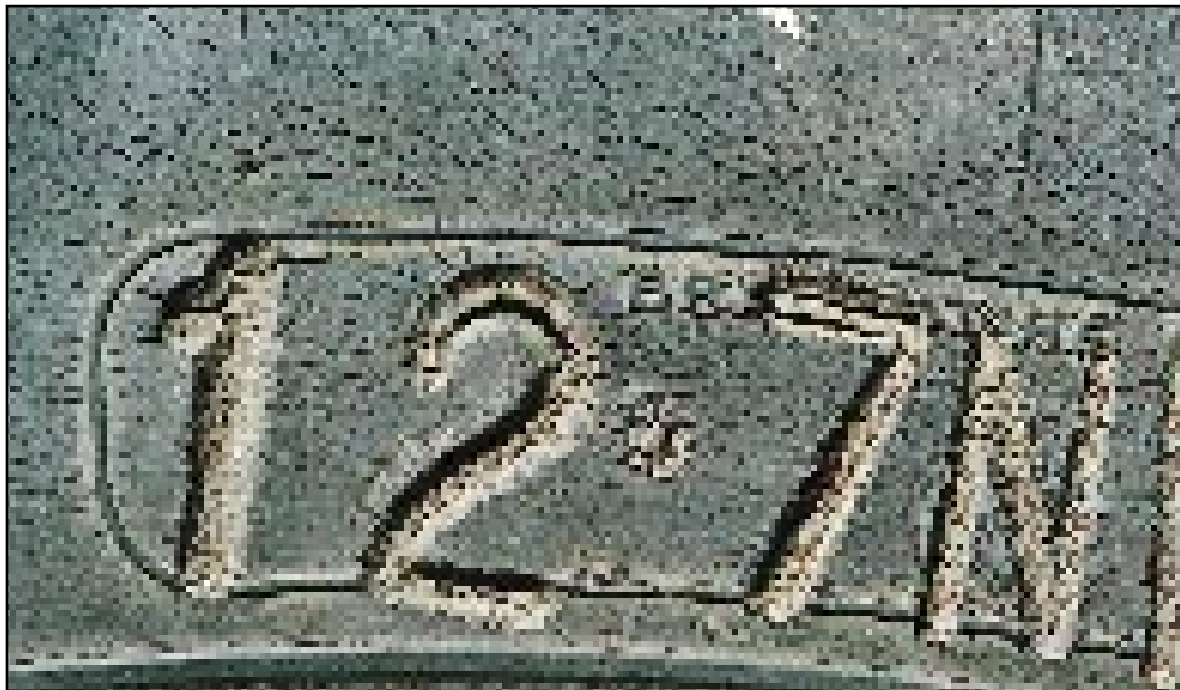
Branding Damage

APPEARANCE	Stress cracks extending from the characters branded into the tire after manufacture.
PROBABLE CAUSE(S)	Caused by branding too deep, in the wrong location on the tire sidewall, at too high a temperature, or at a sharp angle.

TIRE	Tires with hairline cracks can be returned to service. Depending upon crack severity and location, consult your tire manufacturer; if cords are exposed, scrap tire. Otherwise consult your tire repair facility for the possibility of repair.
VEHICLE	None
OPERATIONS	Review the tire manufacturer's branding recommendations.

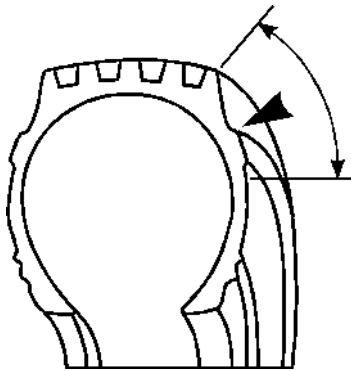
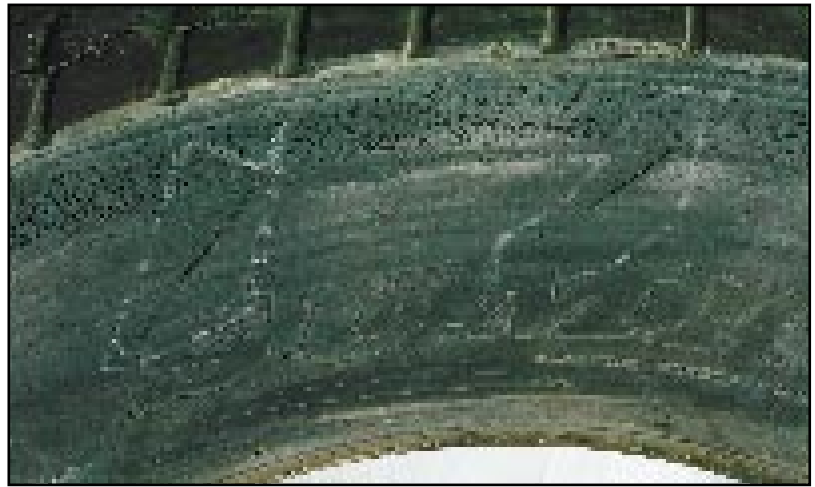
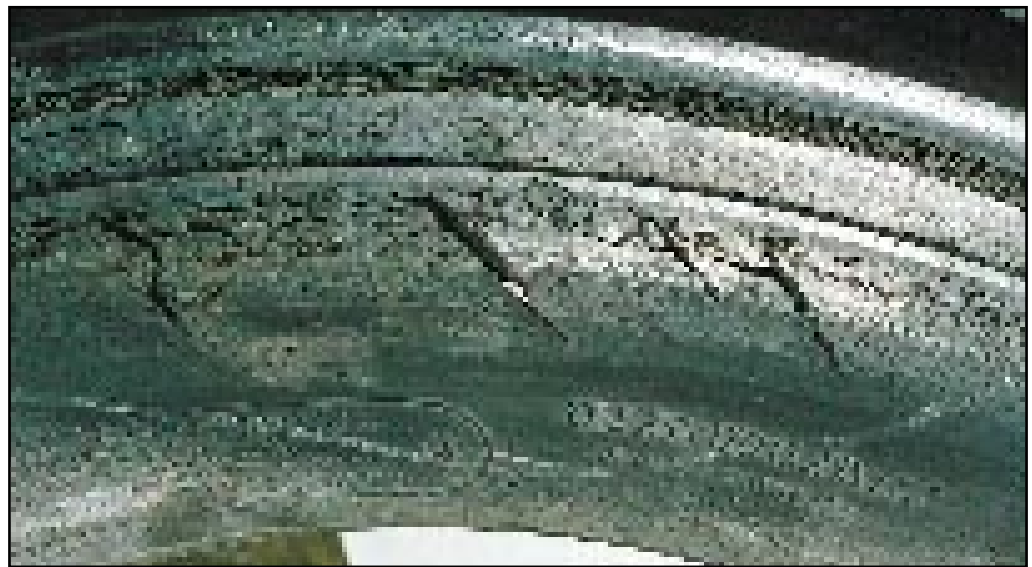
Diagonal Cracking

Diagonal crack or cracks in the upper sidewall area of tires on drive and trailer axles.

Frequently can be a result of torque transfer. Aggravated by underflation. This condition should not be confused with cut(s) from sharp curb edges, road hazards, etc.

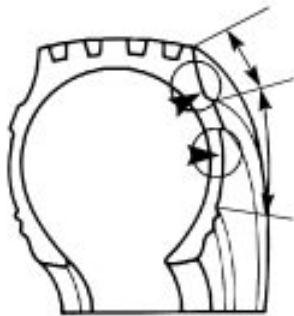
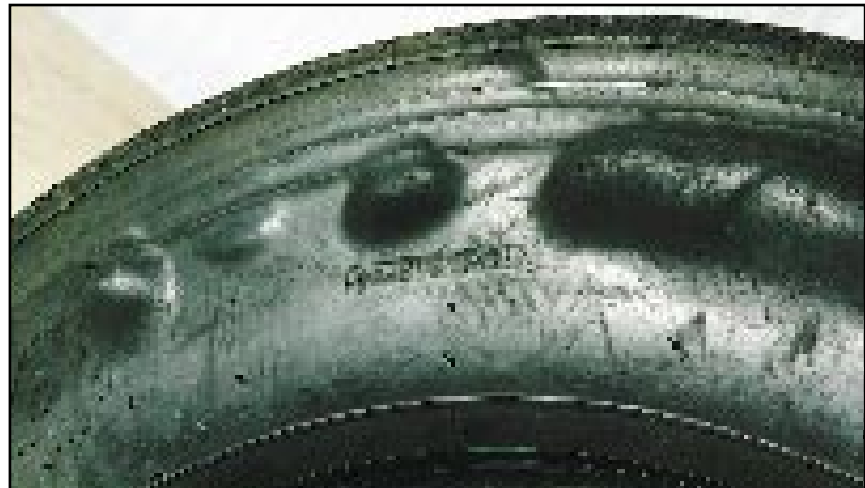
Petroleum Product Damage

APPEARANCE	Sidewalls appear swollen, soft and spongy. In extreme cases, sidewalls may be undulated or distorted. Petroleum odor may be evident.
PROBABLE CAUSE(S)	Oil, diesel fuel, antifreeze or chemical contamination.

TIRE	If contamination is slight, return tire to service. If there is a difference in stiffness or distortion in one sidewall when compared with the other, scrap tire.
VEHICLE	Check vehicle for fluid leaks.
OPERATIONS	Take special precautions during fueling to avoid spills

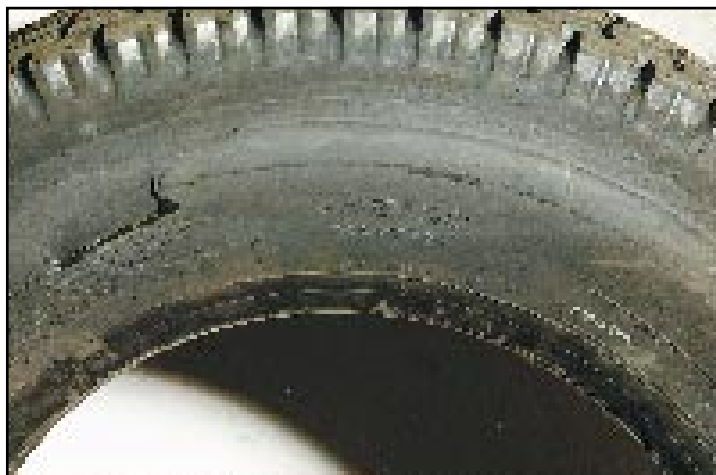
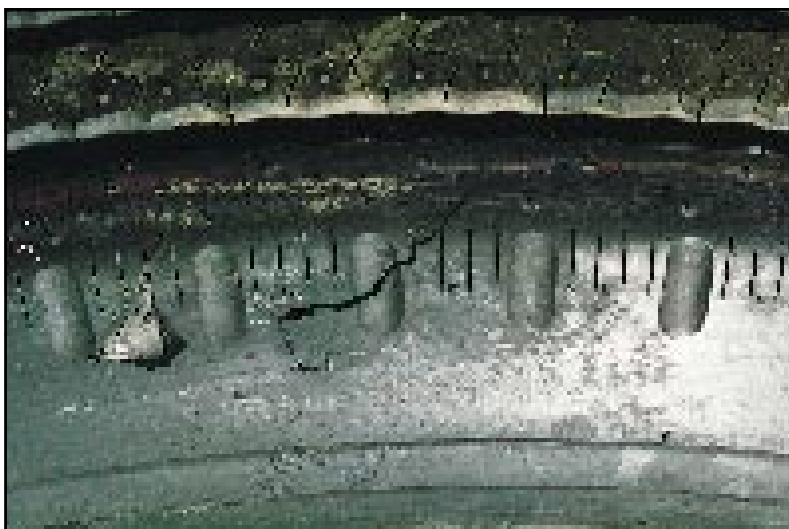
Forklift Damage

Cut similar to impact damage on a brand new tire.

Caused during shipping and handling by lift truck forks.

Do not place in service. Determine responsibility for the damage.

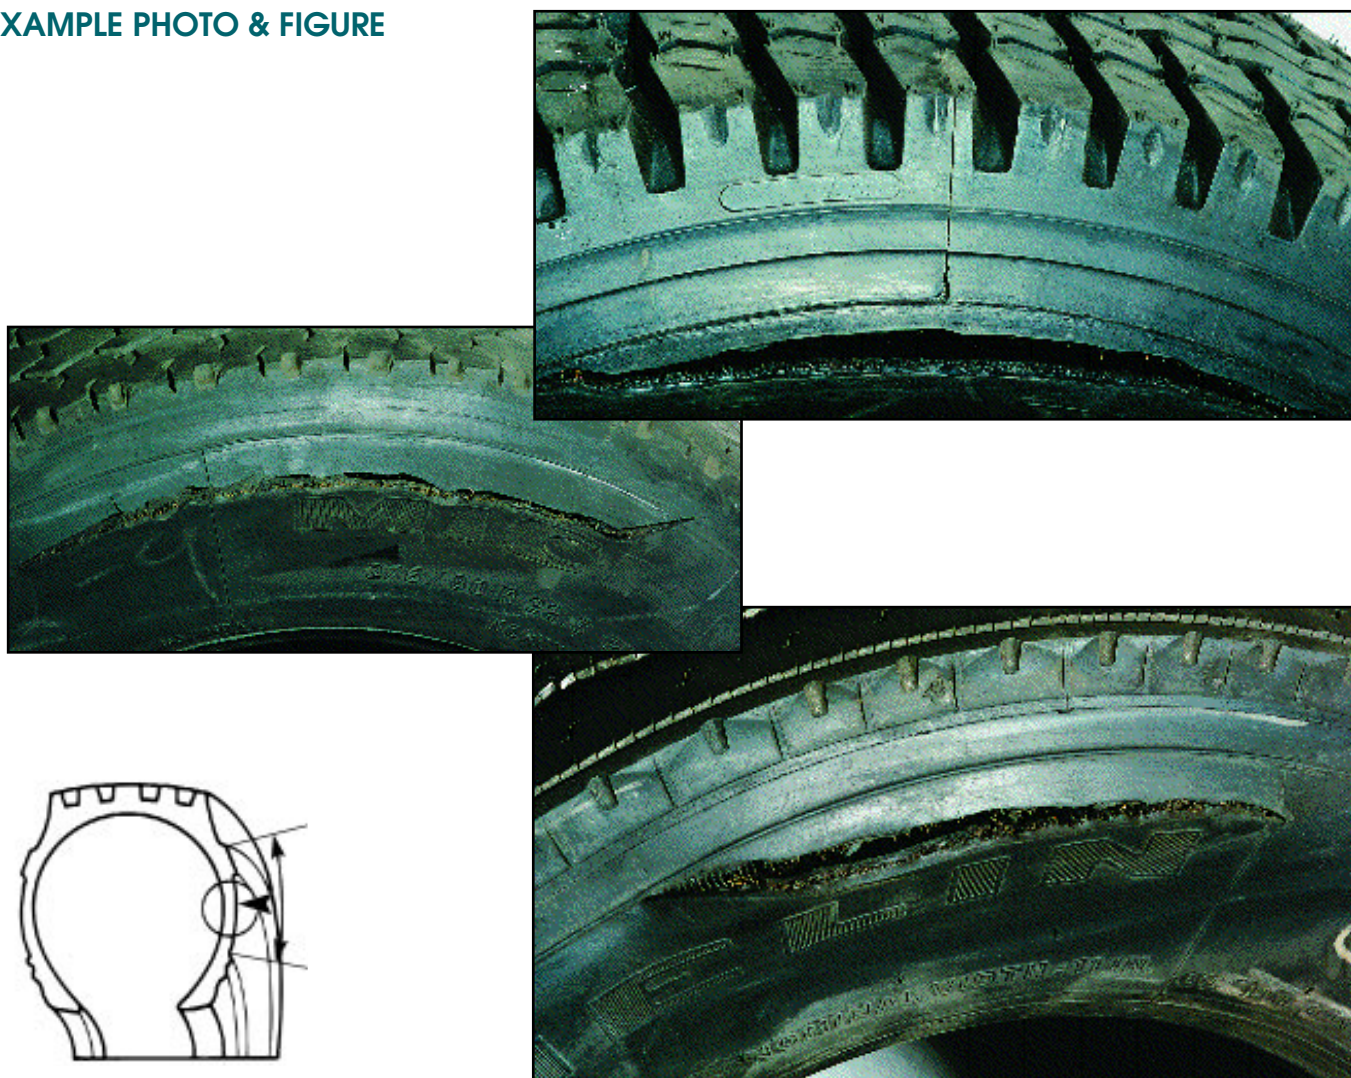
Circumferential Fatigue Rupture (Zipper)

APPEARANCE	A circumferential break in the mid to upper sidewall exposing an even line of broken cords.
PROBABLE CAUSE(S)	Severe underinflation which produces casing cord fatigue, often a result of a puncture.

TIRE	Scrap tire.
VEHICLE	None
OPERATIONS	Routinely inspect all tires with inflation pressures 20% lower than your fleet's inflation standard; thoroughly inspect all tires prior to repair and retreading; always use a safety cage during inflation. Consult your tire or retread supplier for proper inspection procedures.

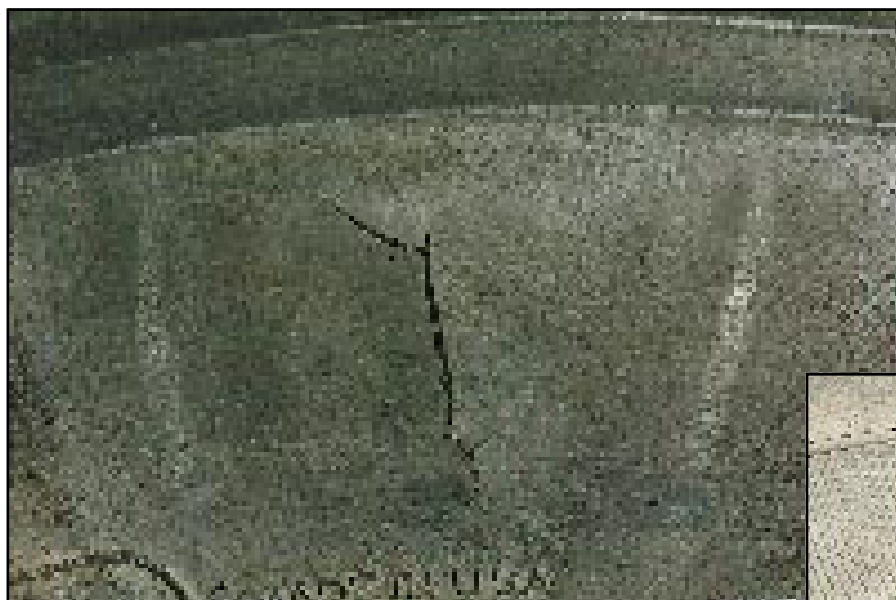
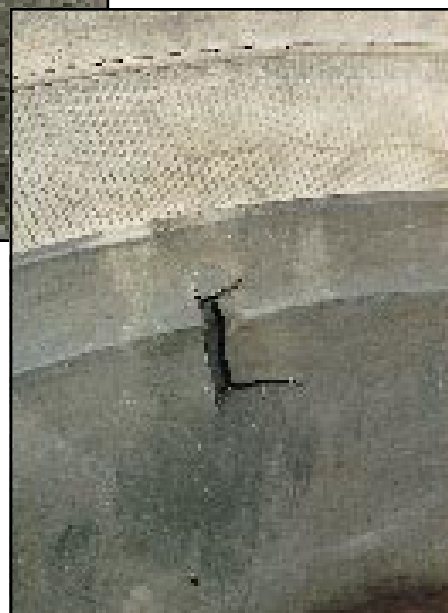
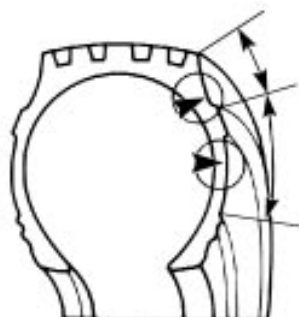
APPEARANCE	Regular smooth opening of the top layer of sidewall rubber that may appear radially or diagonally. Appearance is similar to a cut, however, the opening extends at a sharp angle into the sidewall rubber. No cords are exposed.
PROBABLE CAUSE(S)	Manufacturing process.

TIRE	Remove the tire from service. Consult your tire manufacturer.
VEHICLE	None
OPERATIONS	None

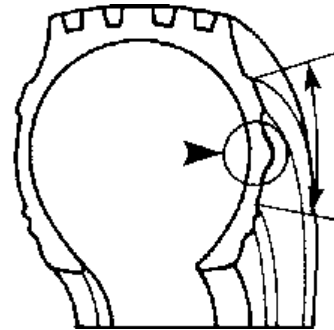
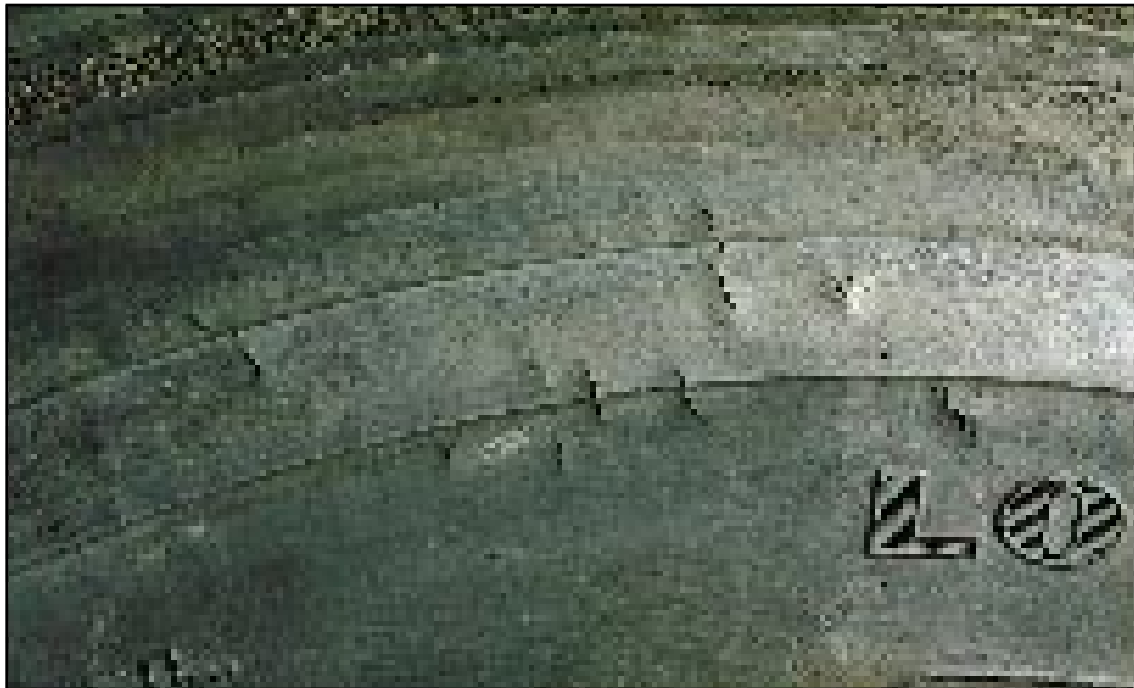
APPEARANCE	Small, raised, scattered areas in the upper sidewall that can be felt when rubbing the casing. In later stages, the sidewall may appear blistered and can lead to a sidewall rupture.
PROBABLE CAUSE(S)	Deterioration of internal components over time. Fatigue of casing. Accelerated by overload/underinflation.

TIRE	Remove the tire from service. If this condition arises during the warranty period, consult your tire manufacturer. Otherwise scrap tire.
VEHICLE	None
OPERATIONS	None

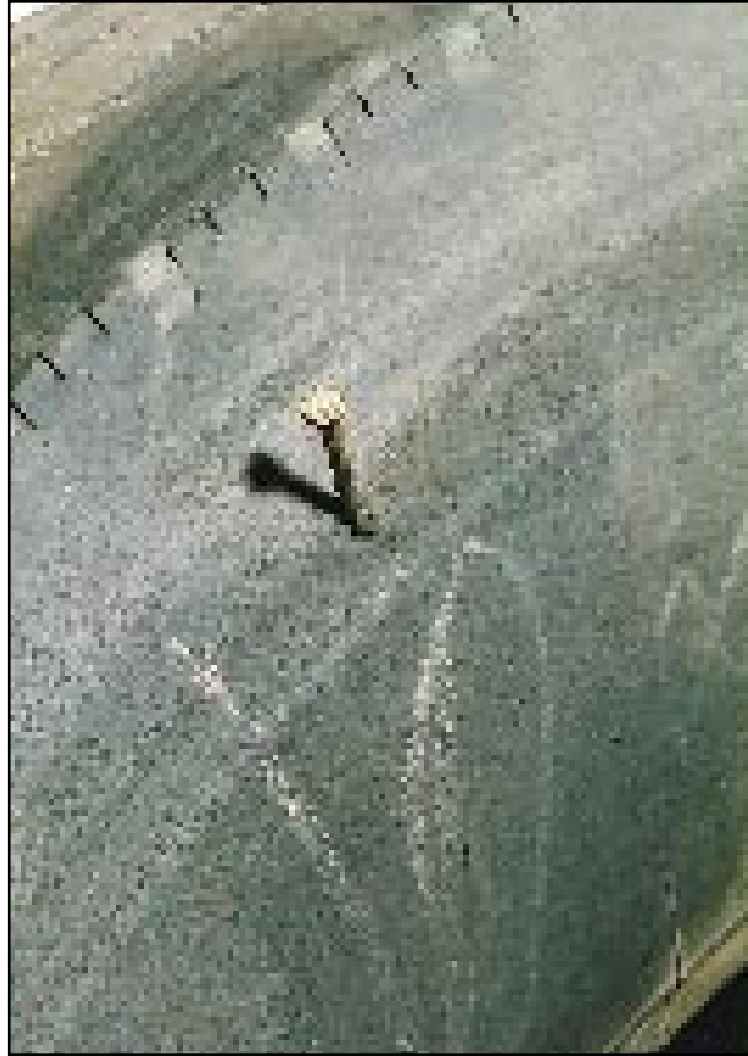
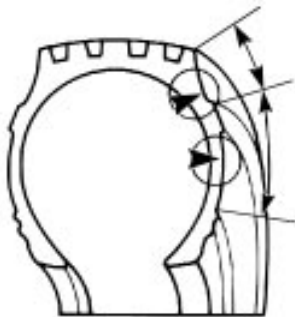
APPEARANCE	Any damage caused by an object that goes through the sidewall of the tire.
PROBABLE CAUSE(S)	Road debris and, occasionally, vandalism with a sharp puncturing instrument.

TIRE	Have the tire inspected by your tire repair supplier to determine repairability.
VEHICLE	None
OPERATIONS	Avoid road hazards.
