RADIAL TIRE CONDITIONS ANALYSIS GUIDE

**A Comprehensive
Review of Tread Wear
And Tire Conditions**

© Copyright 1994 The Maintenance Council
Printed in U.S.A.

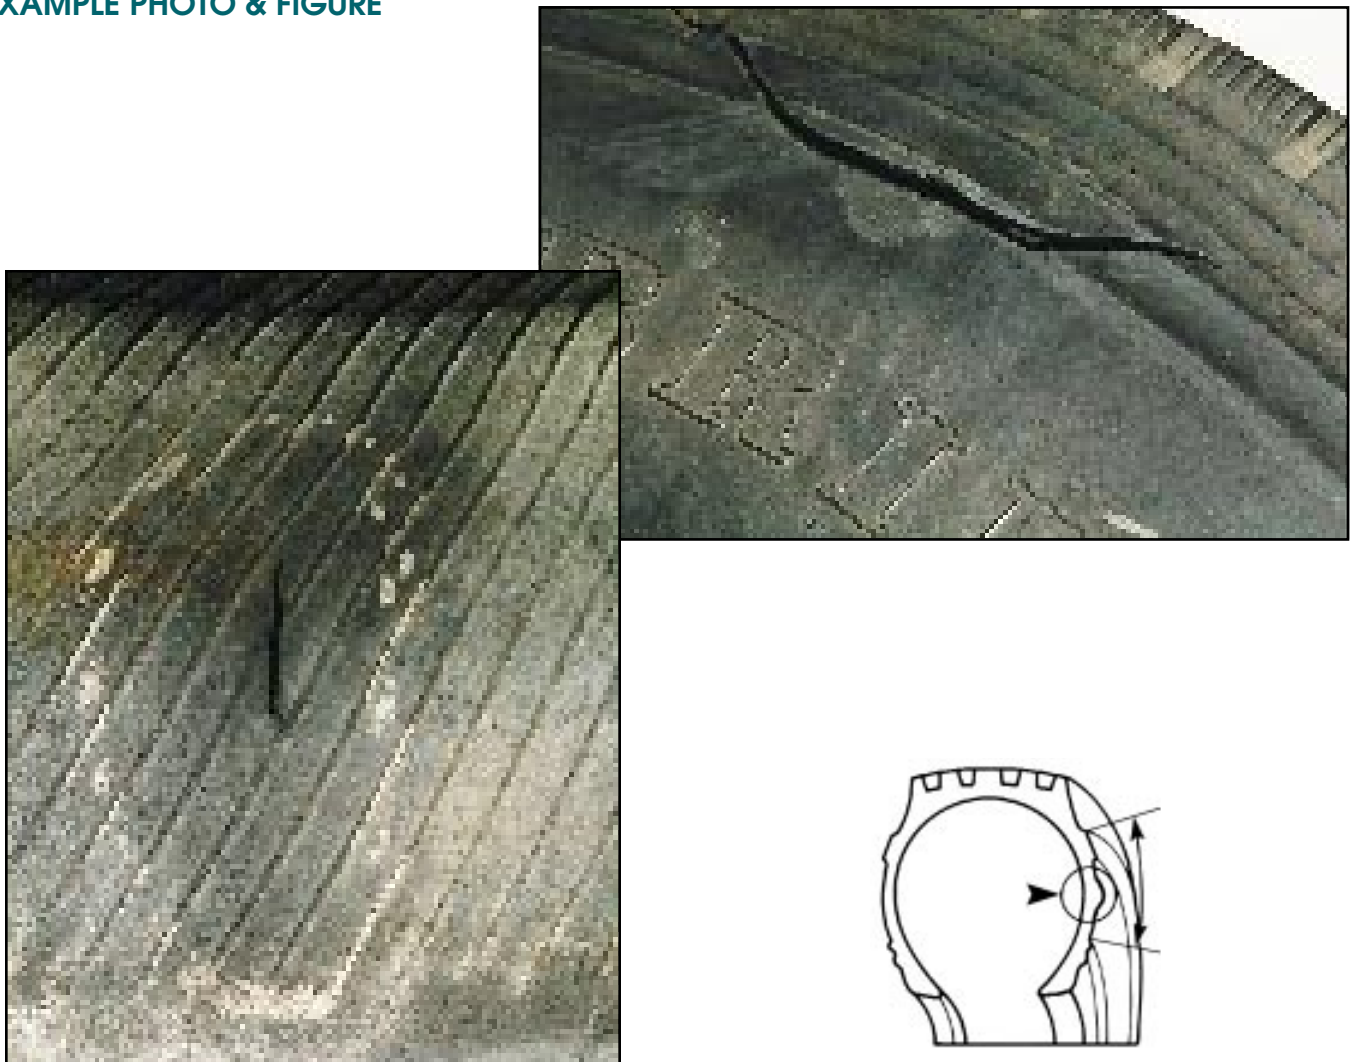
APPEARANCE	A vertical break through the sidewall occurring between two body ply cables, that does not break the cables.
PROBABLE CAUSE(S)	Severe impact. This situation can occur in overinflated and/or overloaded conditions.

TIRE	Have the tire inspected by your tire repair supplier to determine repairability.
VEHICLE	None
OPERATIONS	Review inflation maintenance program and review driver training.

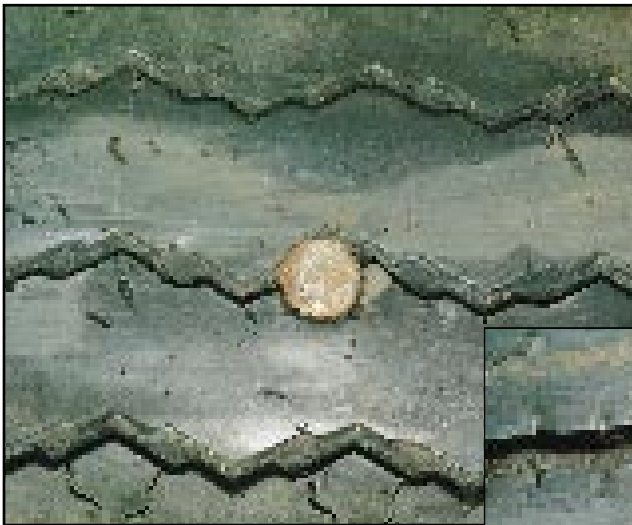
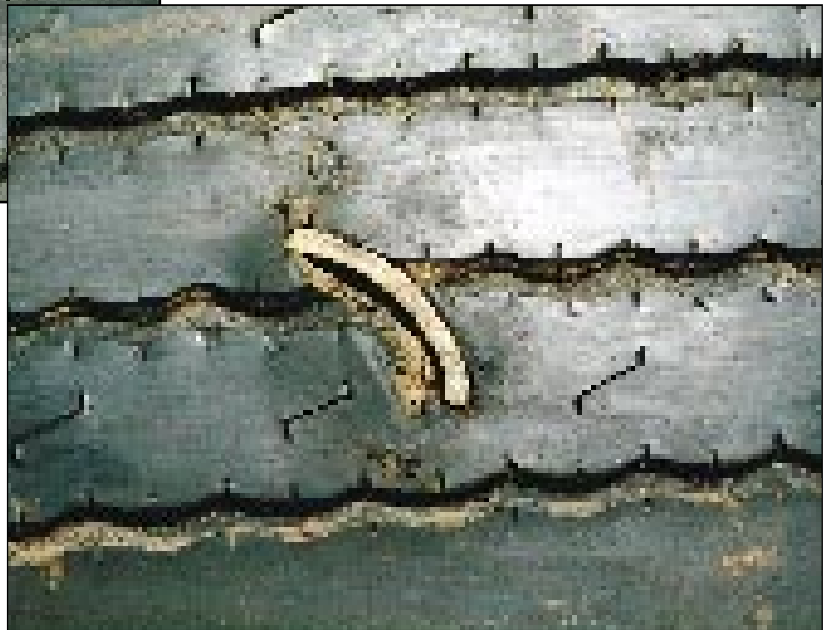
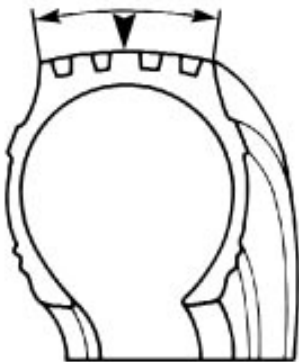
Penetrations And Road Hazards

Evidence of a puncture or damage by a foreign object through the crown area; may result in a separation.

Road hazard or foreign object.

Determine casing integrity. Consult your repair facility for possibility of repair. If the damage is excessive and/or a separation is evident, scrap tire.

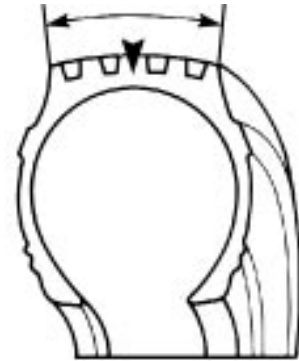
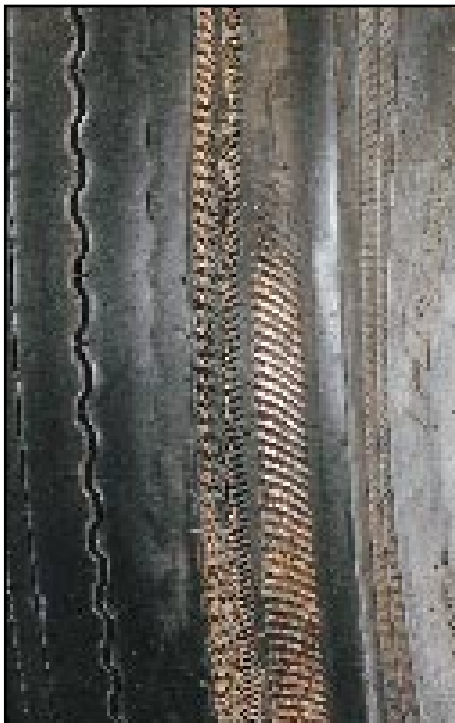
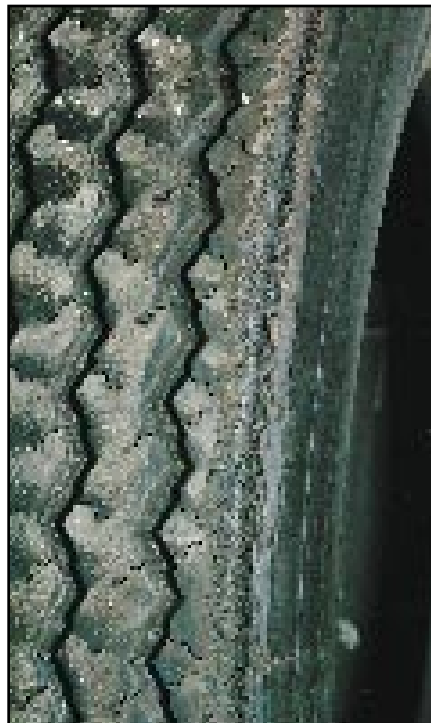
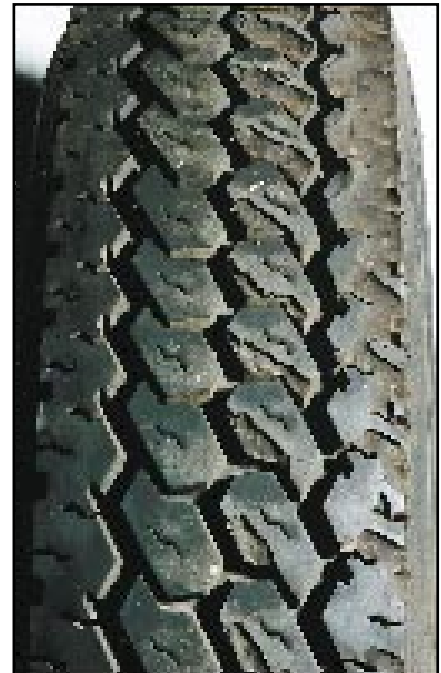
Vehicle Damage

APPEARANCE	Cut in tread or shoulder area, usually 360° around tire.
PROBABLE CAUSE(S)	Contact with vehicle hardware, such as mud flap brackets, trailer wheel house molding, bumpers, etc.

TIRE	If cuts are not deeper than the base or the tread groove, return to a dual position. If the damage is deeper, retread or rebelt if possible. If the condition is more severe, scrap tire.
VEHICLE	Analyze the cause of the condition and correct.
OPERATIONS	Review driving procedures.

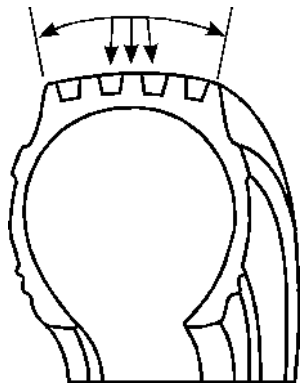
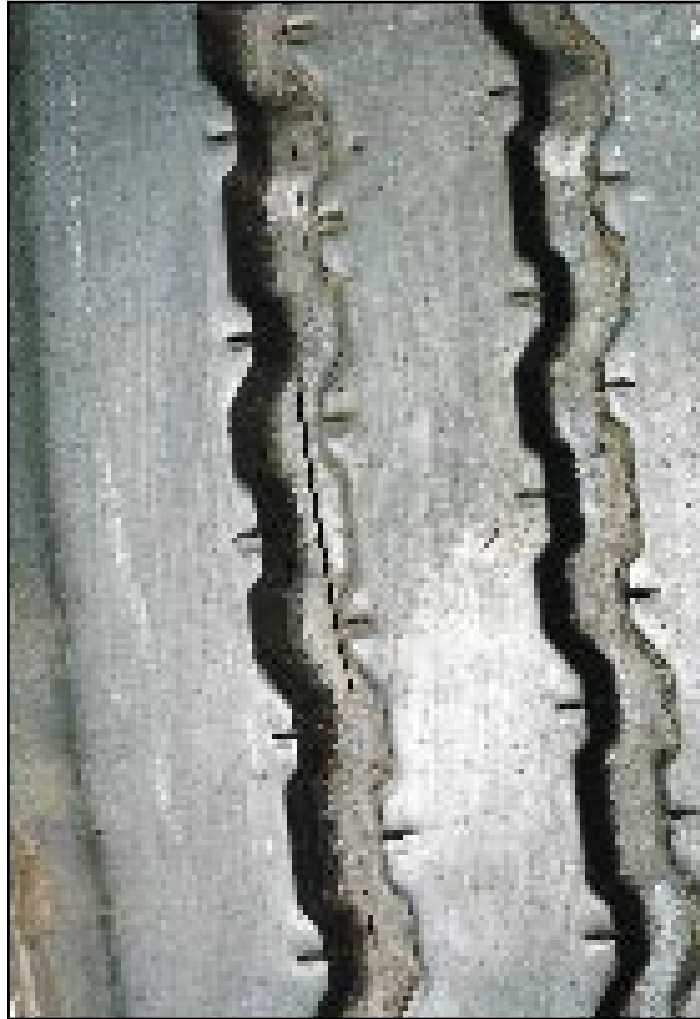
Forklift Damage/Cuts And Snags

APPEARANCE	Individual or multiple cuts, usually in the tread grooves in a localized area of the crown.
PROBABLE CAUSE(S)	Caused by lift truck forks or similar equipment.

TIRE	If the tire is new, determine the responsibility for damage before placing it into service. If the tire has been in service but no steel is exposed, return to service. If steel is exposed, retread or rebelt.
VEHICLE	None
OPERATIONS	Inspect new tires upon receipt.

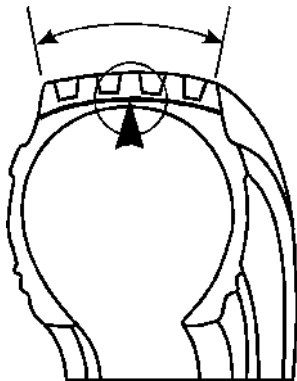
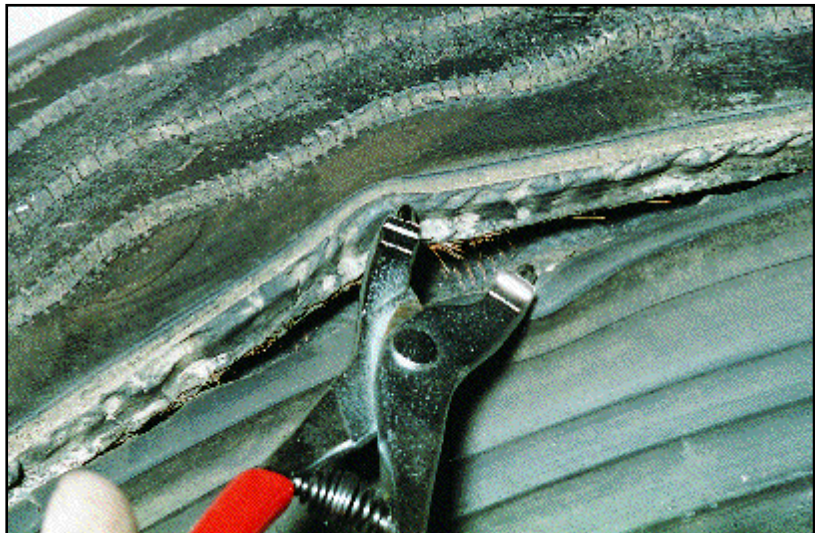
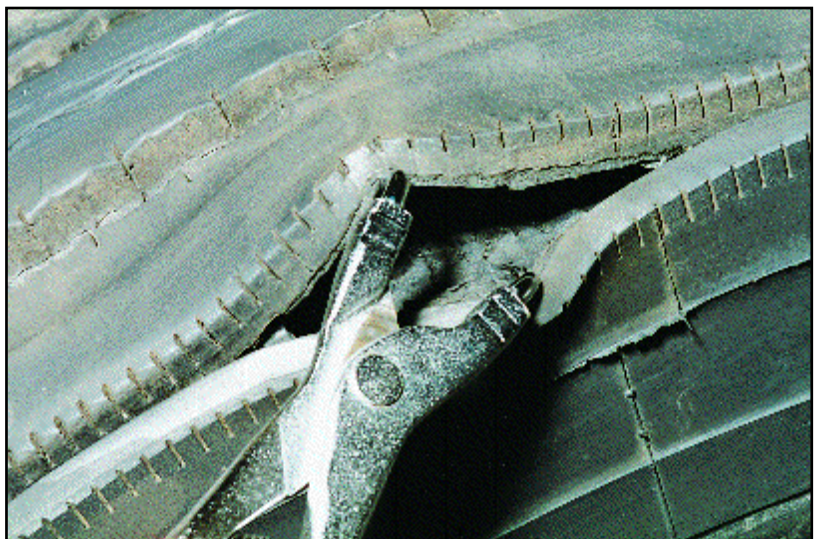
APPEARANCE	A bulge or split through the upper sidewall/shoulder area. Probing will reveal the belts sometimes accompanied by a worn spot in the tread.
PROBABLE CAUSE(S)	Adhesion loss within the tire at the edge of the belt package. May be associated with a penetration or other damage. Can be aggravated by spread axle use or dragging tire sideways.

TIRE	Remove from service and consult your tire manufacturer.
VEHICLE	None
OPERATIONS	Use largest radius turns possible to avoid tire scrubbing.

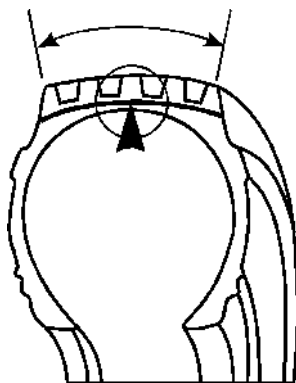
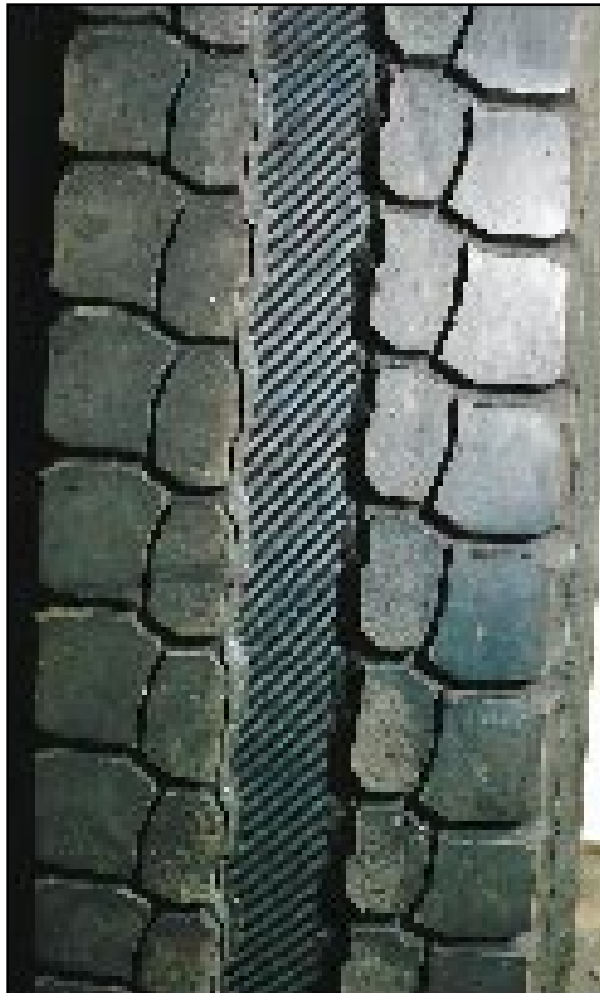
APPEARANCE	Bulge on shoulder or tread face area may be accompanied by split through the bottom of the tread groove. Usually localized wear in the tread above the separated area will occur. May result in a loss of a section of tread. Belt package is intact.
PROBABLE CAUSE(S)	Adhesion loss between the tread rubber and the tire casing. Can be caused by tread penetration.

TIRE	Remove tire from service. Consult your tire manufacturer.
VEHICLE	None
OPERATIONS	None

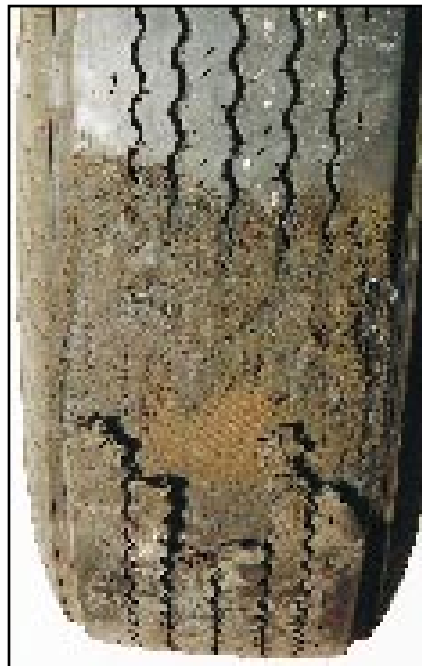
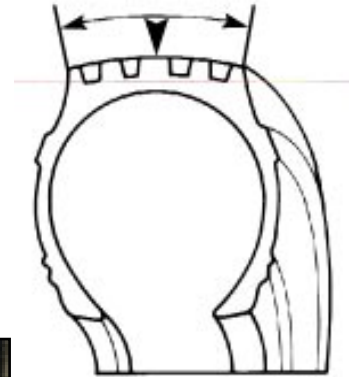
Brake Skid Damage

APPEARANCE	Localized spot of excessive wear across the tread face showing abrasion marks from the tread sliding on the road surface; damage may extend into the casing.
PROBABLE CAUSE(S)	Brake skid usually occurs on trailer and drive tires. Aggravated by new brakes (high friction, not worn in), unbalanced brake system, aggressive use of brakes, driver abuse and unloaded vehicles.

TIRE	If condition does not extend below 2/32" of tread, duals can be rematched to position flat spots 180° from each other. If more severe, the tire can be repaired or retreaded if damage is not into the belts. If skid damage is into the tire belts, it may be possible to remove the top belt and/or rebelt the tire; consult your retreader. If damage is too excessive, scrap tire.
VEHICLE	Check brake materials and brake balance.
OPERATIONS	Review driving procedures.

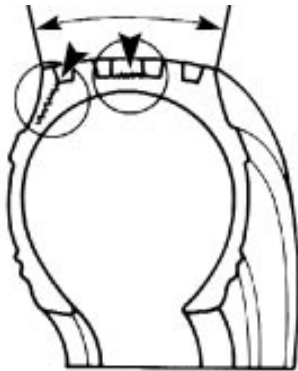
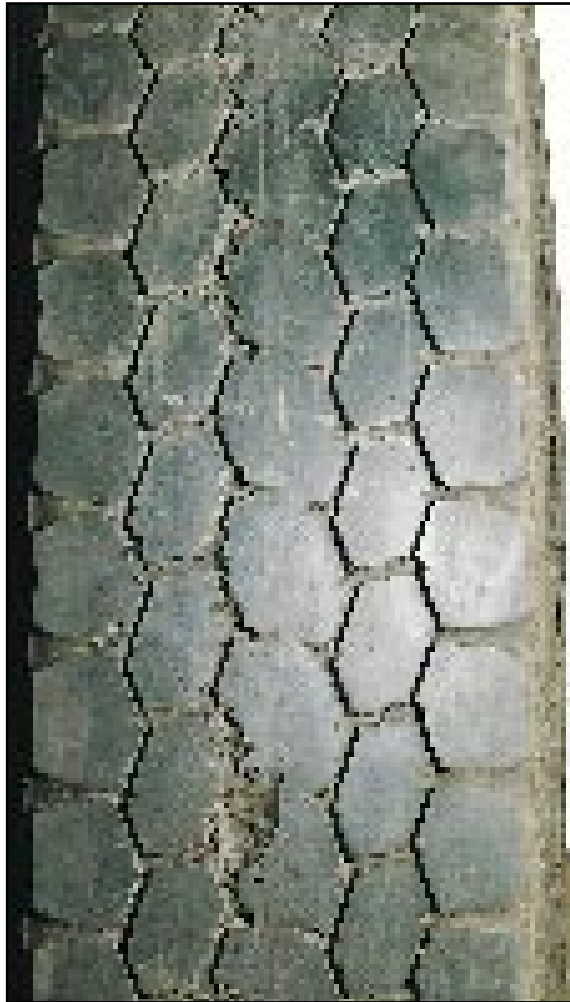
Caused by tire running over curbs or rails or by severe localized impacts. Aggravated by hot tires, spread axles, sharp turning and off road utilization.

Remove the tire from service. Repair or retread.

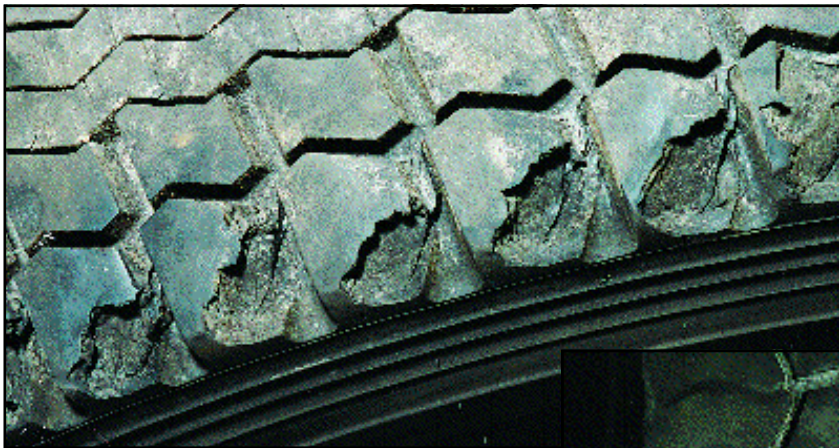
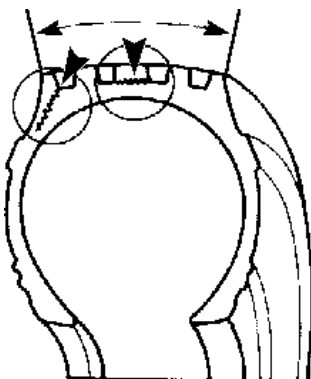
Lug Base Cracking

APPEARANCE	One or more cracks in the tread rubber located between and at the base of lugs in the shoulder area.
PROBABLE CAUSE(S)	This condition is caused by a combination of drive axle torque, load and heat. It also can be due to tire construction or started by stone drilling. It is aggravated by underinflation.

TIRE	If cracks do not extend into the retread buff line, return to dual wheel service. If cracks extend deeper, consult your tire manufacturer.
VEHICLE	None
OPERATIONS	None

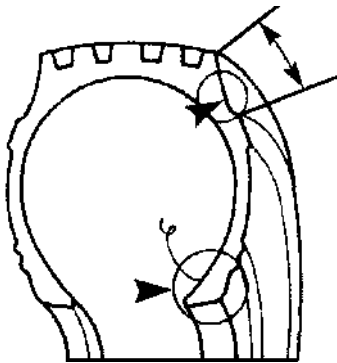
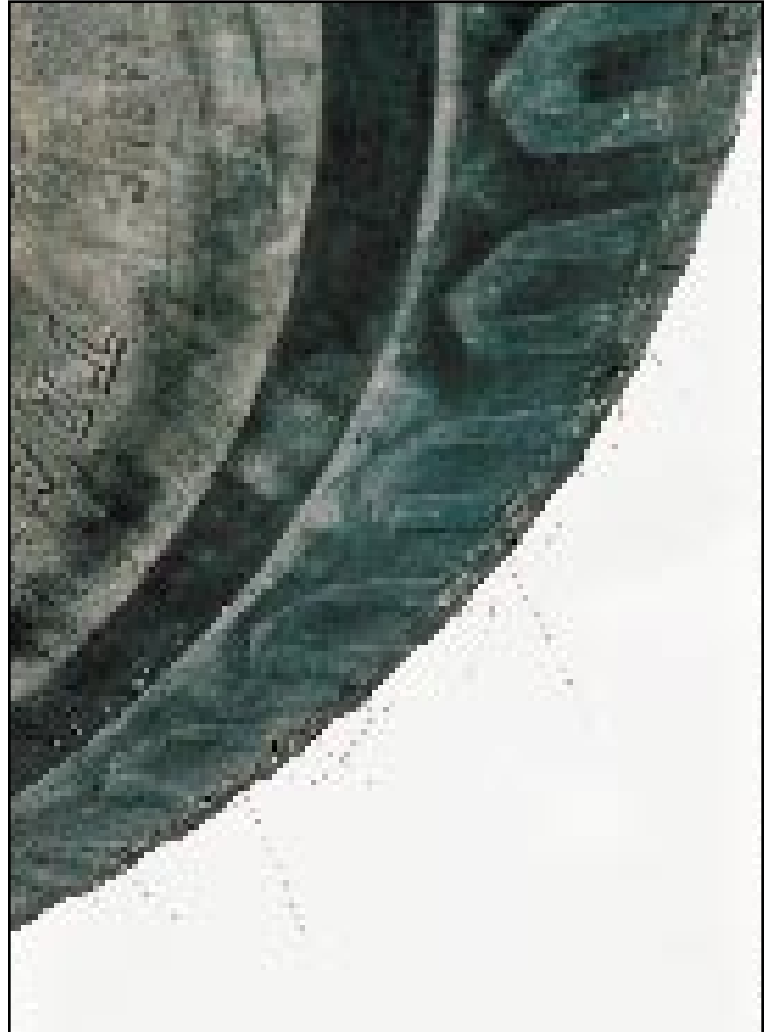
APPEARANCE	Wire protruding through the exterior or interior surface of the tire.
PROBABLE CAUSE(S)	Loose or separated bead or body wires.

TIRE	Consult your tire manufacturer.
VEHICLE	None
OPERATIONS	None

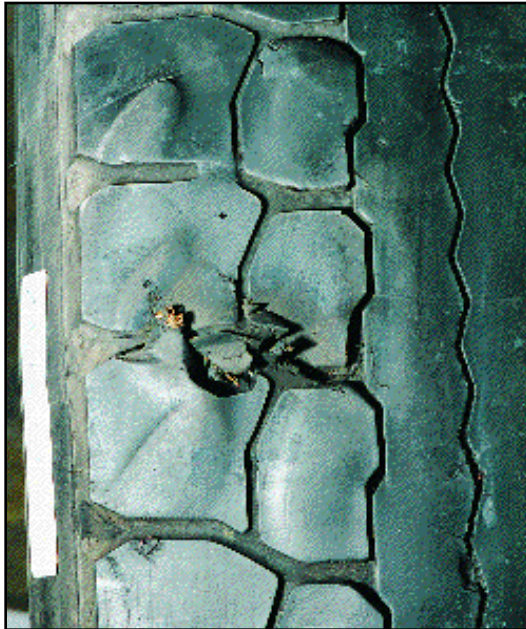
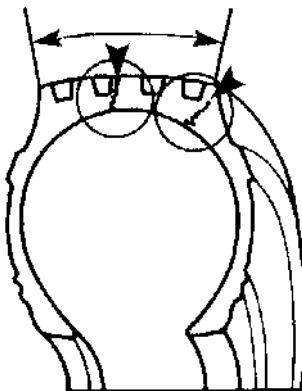
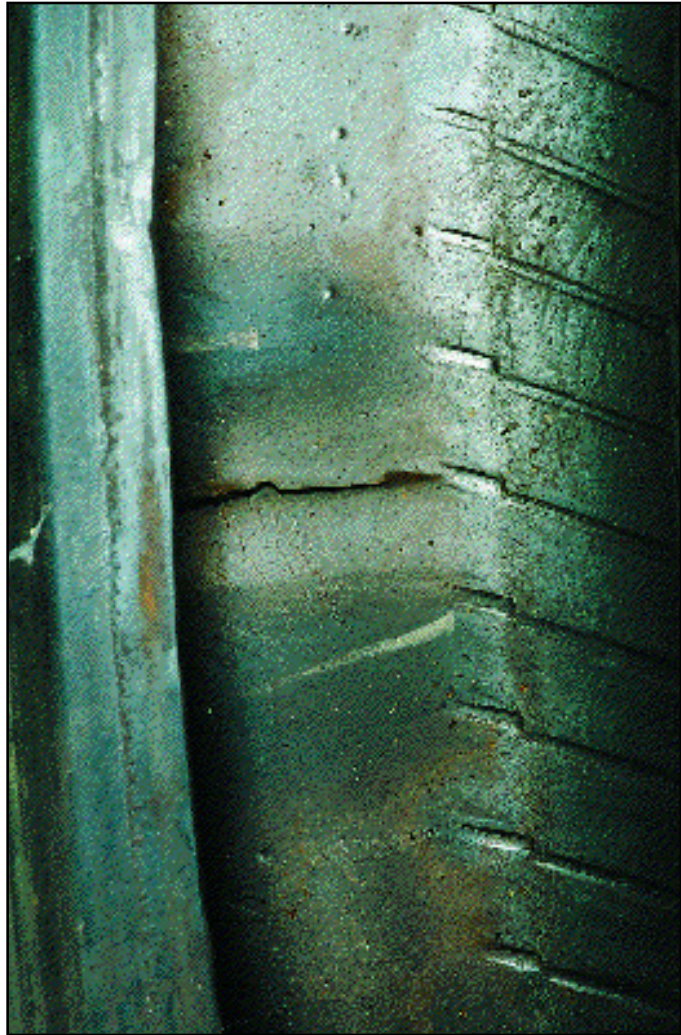
APPEARANCE	Localized break through the tread rubber and the casing.
PROBABLE CAUSE(S)	Severe, concentrated impact with a foreign object or a chuck hole. Aggravated by overinflation and high speed.

TIRE	Scrap tire.
VEHICLE	None
OPERATIONS	None

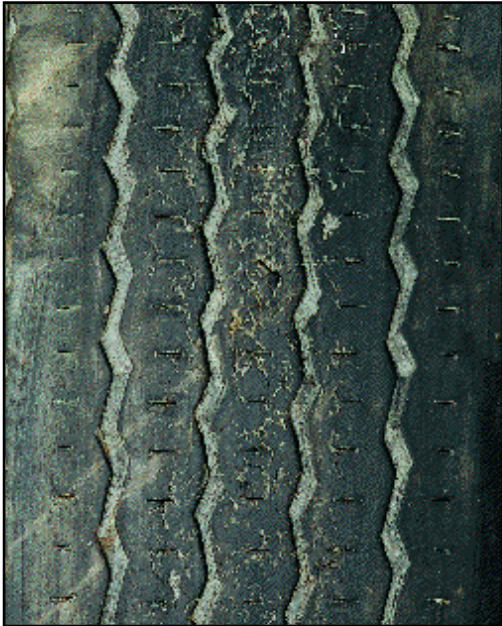
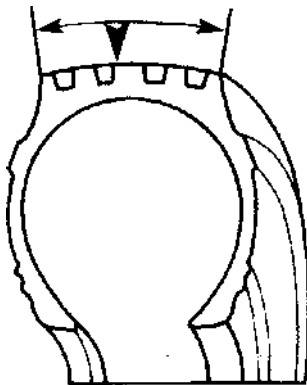
APPEARANCE	Rough, abraded tread surface with numerous small flakes or chunks of tread removed.
PROBABLE CAUSE(S)	Operation of tires with over-the-road tread rubber compounds on gravel surfaces and haul roads; misapplication of the tire to service conditions. Aggravated by high torque, over inflation and short turns, especially on drive tires.

TIRE	Tires with minor chipping and flaking can be returned to service. If damage extends below 2/32" retread the tire. If steel is visible, consult your retreader for the possibility of repair and retread.
VEHICLE	None
OPERATIONS	Review tire selection.

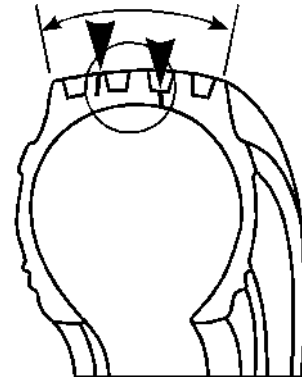
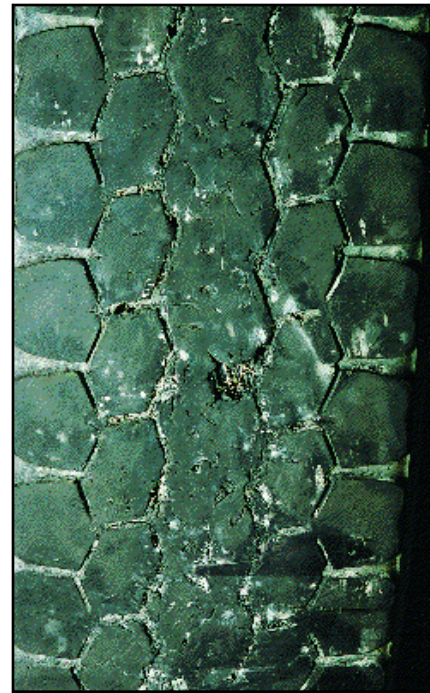
APPEARANCE	Damage caused by stones trapped in the tread which penetrate the tread base and extend into the belts.
PROBABLE CAUSE(S)	Tread design and/or misapplication of the tire to service conditions (gravel roads/quarry operation).

TIRE	Remove remaining stones and return to service. If penetrations are into the belts, consult the retreader or your tire manufacturer. If unable to retread or rebelt, scrap the tire.
VEHICLE	None
OPERATIONS	Review tire selection.

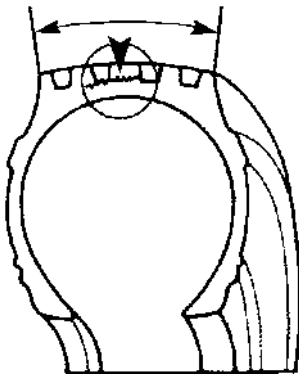
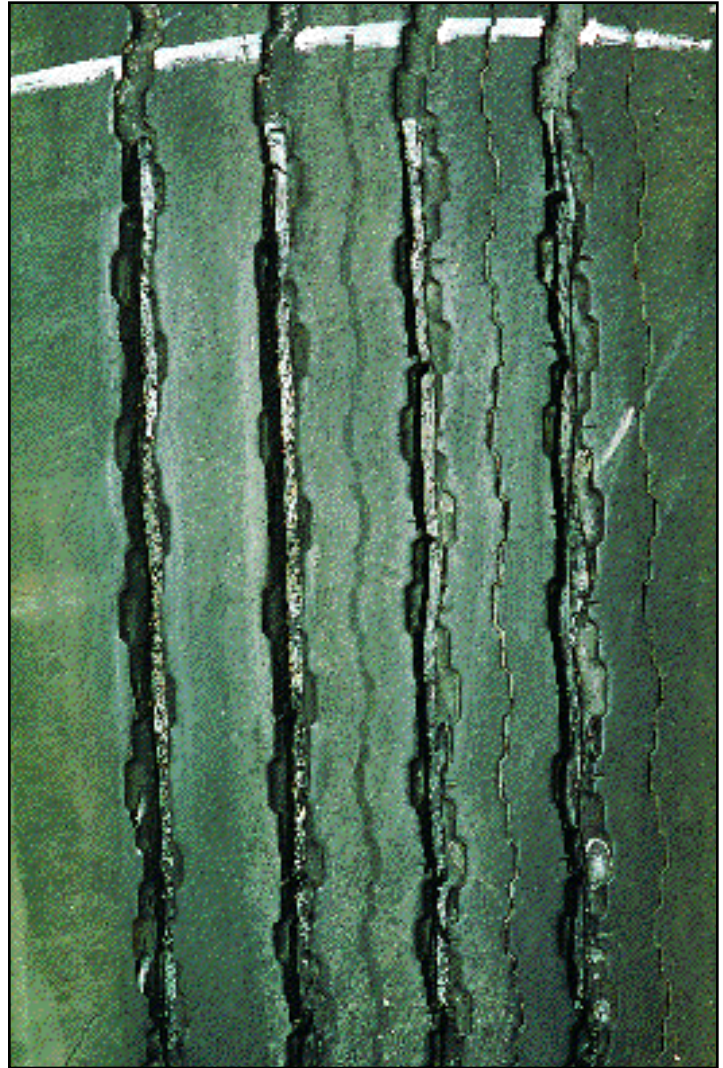
Regrooving Damage

Regrooving too deep.

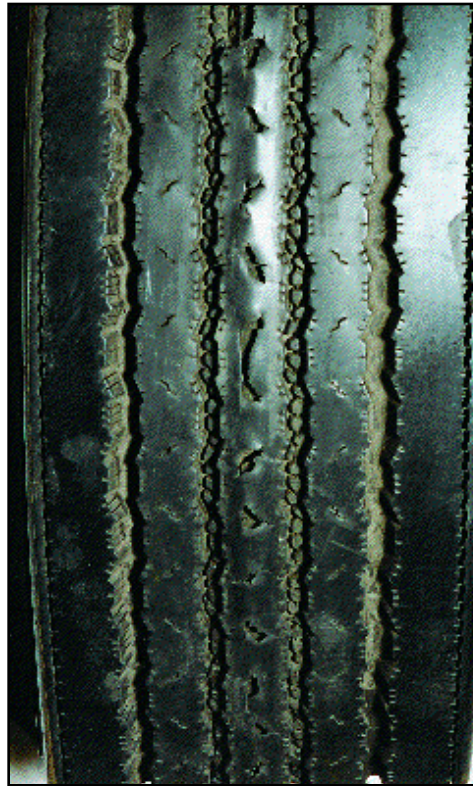
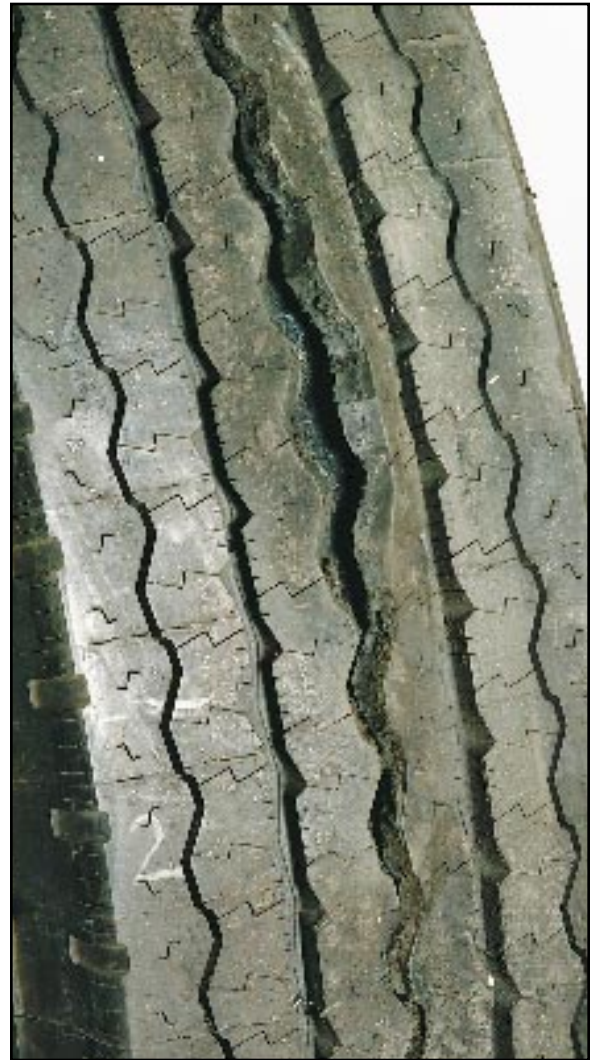
Dynamometer Type Damage

APPEARANCE	Swollen, spongy area hidden inside the center rib/lug extending up to 360° around the tire. Can cause a flat wear spot or may surface as a localized cavity.
PROBABLE CAUSE(S)	Excessive heat buildup on a dynamometer, also on high speed, lightly loaded overinflated applications using deep lug tires.

TIRE	Consult your retreader for the possibility of retreading.
VEHICLE	None
OPERATIONS	Review dynamometer procedures. Review load pressure or tire selection.

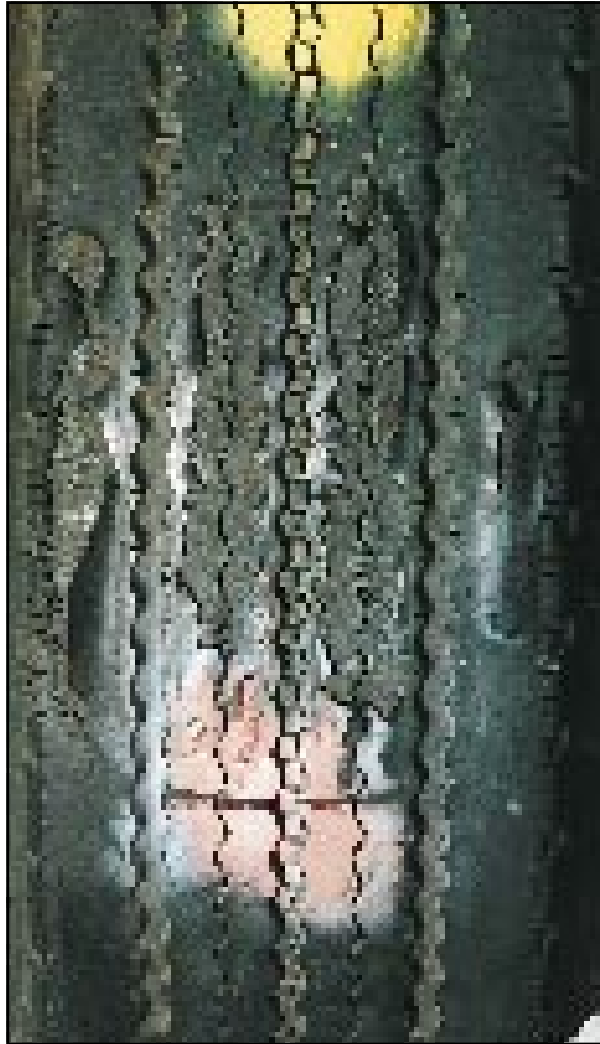
Chemical Damage

APPEARANCE	Localized spot of blistered, spongy or deteriorated rubber in tread area.
PROBABLE CAUSE(S)	Exposure to chemicals, usually solvent in nature, which attack tread rubber.

TIRE	Depending upon extent of chemical damage, return to trailer service or retread tire.
VEHICLE	None
OPERATIONS	None

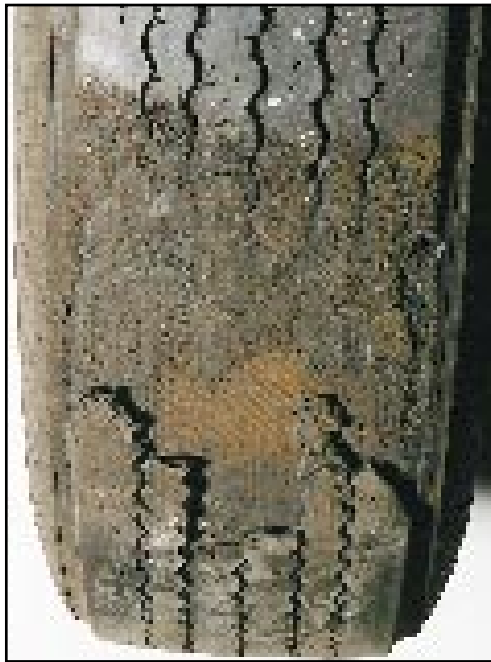
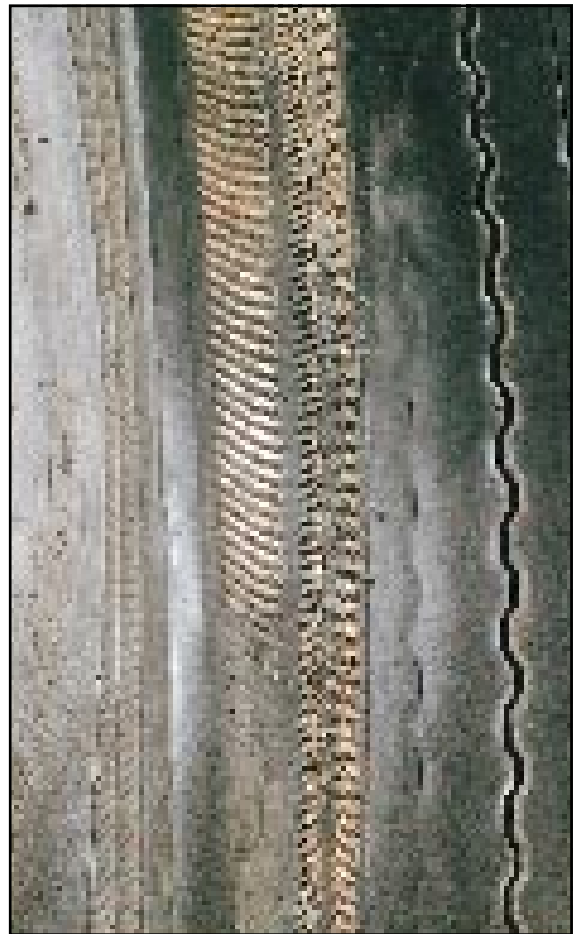
Excessive Wear

APPEARANCE	Tire worn to point of exposing casing reinforcement material.
PROBABLE CAUSE(S)	Run too long in service or brake skid.

TIRE	Retread and rebelt if possible; otherwise scrap tire.
VEHICLE	None
OPERATIONS	None

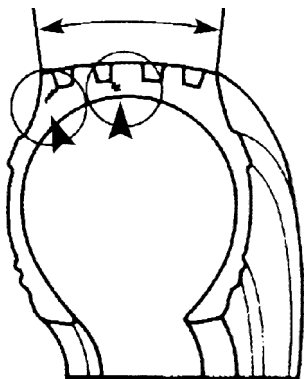
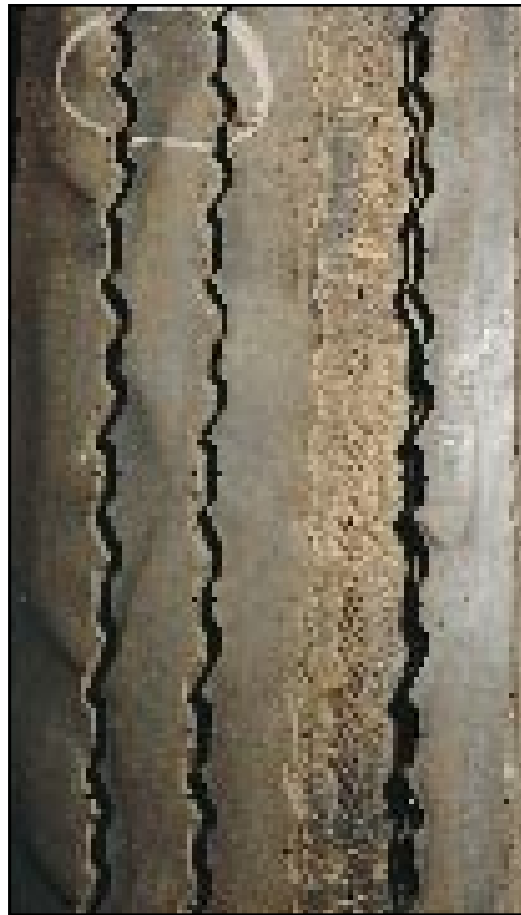
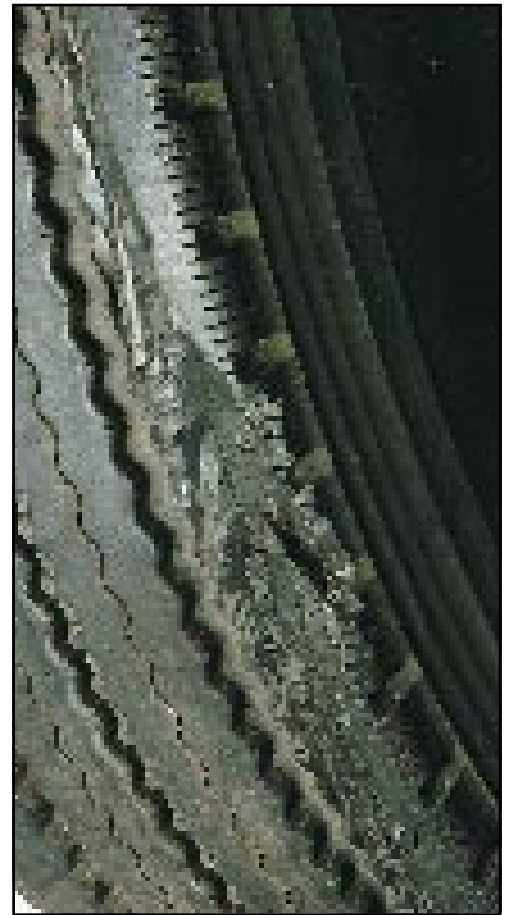
Tear at the base of the main tread grooves, generally at the shoulder; no tread missing.

Caused by running over curbs and rails, or by severe localized impacts, aggravated by spread axles, hot tires and sharp turning.

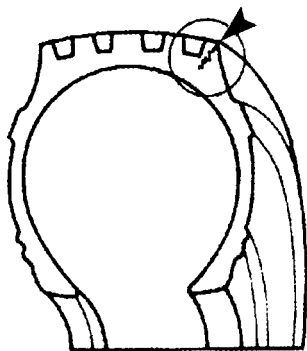
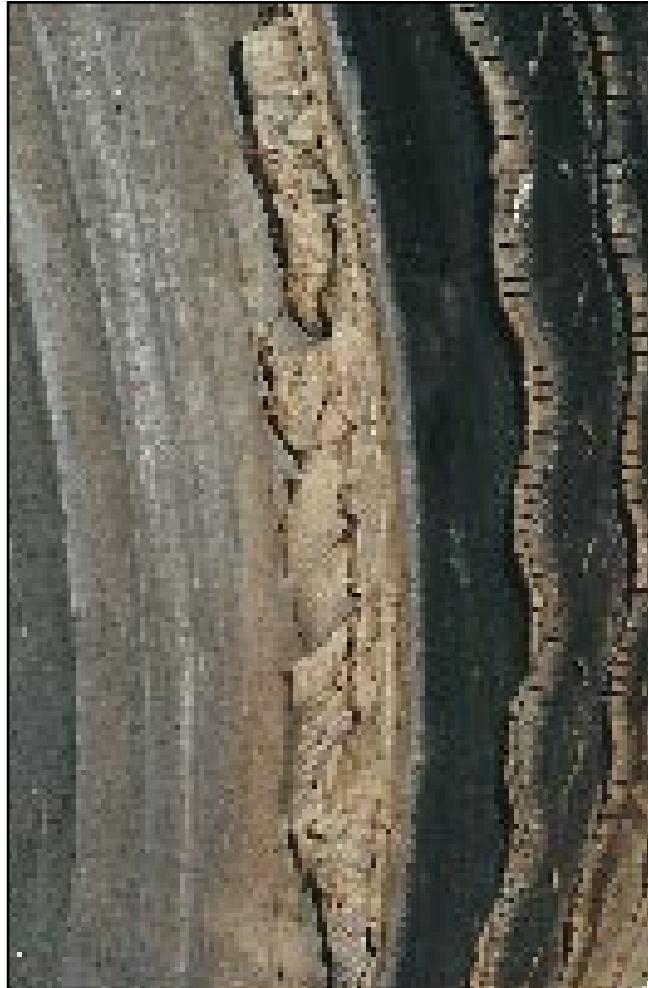
APPEARANCE	Tear at the base of the defense groove (decoupling groove, stress relief groove, shoulder groove).
PROBABLE CAUSE(S)	Caused by running over curbs or rails, or by severe localized impacts, aggravated by sharp turning.

TIRE	If steel is visible, contact your tire manufacturer. If the tear extends near the buff radius, consult your retreader for possible retread. Otherwise return to service.
VEHICLE	None
OPERATIONS	Review driving procedures.

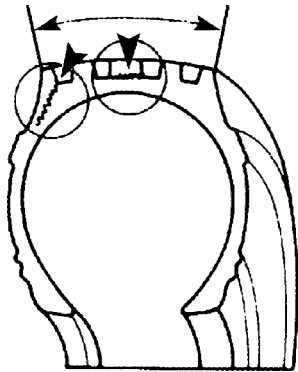
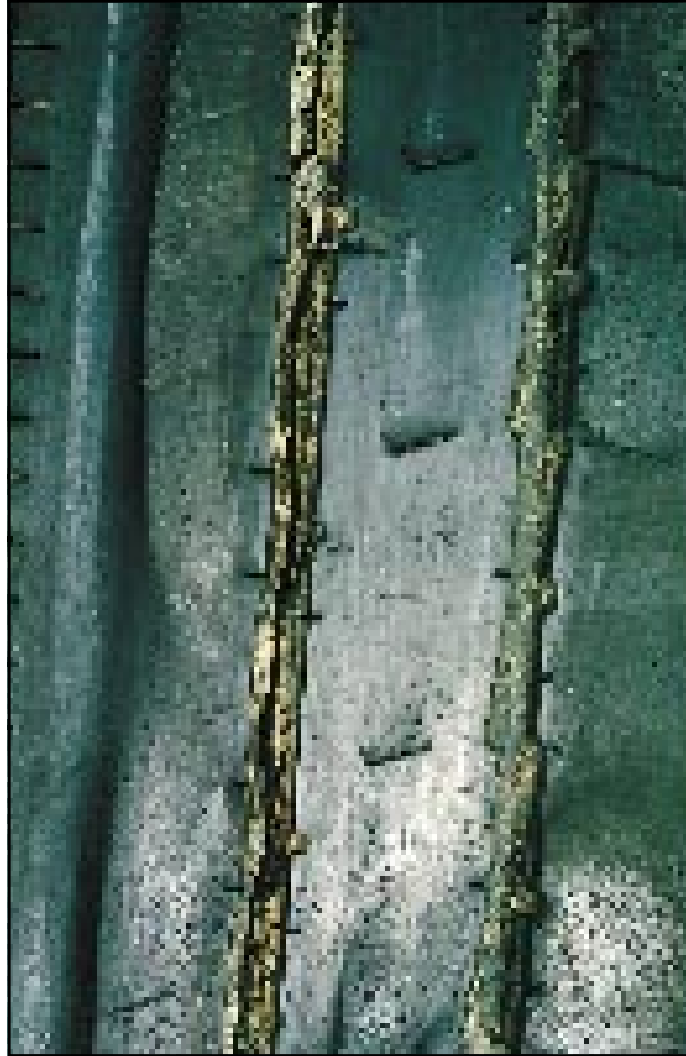
Groove Cracking

Areas at the base of the grooves with cracks.

This condition is caused by high side forces applied to a rib type tire. It can also be caused by petroleum damage, weathering, or exhaust on drive tires.

If cracking is superficial, continue tire in service. If cracks are greater than 2/32" or more past the bottom of the groove, contact your tire manufacturer.

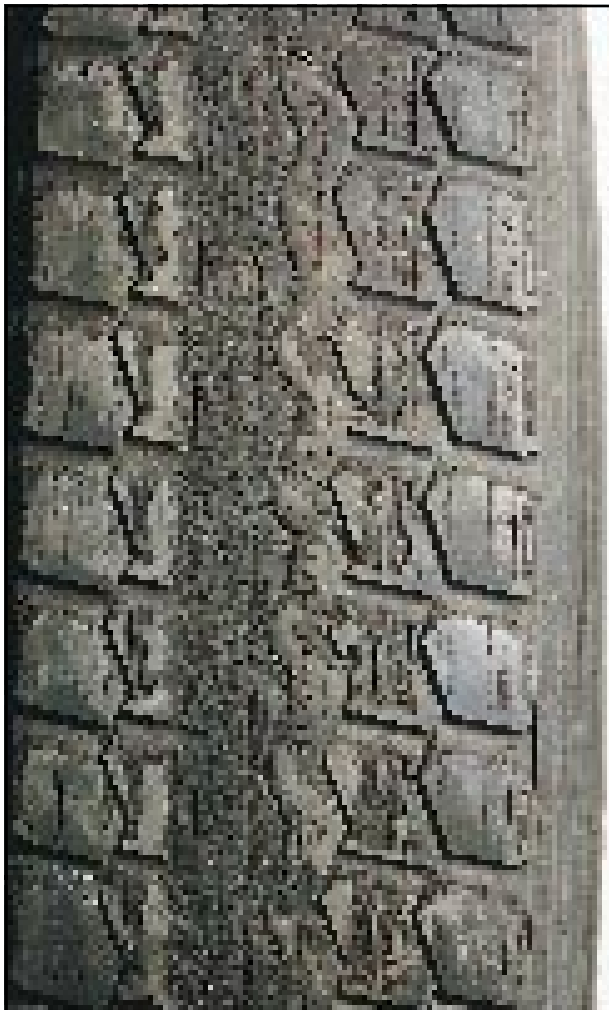
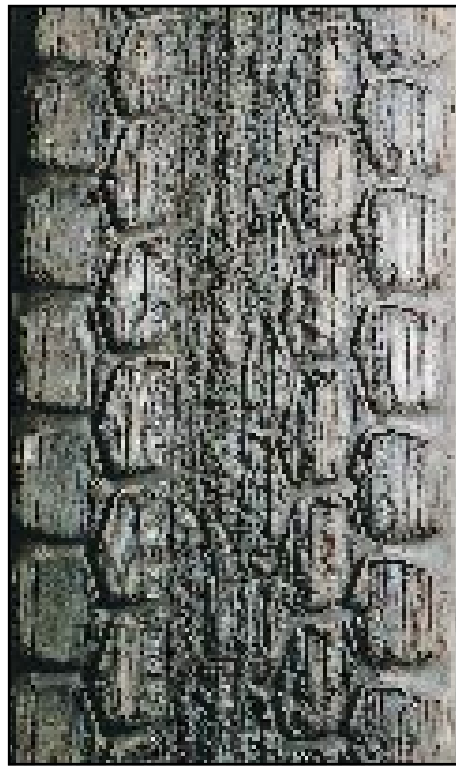
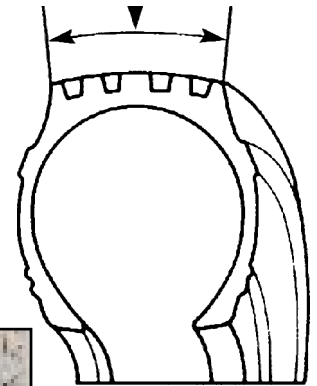
Spin Damage

APPEARANCE	Circumferential cuts or lines around tire.
PROBABLE CAUSE(S)	Spinning drive tires on ice, sand, gravel, etc.

TIRE	Place the tire back into service if the damage does not extend beyond the base of the tread groove. If damage is deeper, retread or rebelt if possible. If the condition is more severe, scrap tire.
VEHICLE	None
OPERATIONS	Review driving procedures and/or drive tire selection.

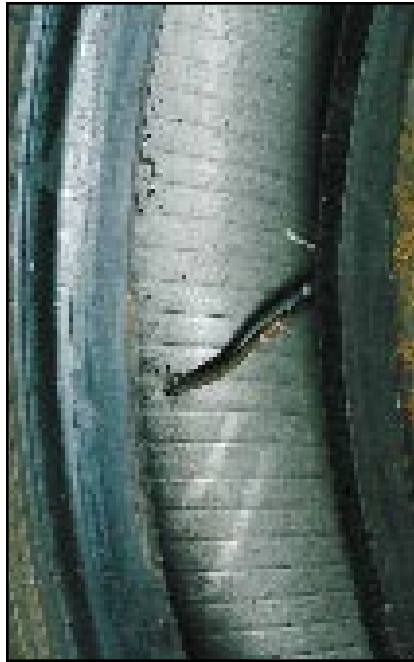
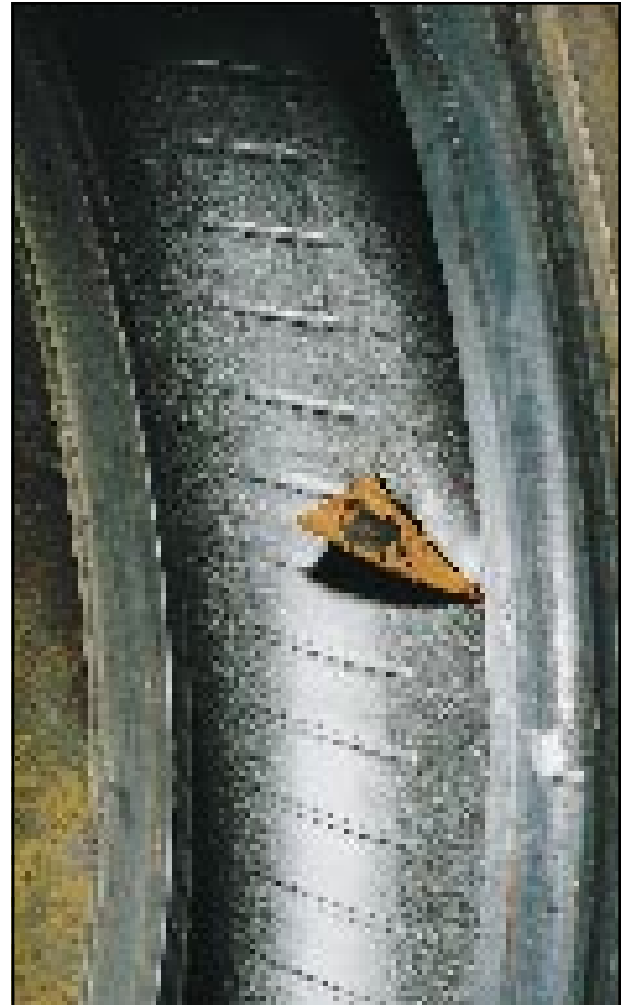
Impact with road hazard.

Remove foreign object. Inspect degree of damage. Repair if permissible according to repair limit standards, and restore moisture seal and air retention integrity. If damage is excessive, scrap tire.

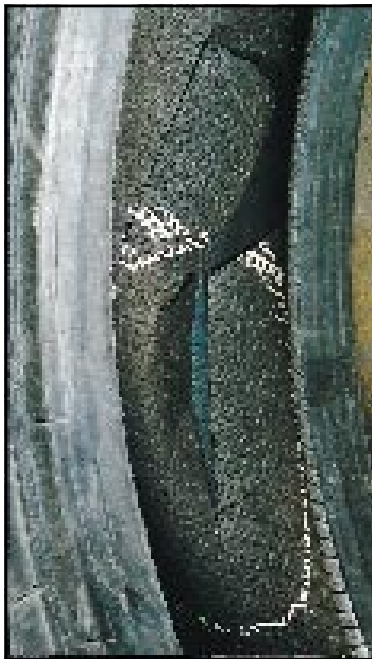
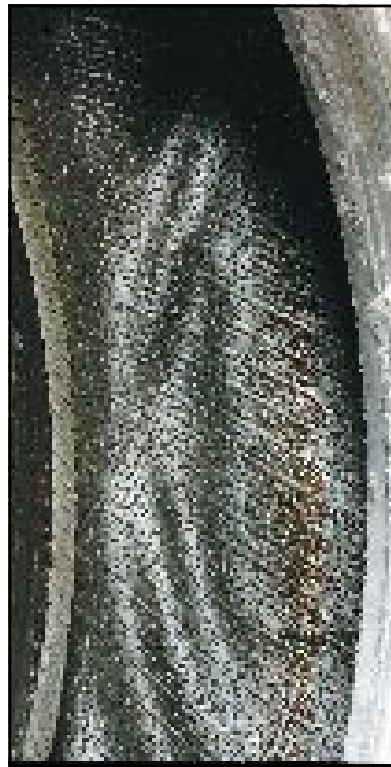
APPEARANCE	Bubble or blister in the tire interior.
PROBABLE CAUSE(S)	Adhesion loss of inner liner material to the casing.

TIRE	Remove from service and contact your tire manufacturer. If blisters are small and few, the inner liner can be repaired and the tire can be placed back into service.
VEHICLE	None
OPERATIONS	None

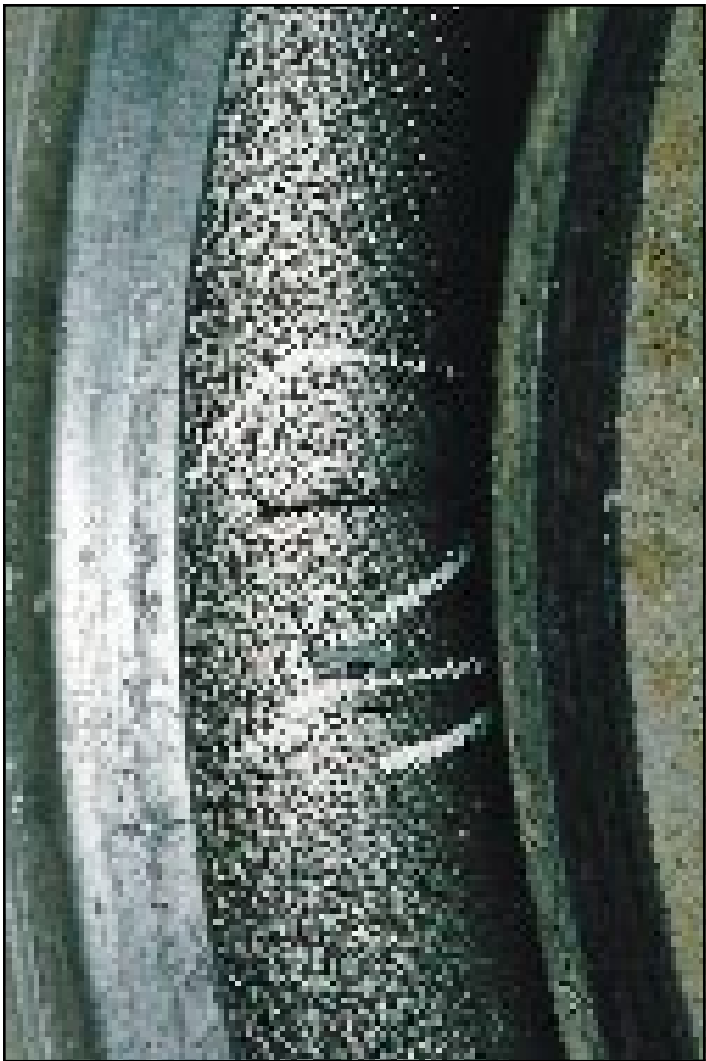
Inner Liner Cracking

APPEARANCE	One or more cracks in the inner liner at locations other than the inner liner splice.
PROBABLE CAUSE(S)	Under inflation, excessive heat buildup in the tire interior. May also be manufacturing related.

TIRE	Remove the tire from service and contact your tire manufacturer.
VEHICLE	None
OPERATIONS	None

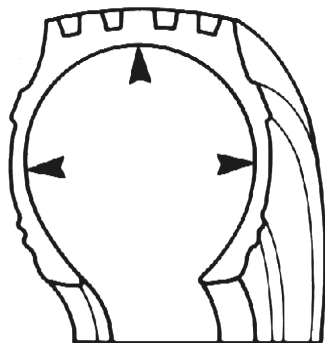
Pulled/Loose Cords

PROBABLE CAUSE(S)

Impacts, penetrations, poor repairs and under inflation which damage ply material.
