RADIAL TIRE CONDITIONS ANALYSIS GUIDE

**A Comprehensive
Review of Tread Wear
And Tire Conditions**

© Copyright 1994 The Maintenance Council
Printed in U.S.A.

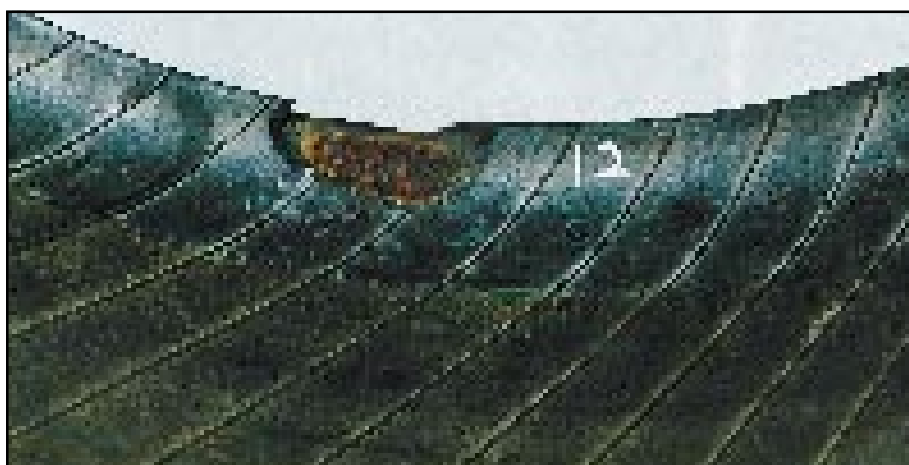
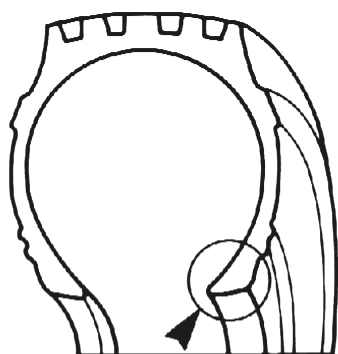
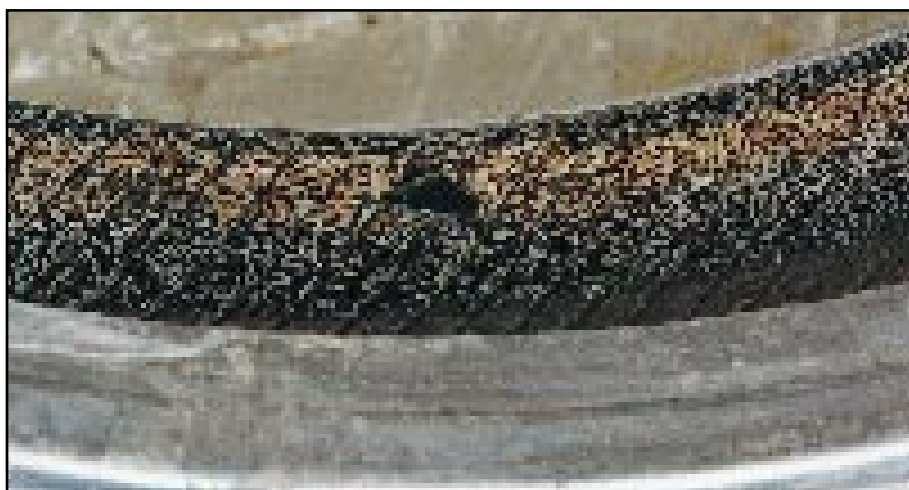
Tearing, Mount/Dismount Damage

APPEARANCE	Tearing or loss of adhesion of the inner liner material inside the bead toe area.
PROBABLE CAUSE(S)	Poor mounting/demounting techniques or lack of lubricant.

TIRE	Repair the inner liner or scrap the tire if damage is too excessive.
VEHICLE	None
OPERATIONS	Review tire mounting/dismounting procedures and the use of tire tools.

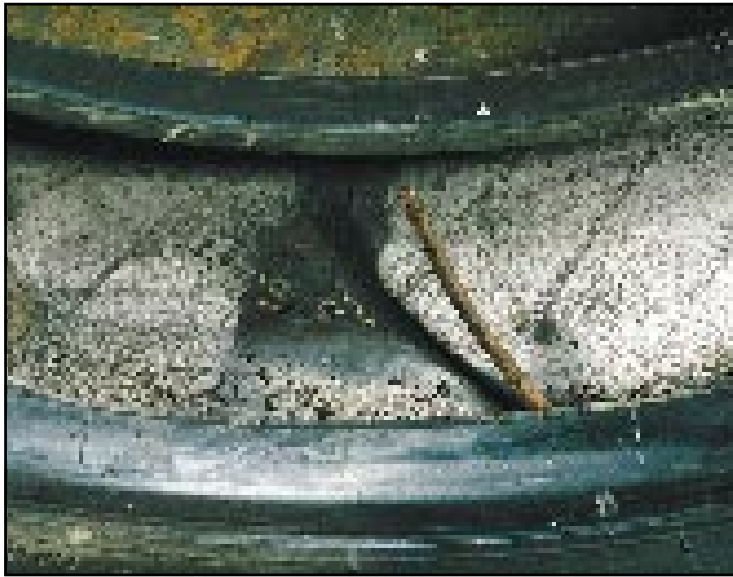
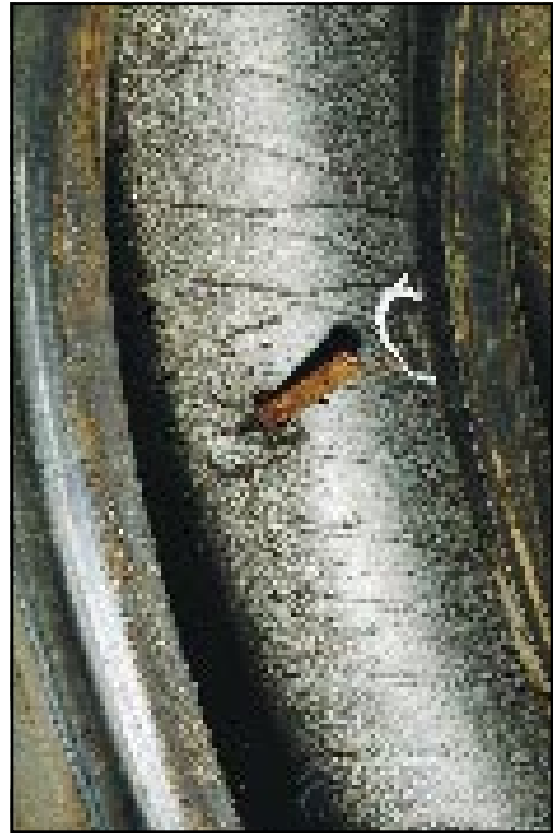
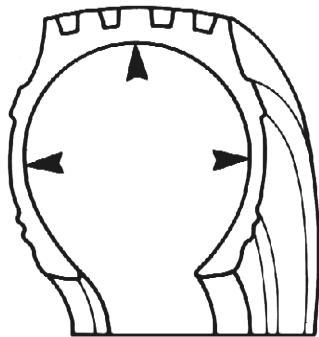
Foreign Object Inner Liner Damage In Tubeless Tire

APPEARANCE	A series of random cuts or abrasion marks around the circumference of the tire interior, not otherwise explained.
PROBABLE CAUSE(S)	Foreign object in tire.

TIRE	Inspect for degree of damage, repair if possible; otherwise scrap the tire.
VEHICLE	None
OPERATIONS	None

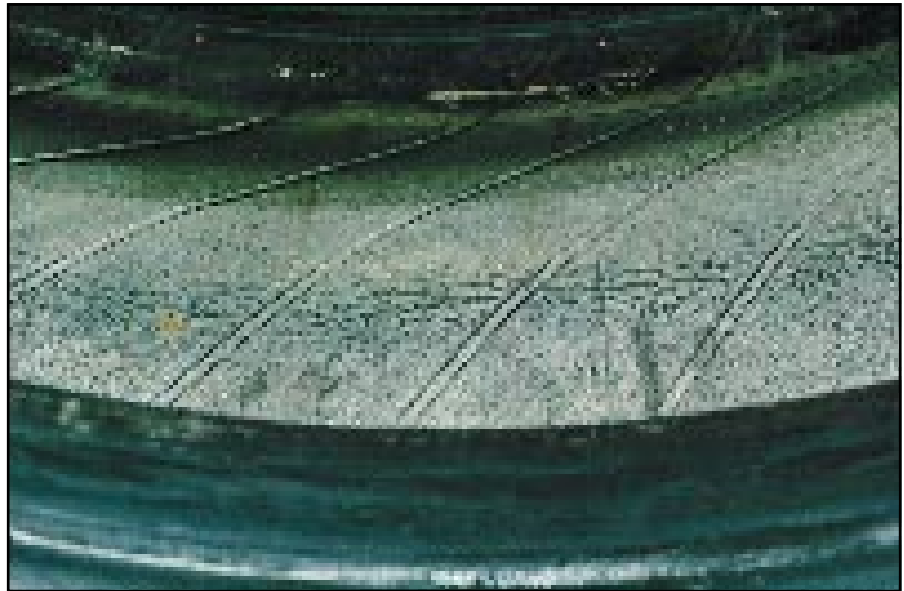
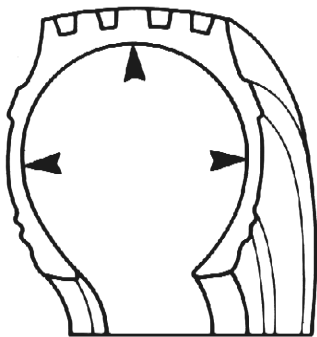
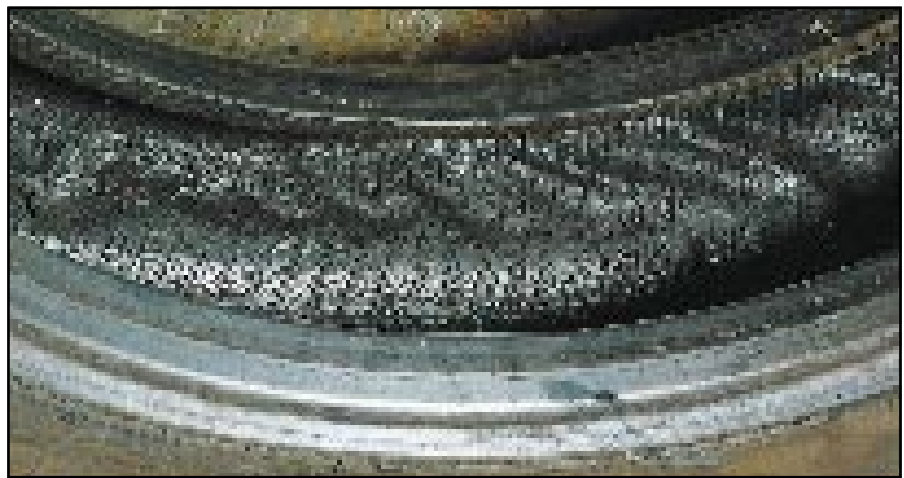
APPEARANCE	Discoloration, blistering and/or separations of the inner liner.
PROBABLE CAUSE(S)	Continued operation after loss of inflation pressure.

TIRE	Scrap the tire.
VEHICLE	None
OPERATIONS	None

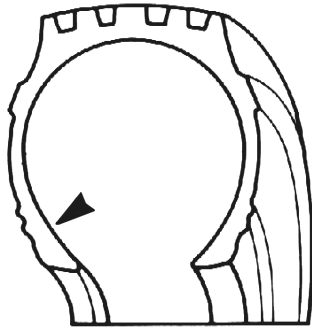
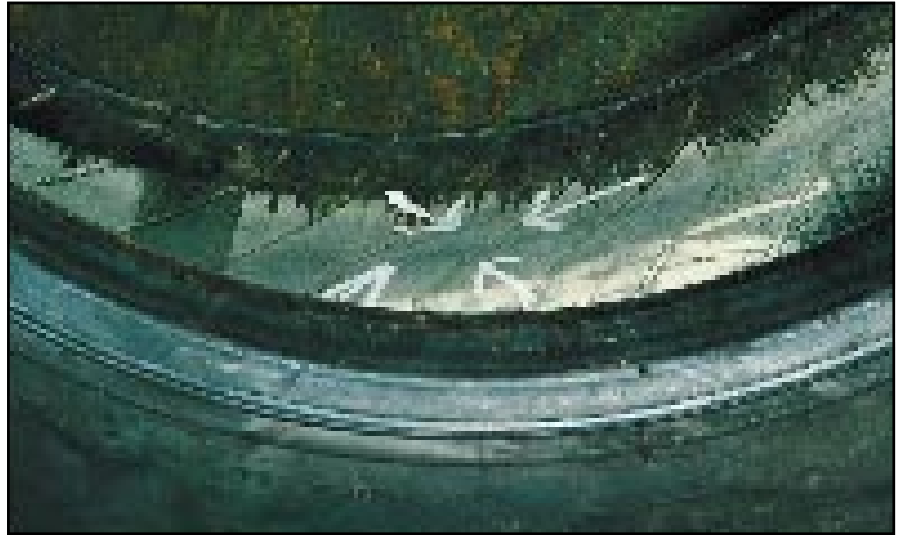
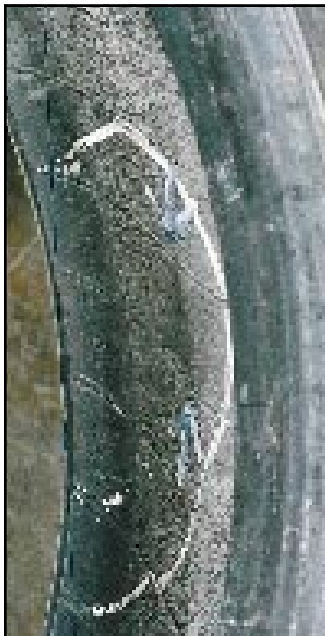
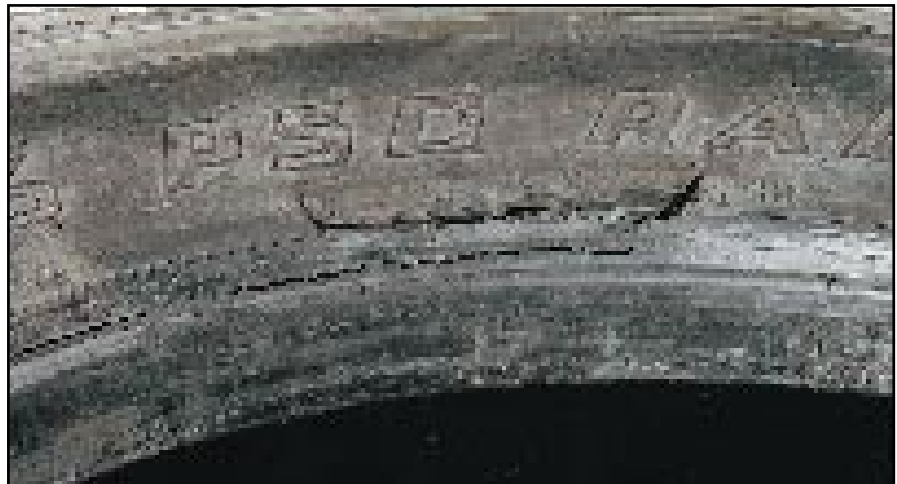
A horizontal, crescent shaped crease or break in the inner liner in the sidewall area. A small bulge may also appear in the damaged area.

PROBABLE CAUSE(S)

Severe impact.

Have the tire inspected by your tire repair supplier to determine repairability.

Severe impacts can cause bent rim flanges. Inspect wheels and recheck alignment.

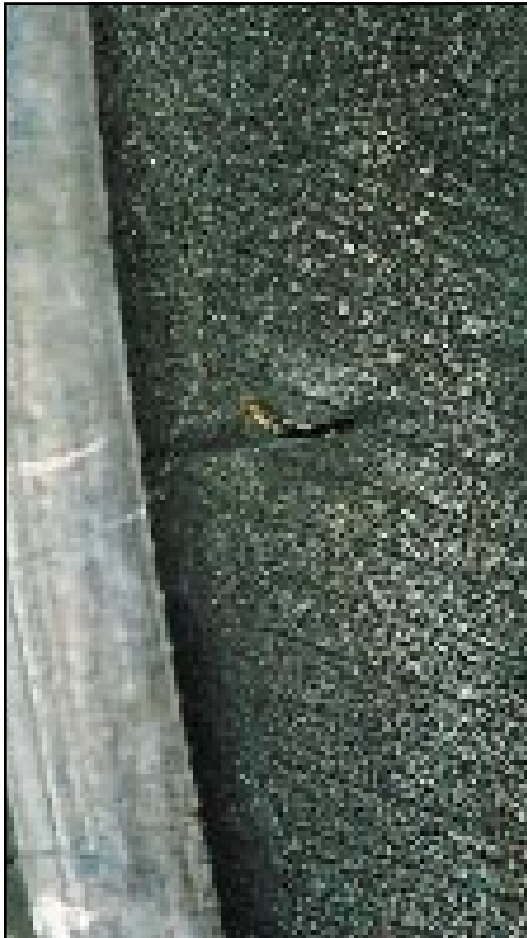
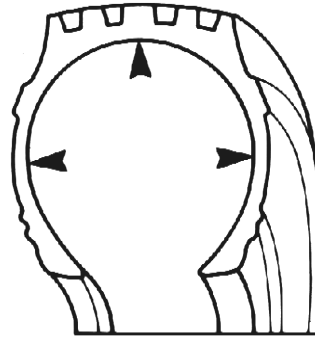
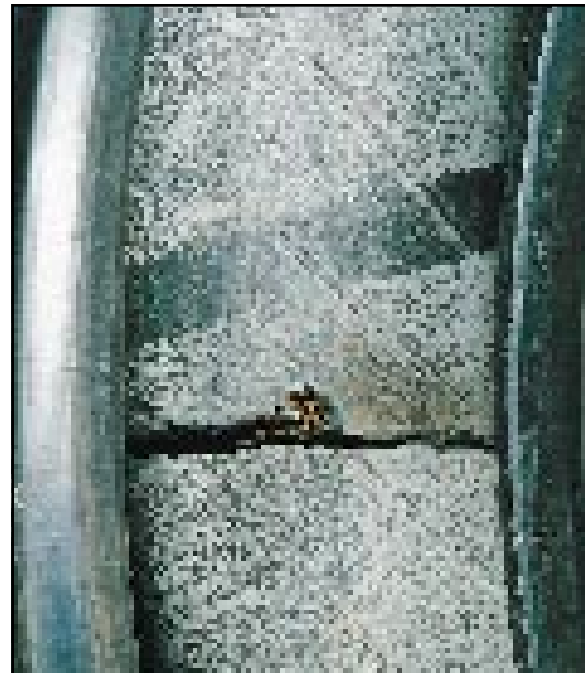
APPEARANCE	Crack or break in tire interior surface. May be accompanied by pulled or loose cords.
PROBABLE CAUSE(S)	Sudden and excessive force applied to the tire exterior which exceeds reinforcing material limits. May be caused by road hazard or driver abuse.

TIRE	Scrap tire.
VEHICLE	None
OPERATIONS	Review driving procedures.

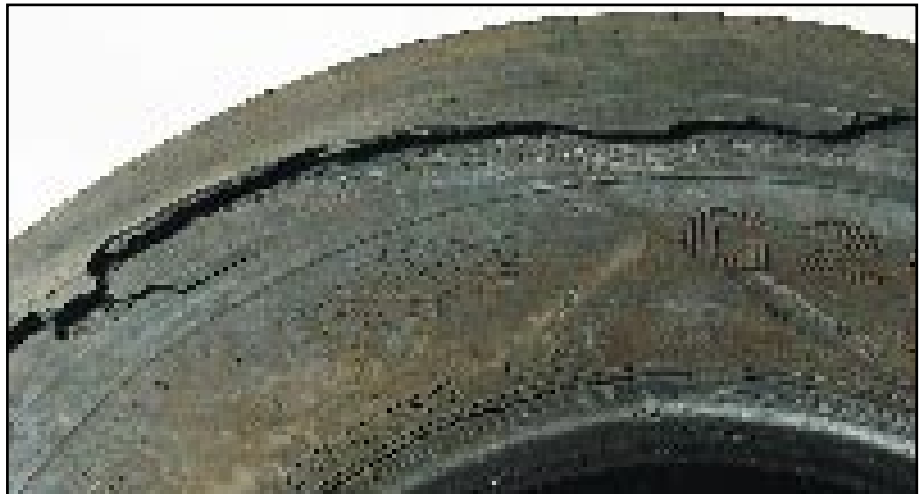
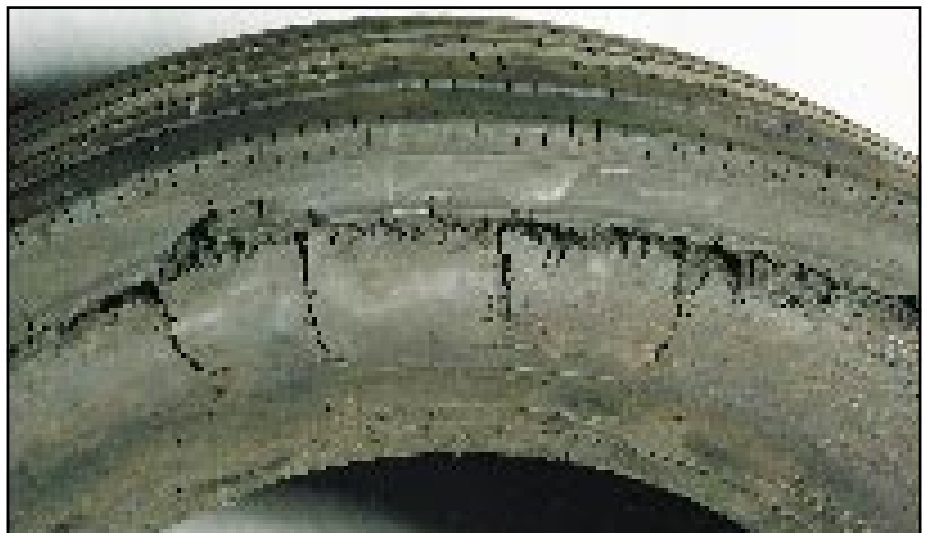
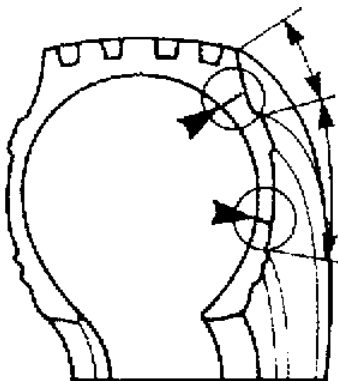
Advanced deterioration of radial tire affecting 360° of tire sidewall.

PROBABLE CAUSE(S)

Loss of inflation pressure. Diagnosis of cause of inflation loss becomes difficult or impossible as this condition progresses.

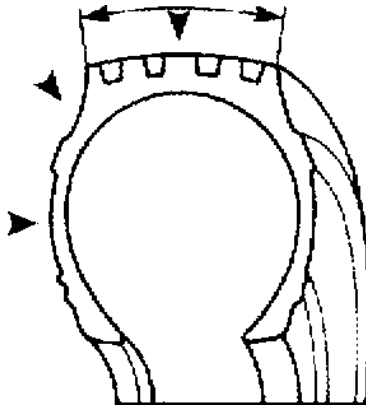
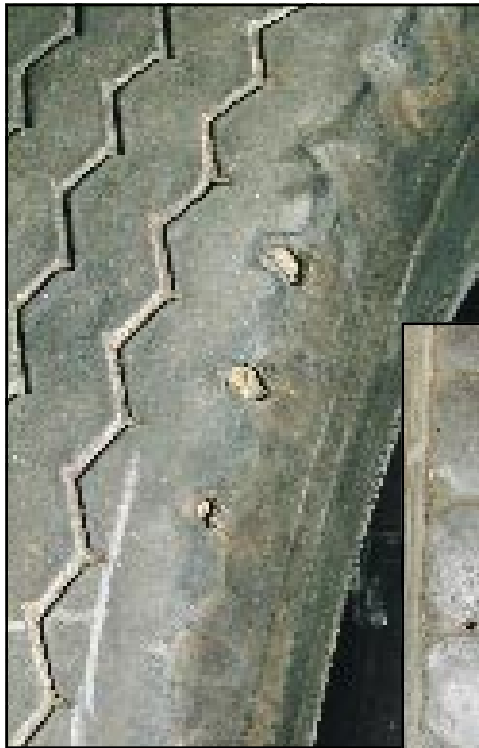
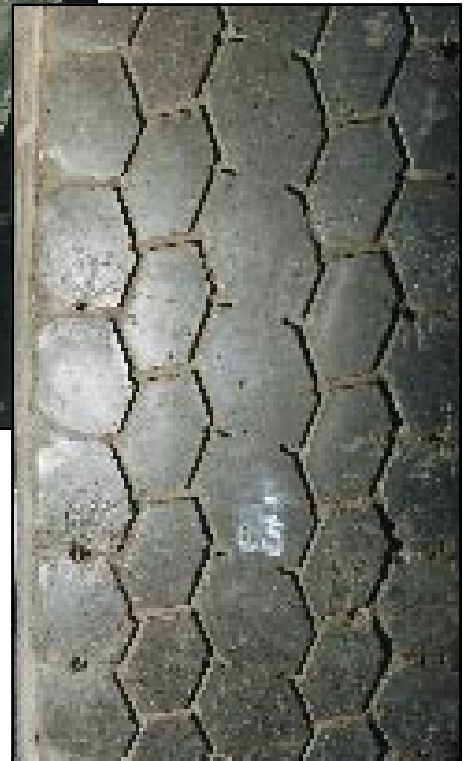
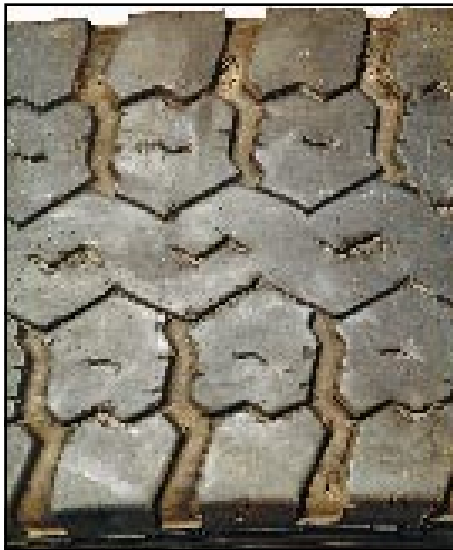
APPEARANCE	Random oriented cracking on tire, sometimes associated with holes or punctures not otherwise explained.
PROBABLE CAUSE(S)	Vehicle contact with electrical cables or lightning.

TIRE	Scrap the tire.
VEHICLE	None
OPERATIONS	None

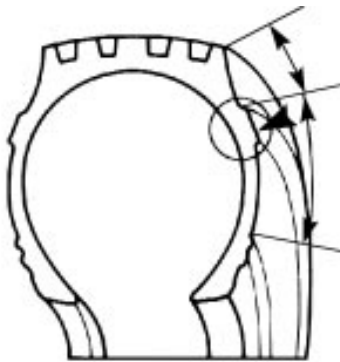
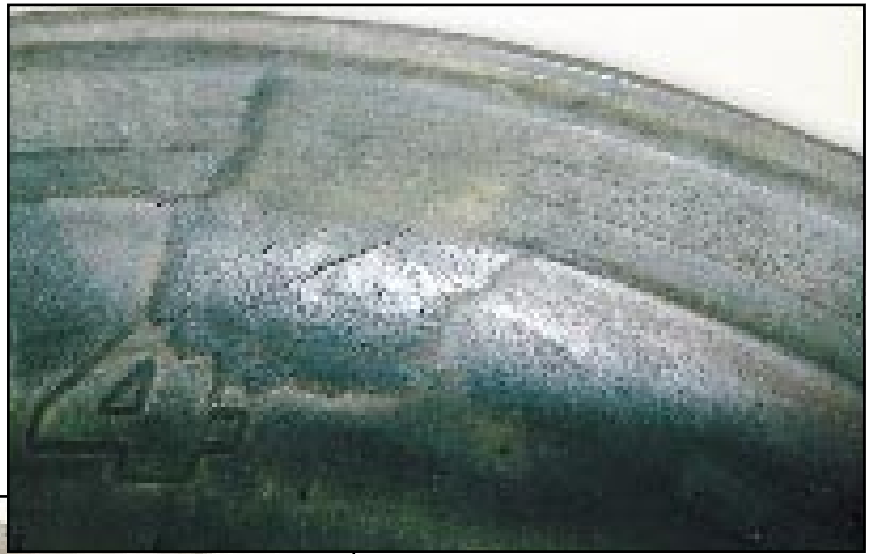
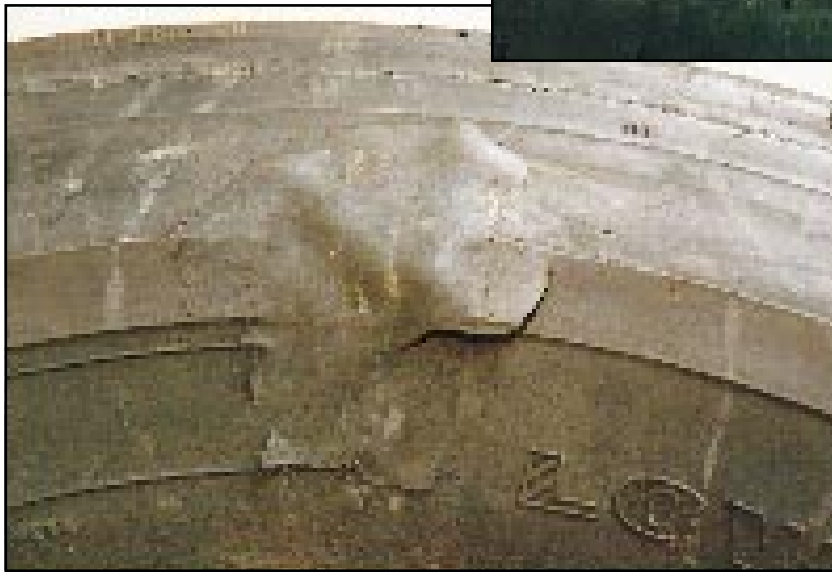
Bad Spot Repair

The repair fill-rubber is missing or loose in the sidewall or tread area and sometimes exhibits cracks.

PROBABLE CAUSE(S)

Poor workmanship. Contaminated buffed area, improper cementing, contaminated fill material, improper cure time or pressure, improper injury removal, etc.

Consult your retreader/repair person for possible warranty adjustment. Re-repair if possible or scrap the tire if it is unrepairable.

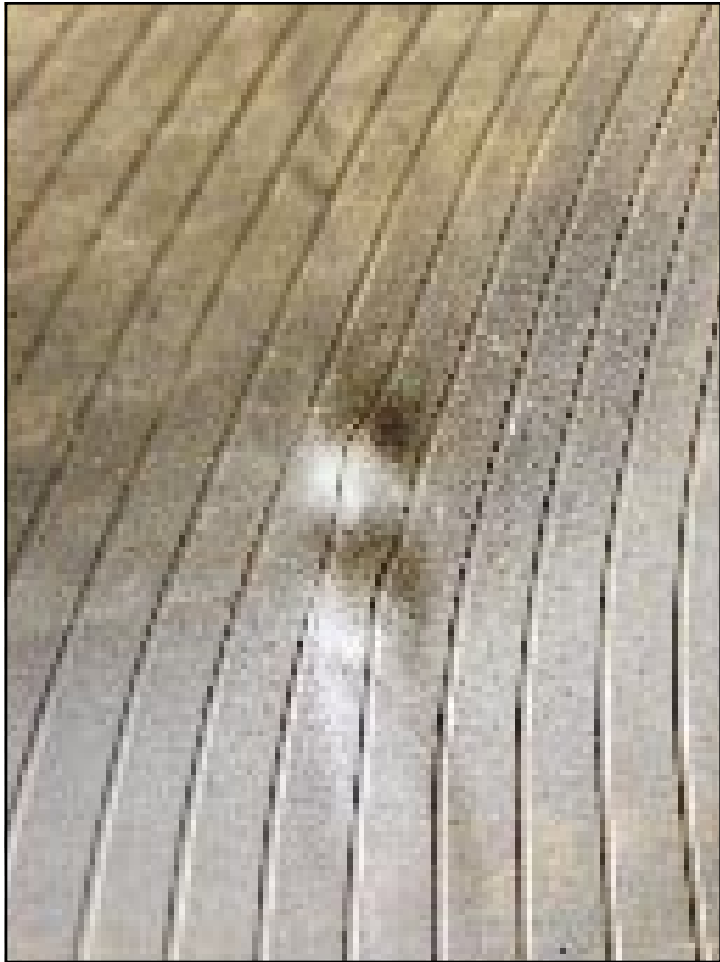
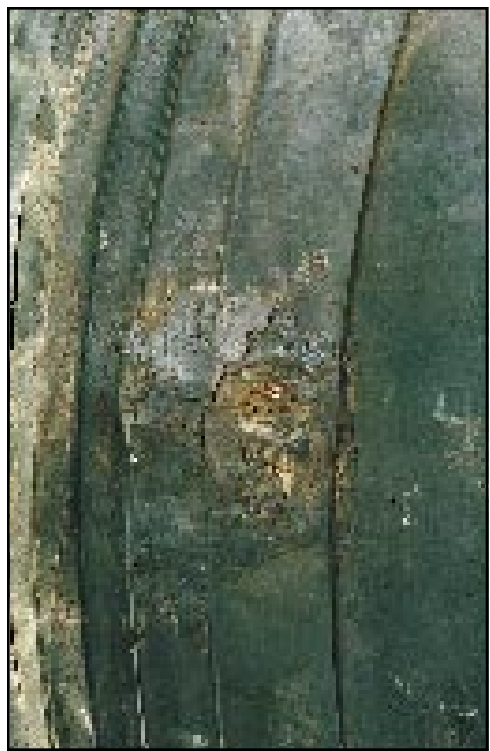
Spot Repair Should Be A Section Repair

APPEARANCE	The repair fill-rubber is missing or loose from a sidewall spot repair. Ply cords may be exposed. A distortion or separation is evident inside the tire.
PROBABLE CAUSE(S)	Poor workmanship. Not all the injury was removed. A full reinforced section repair should have been made.

TIRE	Consult your retreader/repair person for possible warranty adjustment. Re-repair if possible or scrap the tire if it is unrepairable.
VEHICLE	None
OPERATIONS	None

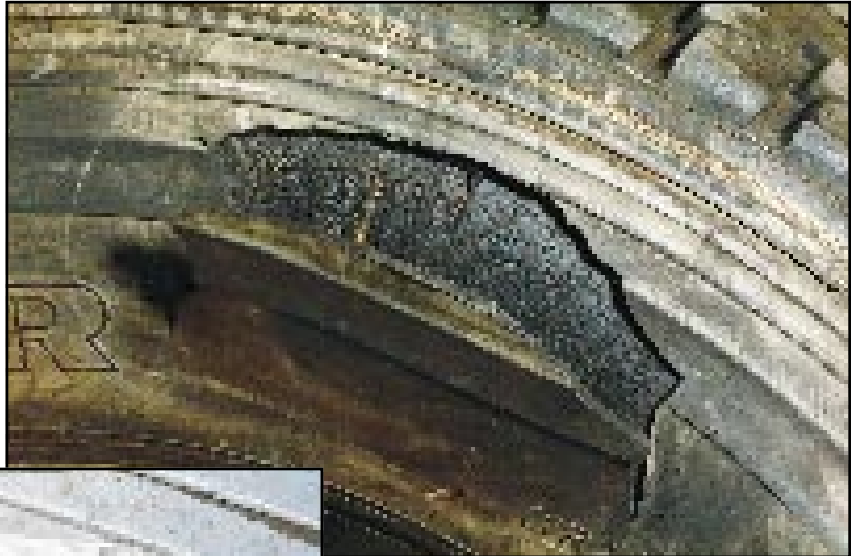
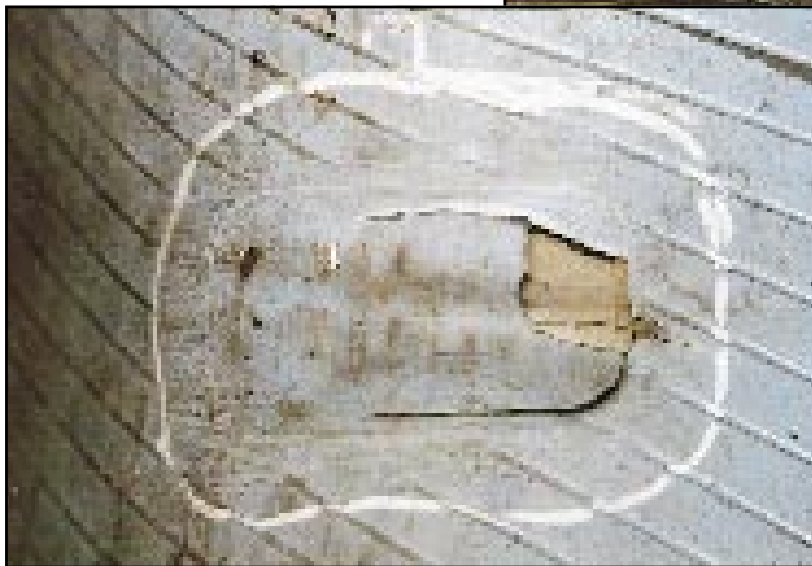
Improper Nail Hole Repair

APPEARANCE	Interior: A crack or split extends from the repair unit. The repair unit may be dimpled, cracked or loose. Some signs of heat build up may be evident such as powdery or sticky rubber. Exterior: Separation of tire components may be evident in advanced stages.
PROBABLE CAUSE(S)	Nail hole repair procedures were used instead of section repair procedures resulting in inadequate injury removal. An improper size and type of repair unit was used.

TIRE	Consult your retreader/repair person for possible warranty adjustment. Re-repair if possible, otherwise scrap the tire.
VEHICLE	None
OPERATIONS	Review repair techniques with your repair person.

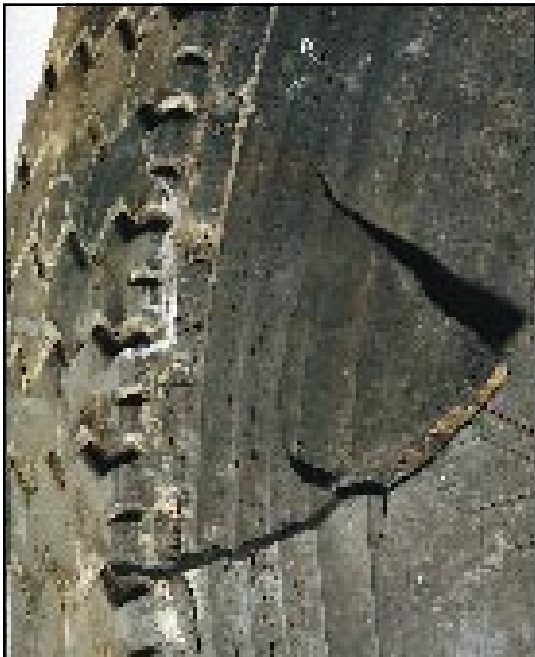
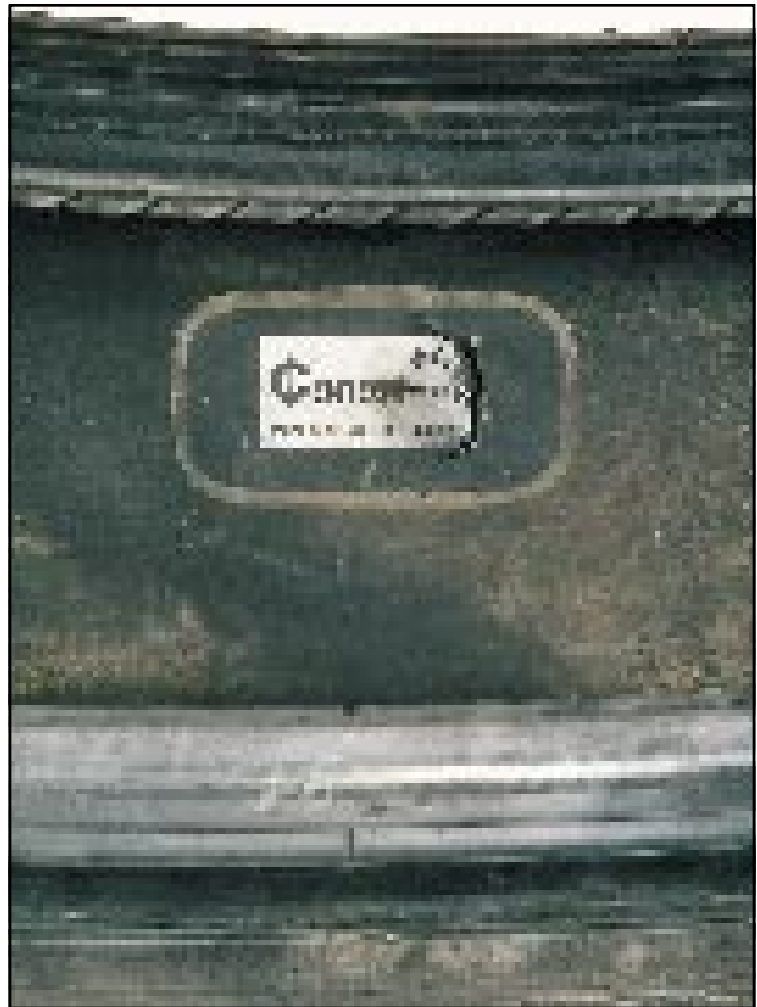
Improperly Aligned Repair

APPEARANCE	<p>Interior: The repair unit may be dimpled, lifted or cracked. The repair unit alignment arrows do not point in the proper direction.</p> <p>Exterior: Tire components may be separated.</p>
PROBABLE CAUSE(S)	<p>Improperly installed repair unit. (In this case, the bead arrows do not point to the beads.) Improperly trained repair personnel.</p>

TIRE	<p>Consult your retreader/repair person for possible warranty adjustment. Re-repair if possible, otherwise scrap the tire.</p>
VEHICLE	<p>None</p>
OPERATIONS	<p>Review repair techniques with your repair person.</p>

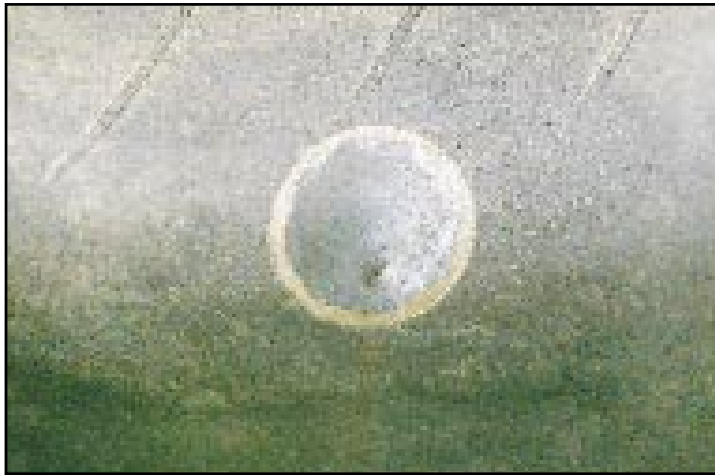
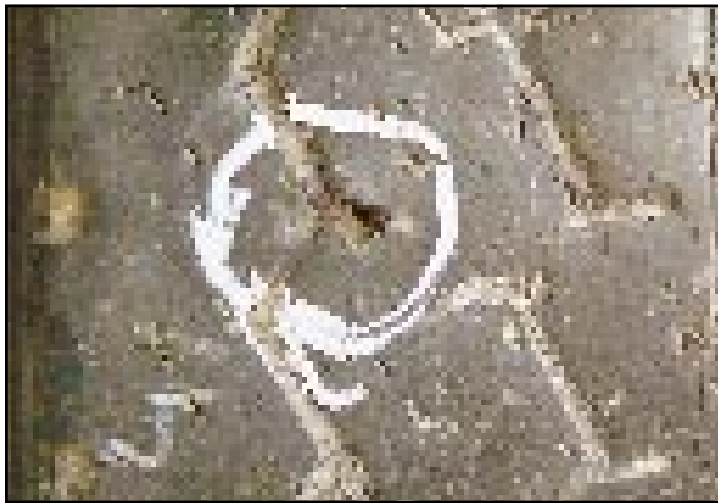
Unfilled Nail Hole Repair

APPEARANCE	Interior: The repair unit is dimpled or cracked. Exterior: Rust is evident in the unfilled hole.
PROBABLE CAUSE(S)	The injury was not filled with a plug or rubber fill material.

TIRE	Consult your retreader/repair person for possible warranty adjustment. Re-repair if possible, otherwise scrap the tire.
VEHICLE	None
OPERATIONS	Review repair requirements with road service vendors and monitor on the road tire service.

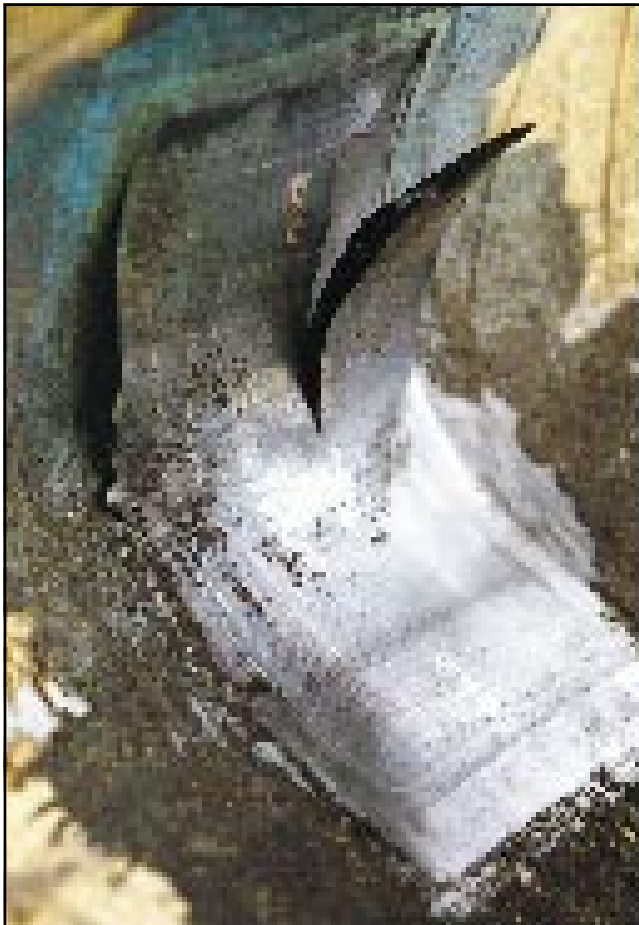
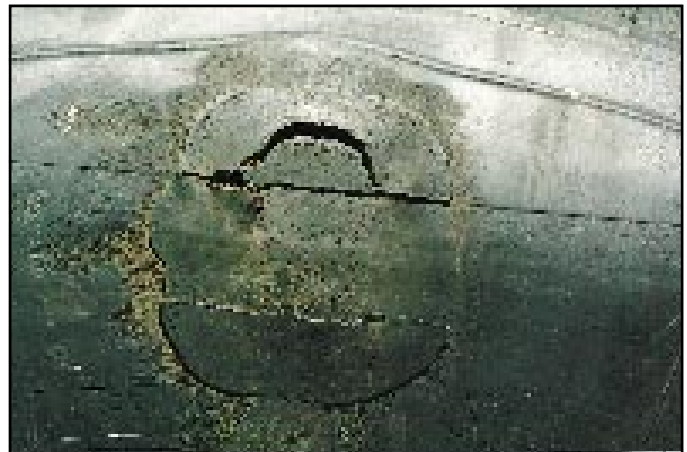
Bridged Repair

APPEARANCE	Interior: The repair unit is loose, split or torn in the tire's shoulder area. A bulge, polished or goeey area caused by excessive heat may be evident under the repair unit. The fill material may also be cracked. Exterior: A sidewall bulge may be evident and the fill material may be cracked. Tire components may be separated.
PROBABLE CAUSE(S)	Improper placement of the repair unit during installation which resulted in trapped air under the repair unit. The tire beads were probably spread during installation of the repair unit.

TIRE	Consult your retreader/repair person for possible warranty adjustment. Re-repair if possible, otherwise scrap the tire.
VEHICLE	None
OPERATIONS	Review repair techniques with your repair person.

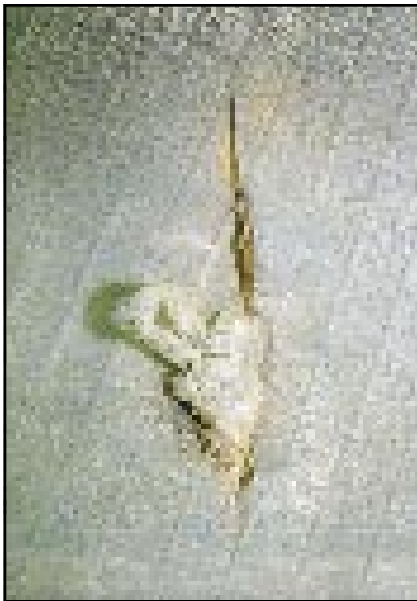
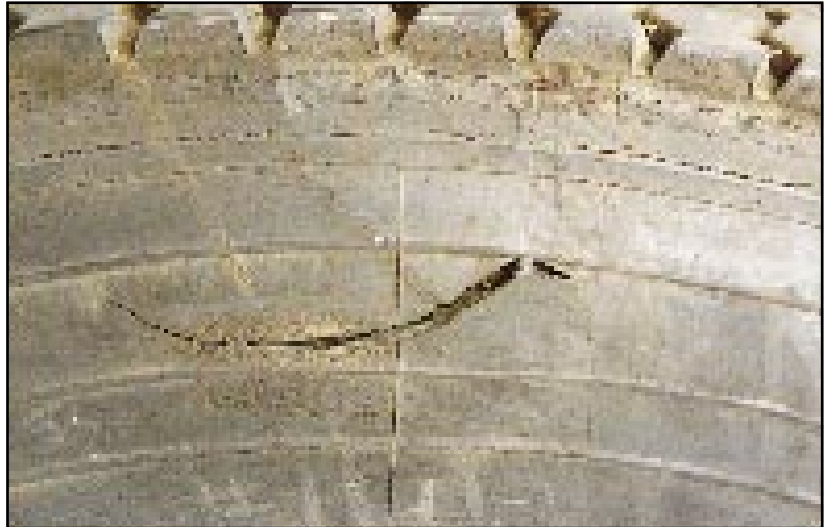
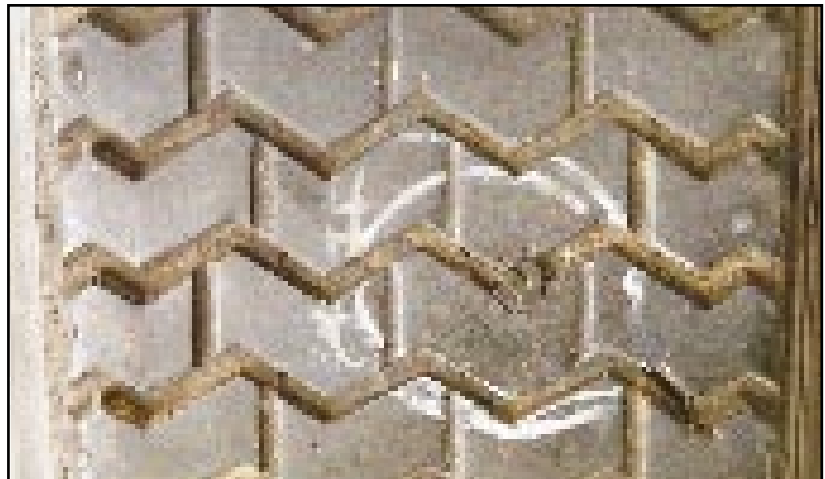
On the Wheel Repair

APPEARANCE	Interior: A rubber-coated cord or a cured rubber plug is used to fill the hole with no repair unit covering the injury. Cracks or separation around the hole may be evident. Further damage from penetrating objects may also be evident. Exterior: The tread or tire components may be separated.
PROBABLE CAUSE(S)	The tire was not demounted and properly inspected and repaired. This type of repair is not recommended.

TIRE	Consult your retreader/repair person for possible warranty adjustment. Re-repair if possible, otherwise scrap the tire.
VEHICLE	None
OPERATIONS	Review repair requirements with road service vendors and monitor on the road tire service.

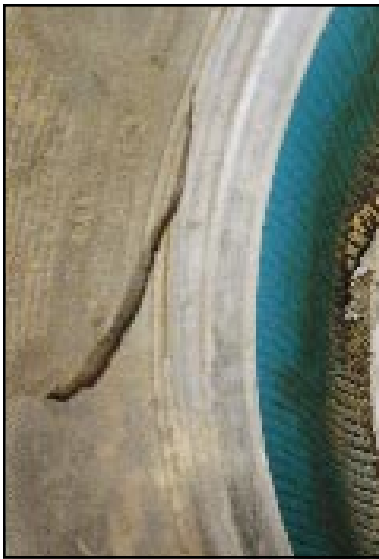
Bad Bead Repair

APPEARANCE	Interior: The inner liner may be separated and the bead area may exhibit exposed fabric or steel, cracking, loose rubber and/or improper bead contour. Exterior: Separation of the tire components may be evident.
PROBABLE CAUSE(S)	The injury exceeds repair limitation, poor workmanship, improper cure, incorrect fill material, or poor mounting/demounting techniques.

TIRE	Consult your retreader/repair person for possible warranty adjustment. Re-repair if possible, otherwise scrap the tire.
VEHICLE	None
OPERATIONS	Review mounting/demounting procedures to eliminate bead damage.

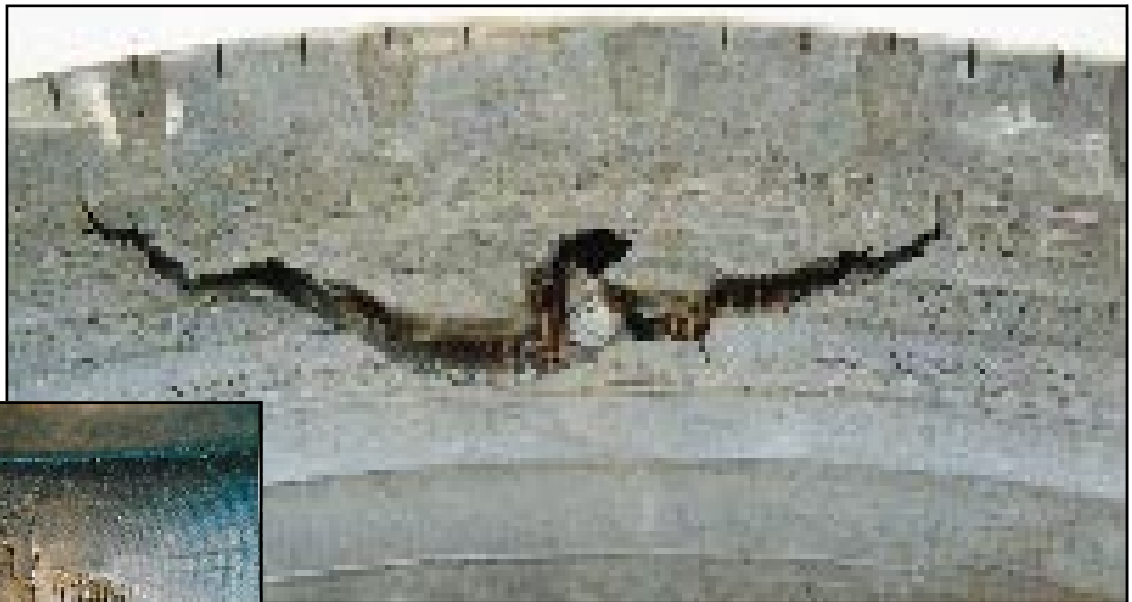
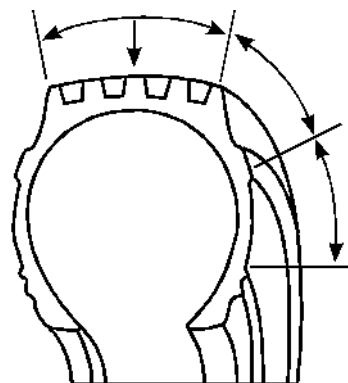
Failed Repair - Injury Not Removed

APPEARANCE	Interior: A split/crack extends from under the repair unit. The repair unit may also be torn loose or be missing. Exterior: Tire components may be separated leaving rusty, loose cords.
PROBABLE CAUSE(S)	All injury or separation was not detected and removed during the repair process, poor workmanship.

TIRE	Consult your retreader/repair person for possible warranty adjustment. Scrap the tire.
VEHICLE	None
OPERATIONS	Review repair techniques with your repair person.

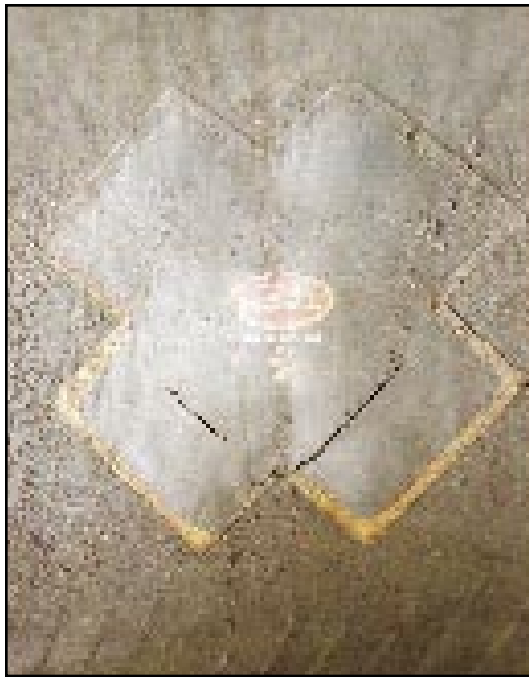
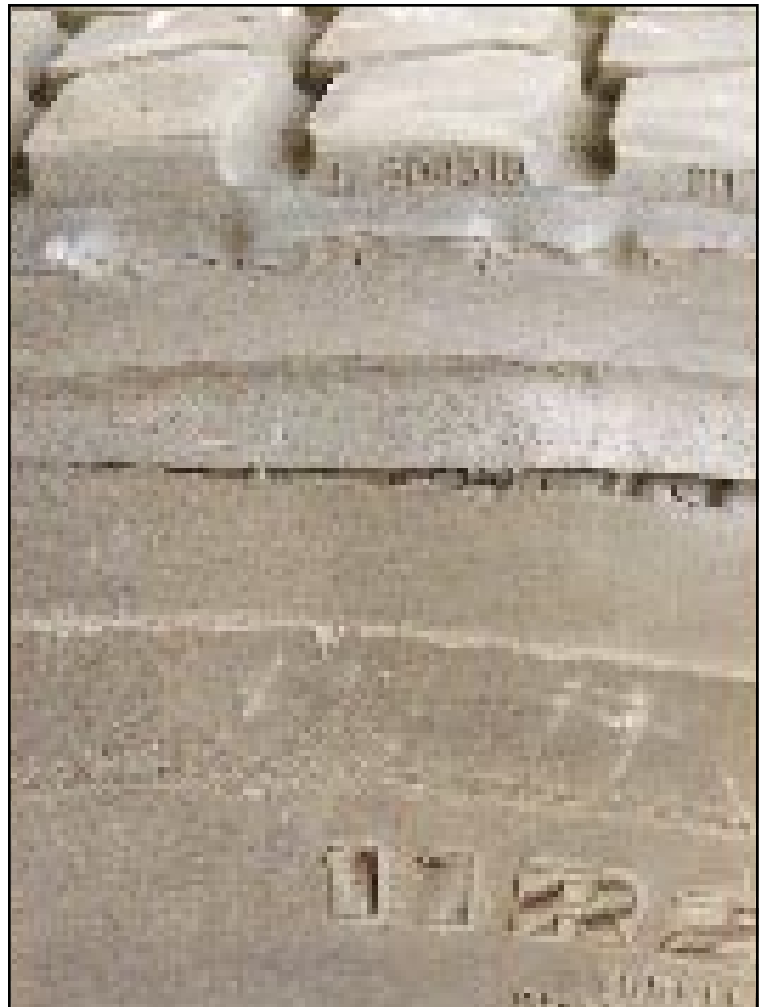
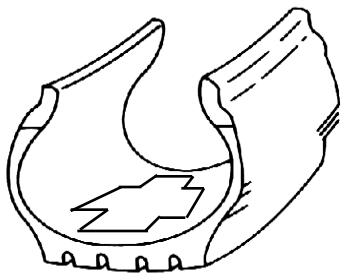
Bias Repair in Radial Tire

APPEARANCE	Interior: The repair unit is cracked or distorted. Bias repair units may be round or "X" shaped and are not labeled "Radial" (All radial, reinforced tire repair units are marked "Radial.") Exterior: Tire components may be separated.
PROBABLE CAUSE(S)	An incorrect repair unit was installed, improperly trained personnel.

TIRE	Consult your retreader/repair person for possible warranty adjustment. Re-repair if possible, otherwise scrap the tire.
VEHICLE	None
OPERATIONS	Review repair techniques with your repair person.

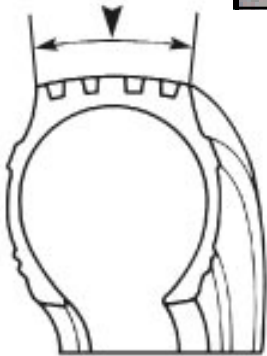
APPEARANCE	Large sections, if not all, of tread has separated from the casing; porosity is evident. This appears as a sponge-like surface that is frequently tacky.
PROBABLE CAUSE(S)	Lack of proper cure conditions, i.e., time, temperature and pressure.

TIRE	Consult your retreader for possible warranty adjustment. Retread and rerun.
VEHICLE	None
OPERATIONS	None

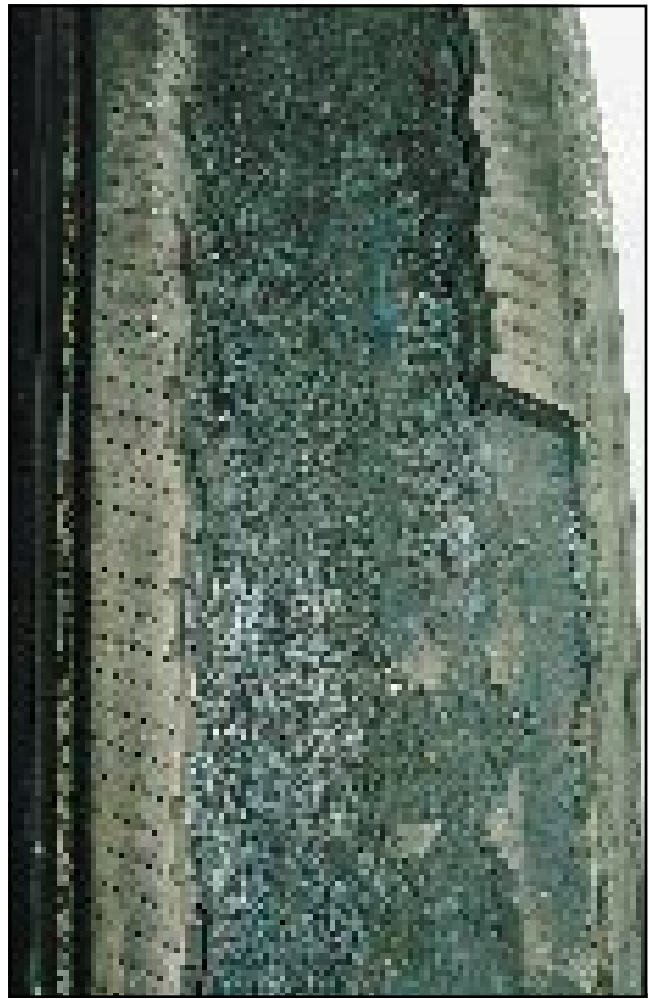
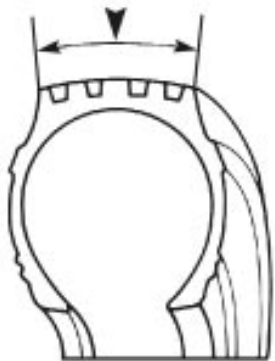
APPEARANCE	A portion of tread rubber only, located in any area of the tire, lifts and separates from the buffed surface of the tire body.
PROBABLE CAUSE(S)	Faulty retread workmanship and/or material such as a scorched or contaminated buffed surface, old cushion gum or tread rubber, improper cure conditions, missed nail hole, or a faulty repair.

TIRE	Consult your retreader for possible warranty adjustment. Retread the tire again.
VEHICLE	None
OPERATIONS	None

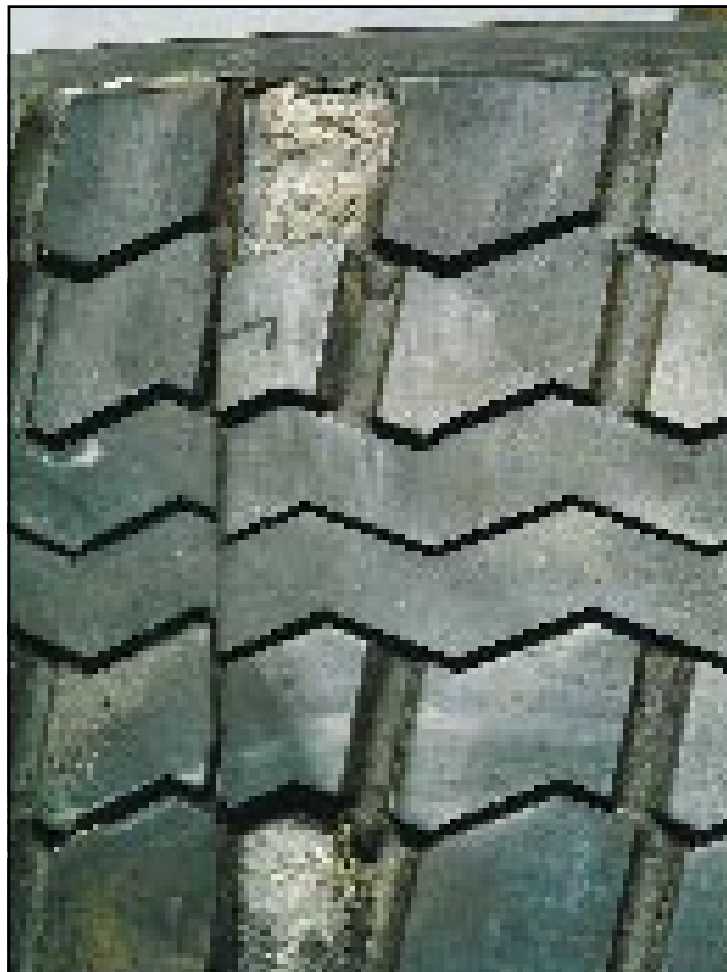
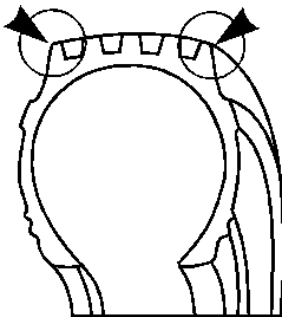
APPEARANCE	Portion(s) of tread are missing in the area of the tread splice in a pre-cured retread.
PROBABLE CAUSE(S)	Improper workmanship or contamination at the splice.

TIRE	Run out the tread in the desired position or consult your retreader for a tread spot repair. Retread again if possible.
VEHICLE	None
OPERATIONS	None

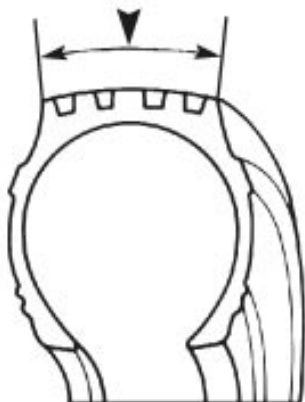
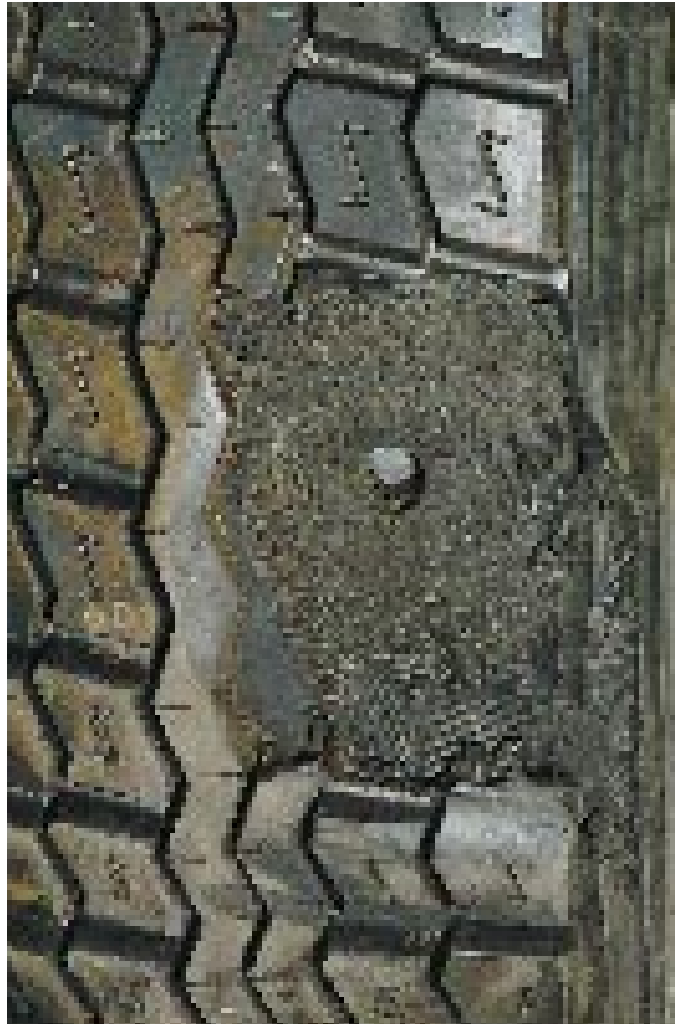
Tread Separation - Repair Related

APPEARANCE	A portion of the tread is separated from the buffed surface. A repair is evident in the area of the separated tread.
PROBABLE CAUSE(S)	Faulty repair. Air seeped through or was trapped in the injury and under the tread which eventually reduced adhesion between the tread and the tire and resulted in a separation.

TIRE	Consult your retreader and/or repairman for possible warranty adjustment or repair and retread the tire again.
VEHICLE	None
OPERATIONS	Consult your repairman to correct repair problem.

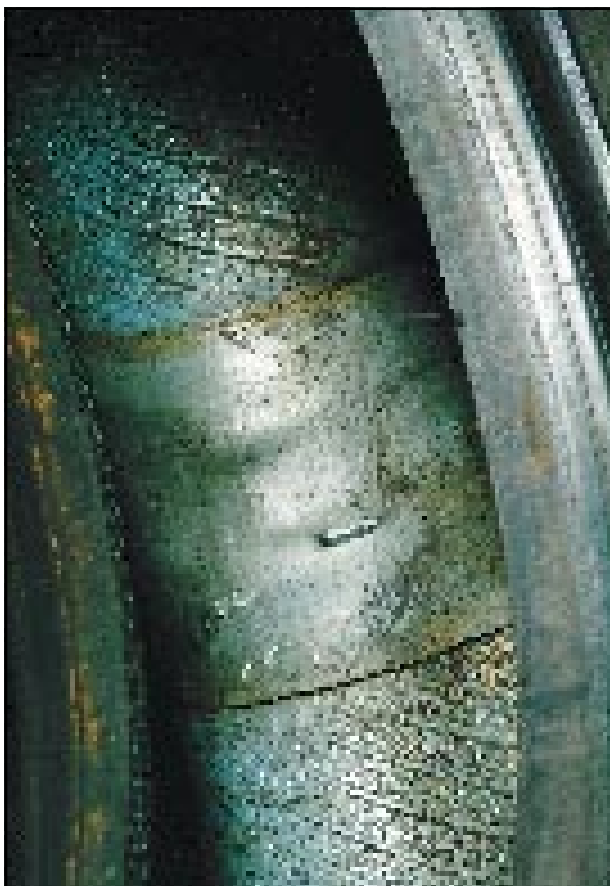
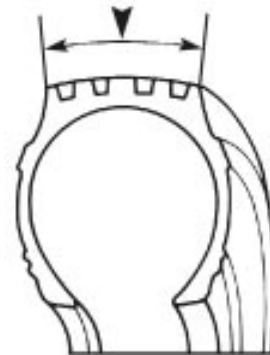
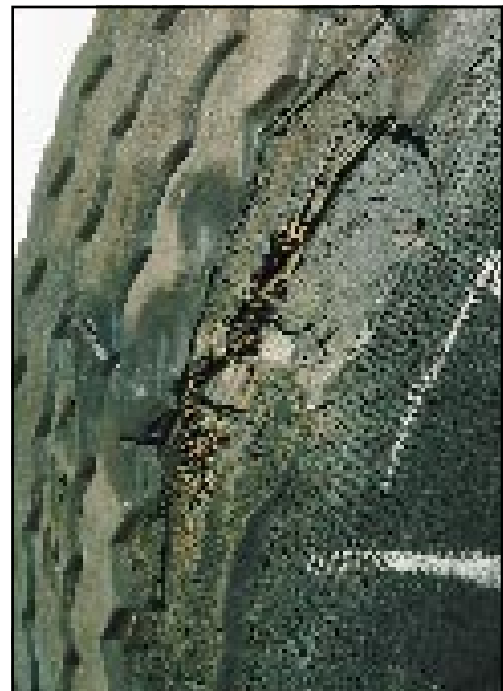
Belt Separation - Repair Related

APPEARANCE	Exterior: The tread and one or more belts is loose or missing from a portion or from the whole tire. A repair or skive is evident in the area of the separation. Interior: The repair unit may be sunk, dimpled, or cracked.
PROBABLE CAUSE(S)	A faulty repair or skive. Air migrated through the injury causing separation between the belts.

TIRE	Consult your repairman and/or retreader for possible warranty adjustment. Scrap the tire.
VEHICLE	None
OPERATIONS	None
