RADIAL TIRE CONDITIONS ANALYSIS GUIDE

**A Comprehensive
Review of Tread Wear
And Tire Conditions**

© Copyright 1994 The Maintenance Council
Printed in U.S.A.

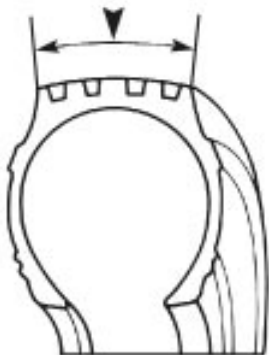
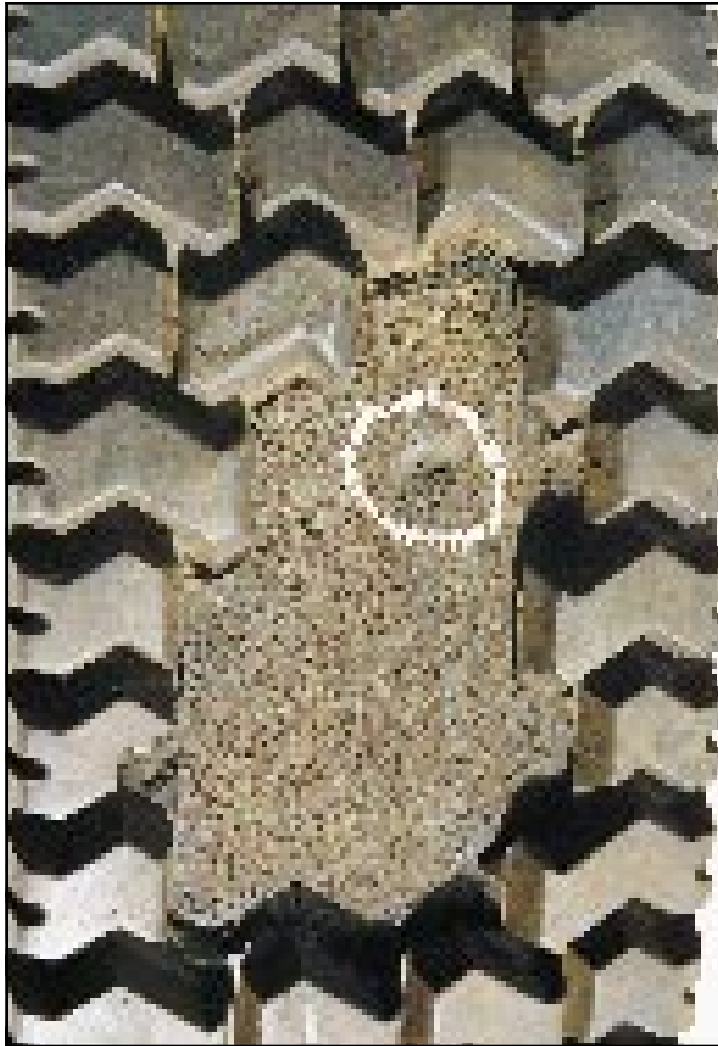
APPEARANCE	A portion of the tread is separated from the casing at the buff line in the area of the unrepaired puncture. This usually occurs soon after retreading.
PROBABLE CAUSE(S)	An undetected and unrepaired penetration.

TIRE	Consult your retreader for possible warranty adjustment. Retread again if possible.
VEHICLE	None
OPERATIONS	None

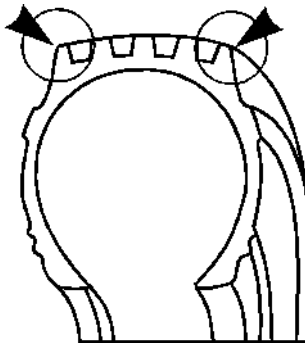
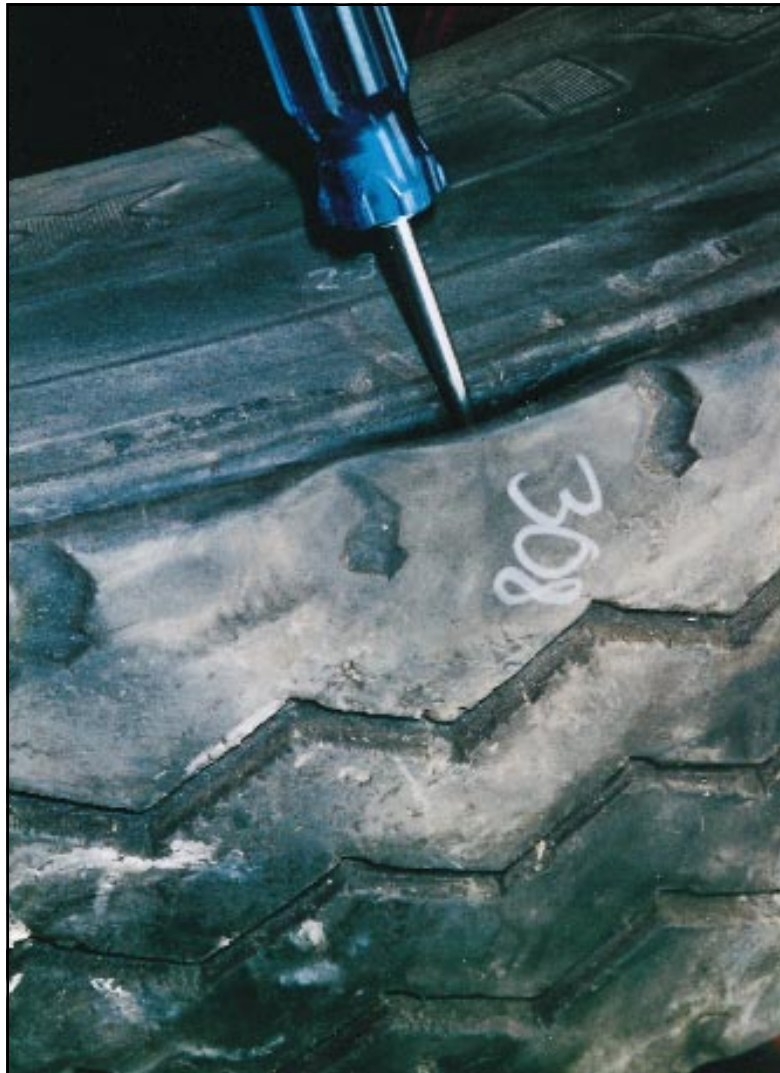
APPEARANCE	The tread is worn to excess on one shoulder of the tire; the edge of the tread is loose and exhibits more wear in the area of separation.
PROBABLE CAUSE(S)	Caused by cure related problems, retread processing problems, the shoulder buffed lower on one side or possible belt edge separation.

TIRE	Consult your retreader for possible warranty adjustment. If the tire casing is sound, retread the tire. If the belt is separating from the casing, consult the original tire manufacturer.
VEHICLE	None
OPERATIONS	None

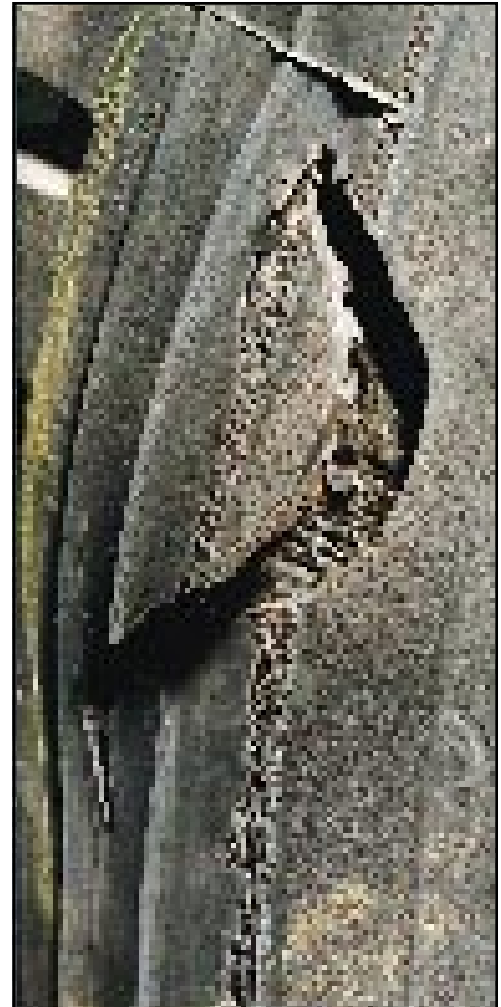
Failed Inner Liner Repair

APPEARANCE	Interior: A crack extends from the repair rubber. Buff marks may be visible around the repair rubber. The repaired area may be coated with liner sealer. Exterior: Tire components may be separated.
PROBABLE CAUSE(S)	An attempt to repair liner blisters or an open liner splice failed to seal the air cavity of the tire and air migrated into the tire body causing separation.

TIRE	Consult your retreader for possible warranty adjustment. Scrap the tire.
VEHICLE	None
OPERATIONS	None

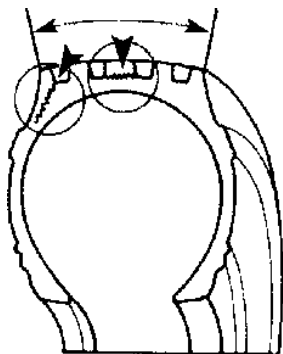
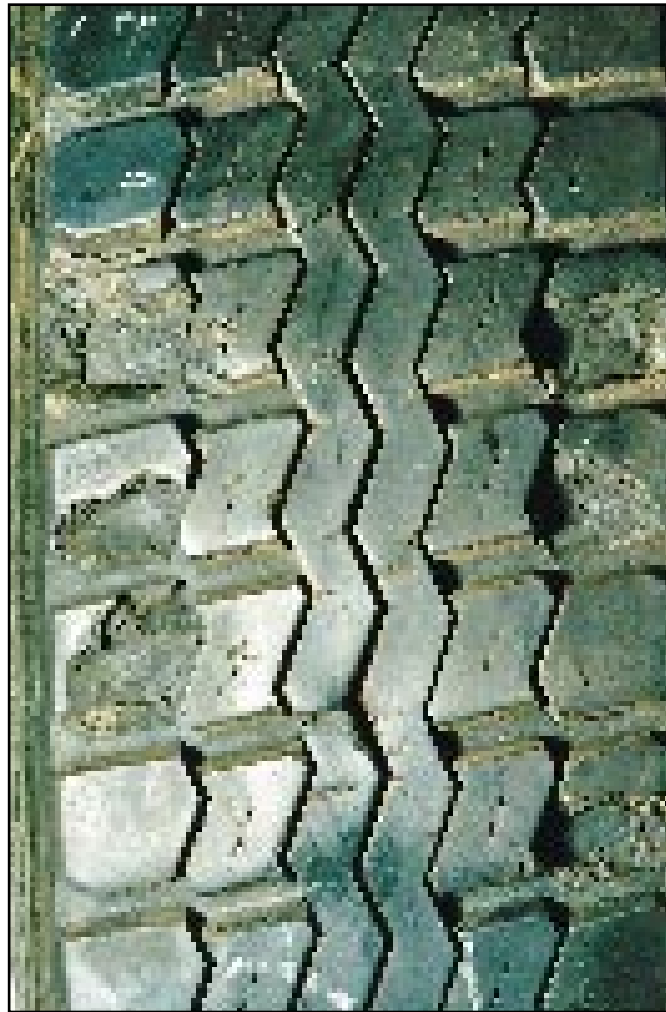
Lug Base Cracking

APPEARANCE	Cracking is evident at the base of the tread lugs. Some lugs may be torn from the tread in severe cases.
PROBABLE CAUSE(S)	The wrong tread design was used for the operation (single axle, high torque drive application with deep traction tread design may contribute to this condition), rubber compound, excessive or lack of undertread, over curing.

TIRE	Consult your retreader for possible warranty adjustment. Retread if possible.
VEHICLE	None
OPERATIONS	Review tread design selection for application.

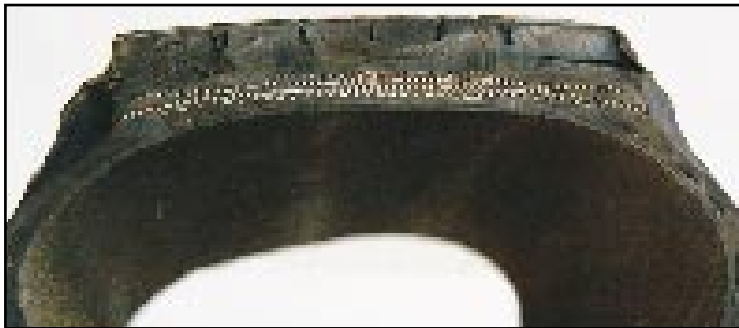
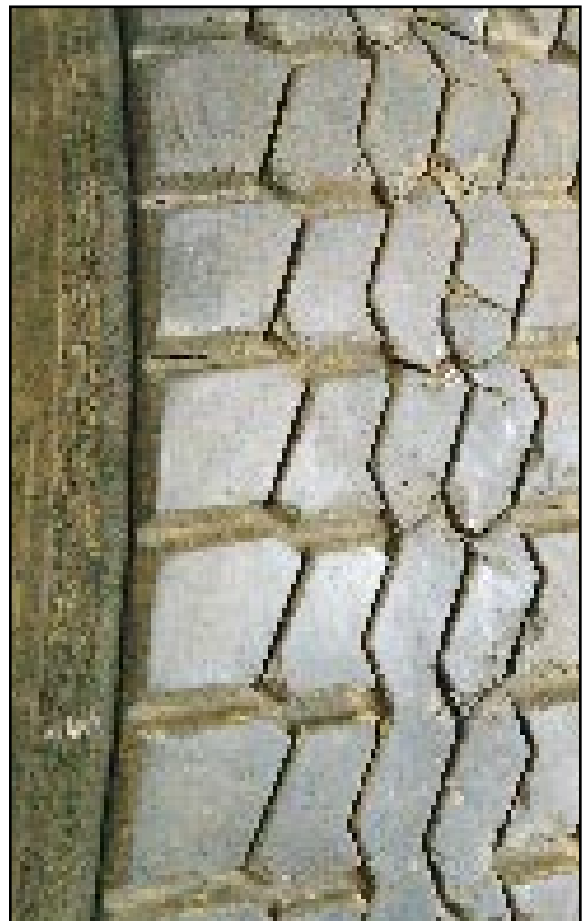
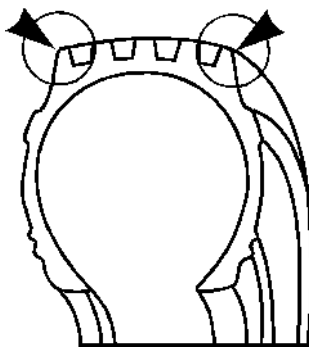
Improper Tread Width

APPEARANCE	A crack appears at the tread edge which can extend into the belt. The tread edge may lift off the casing.
PROBABLE CAUSE(S)	Inadequate support of the belt package during operation which creates a new flex point in the tire. The result is a breakdown of the belts or rubber at the bondline of the retread and the casing.

TIRE	Consult your retreader for possible warranty adjustment.
VEHICLE	None
OPERATIONS	None

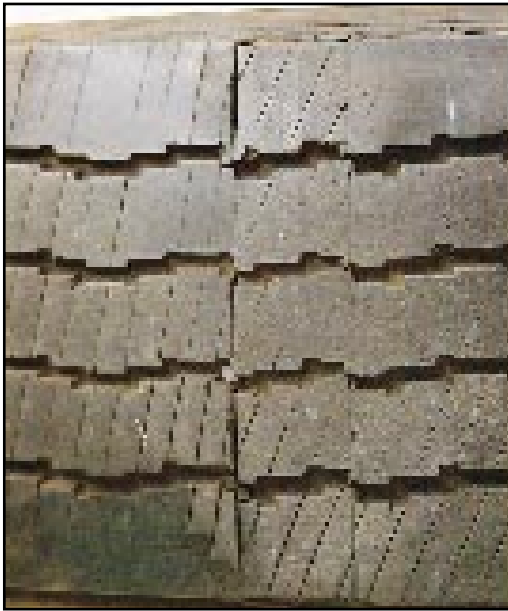
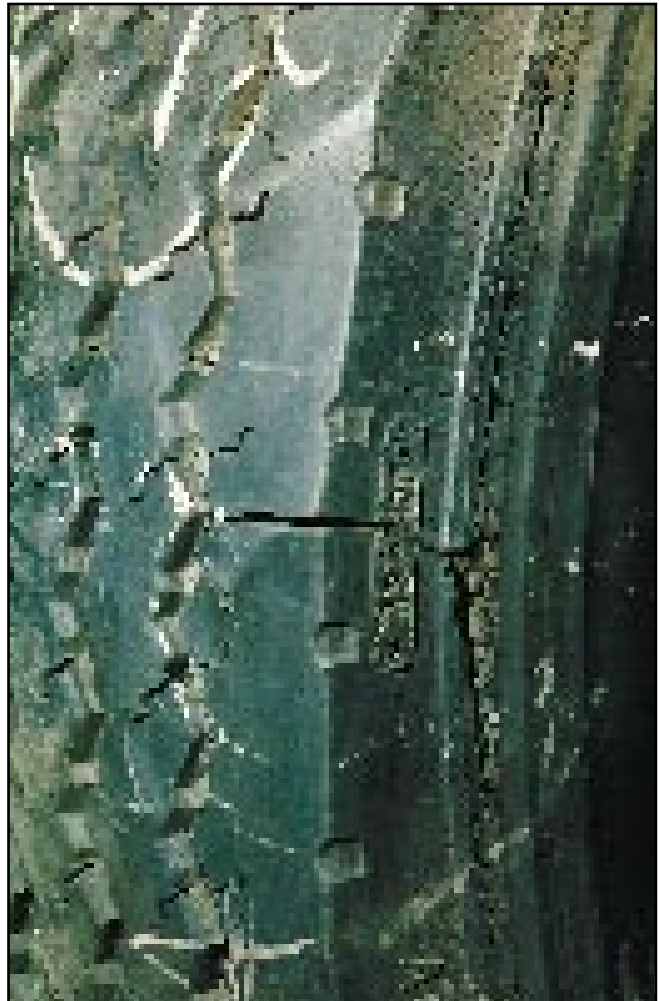
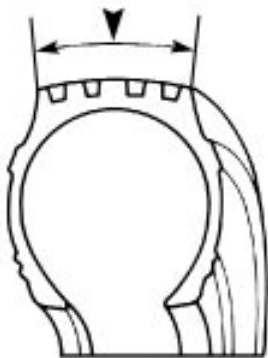
APPEARANCE	A space is evident between the tread ends.
PROBABLE CAUSE(S)	Poor workmanship, poor tread end adhesion or the tread was cut too short.

TIRE	The tire may run out its tread life and be returned to service; or consult your retreader for possible warranty adjustment and retread again.
VEHICLE	None
OPERATIONS	None

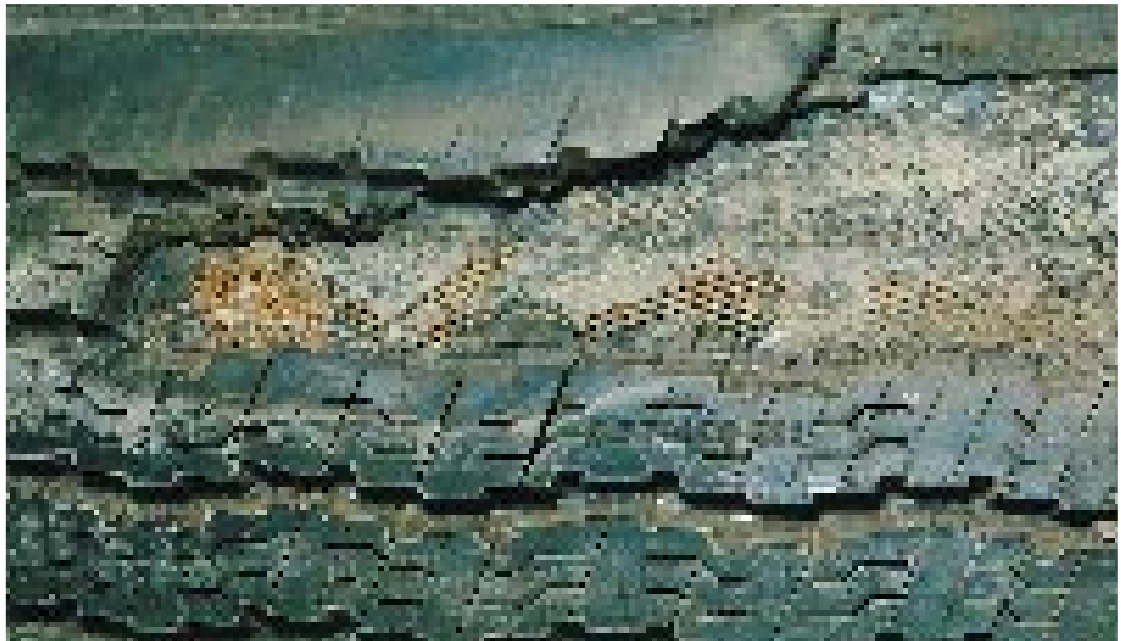
Skive Failure

APPEARANCE	A bulge or excessive wear in the tread area, or area where the tread is missing at a skive.
PROBABLE CAUSE(S)	Improper skive or skive fill which traps air or allows air to seep under the tread and results in a localized loss of tread adhesion. Tread or casing separation may occur if not caught early in treadlife.

TIRE	Consult your retreader for possible warranty adjustment. If within limits of repair, repair the tire again and retread.
VEHICLE	None
OPERATIONS	None

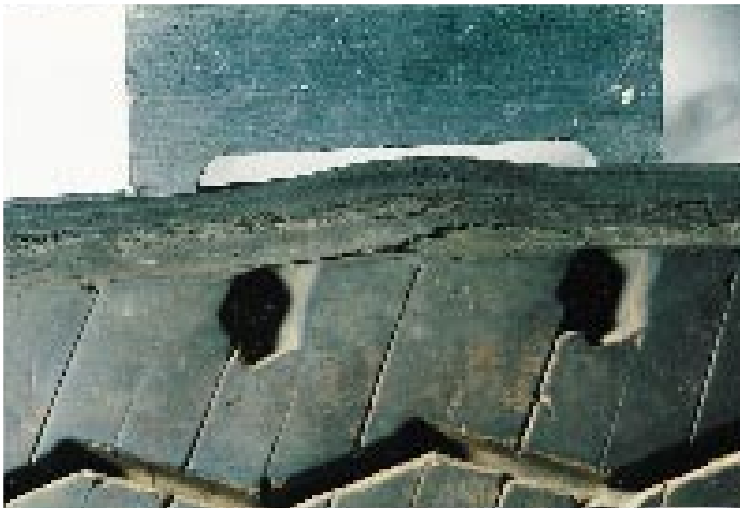
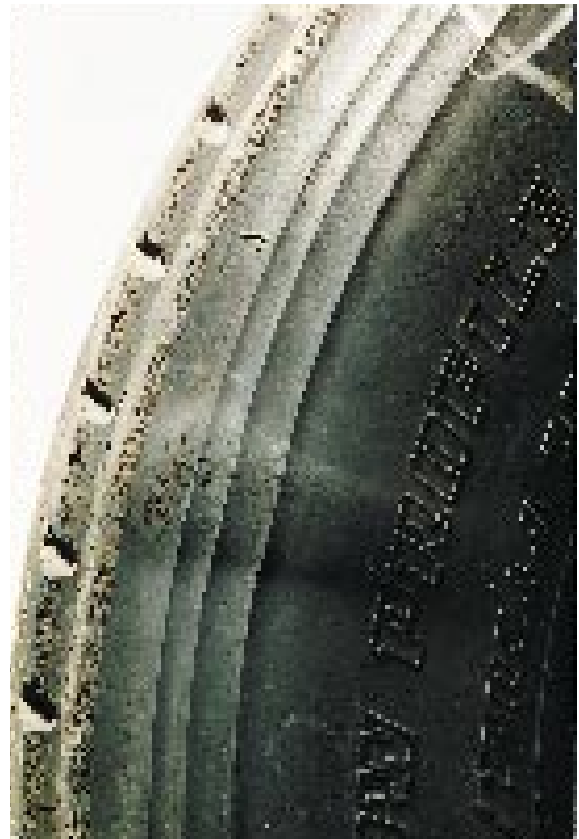
Repair Related Bulge

An excessive bulge in the mid/upper sidewall which may progress to a complete separation of the sidewall rubber from the casing. A slight bulge associated with a repair which can be identified with a blue triangular label is normal as the cables reposition themselves after repair. The bulge must not exceed 3/8".

The repair unit is too small or improperly installed.

Consult your tire repairman to correct the repair problems.

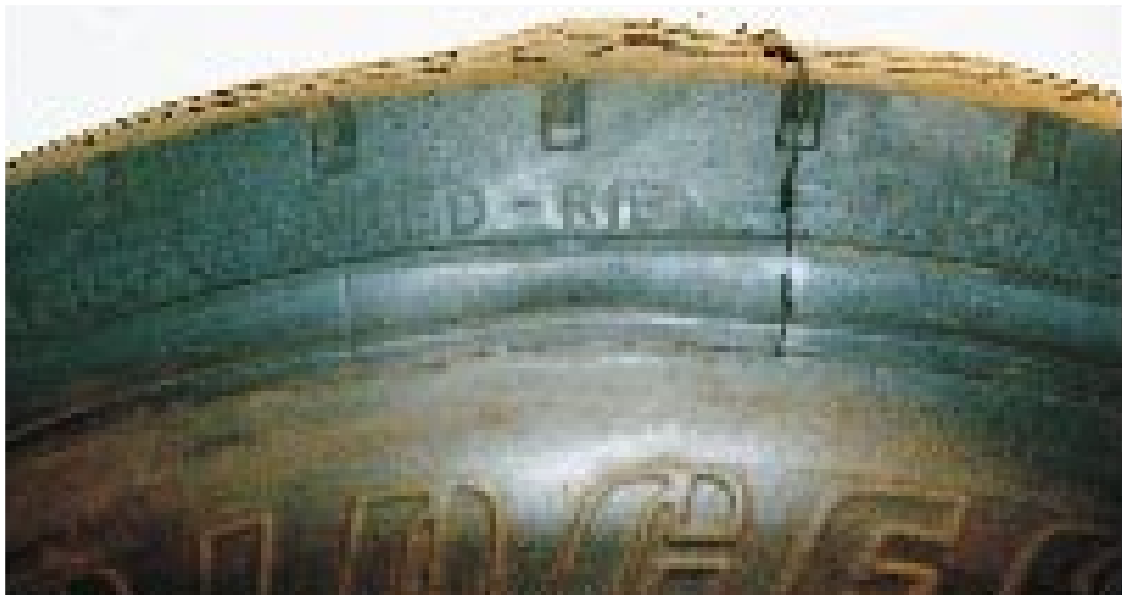
The retread tire was too large for the mold in which it was cured, thus causing distortion in the tire during the curing process.

Consult your retreader/repair person for possible warranty adjustment.

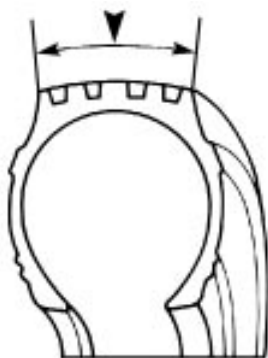
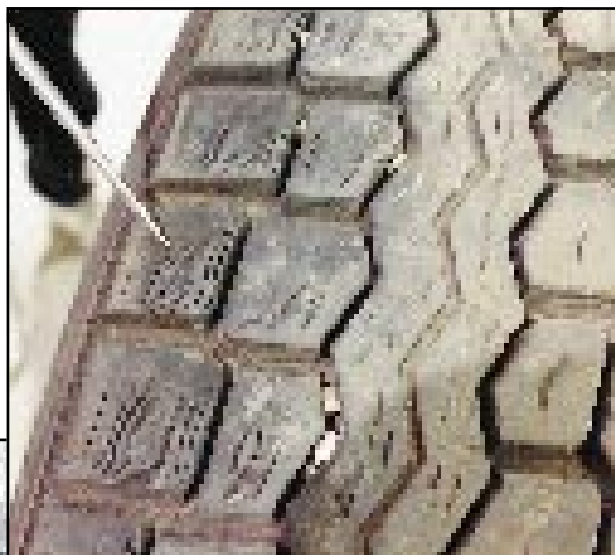
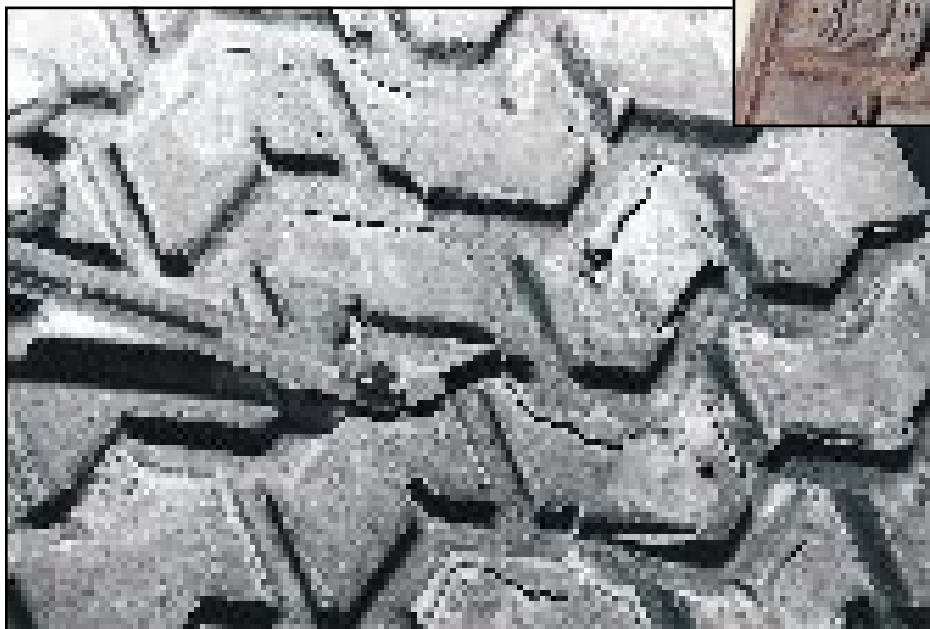
Excessive mold lube or a rubber compounding problem, surface cure of the tread rubber or poor mold fitment.

The tread can be run out if the condition is not severe, otherwise consult your retreader for possible warranty adjustment and retread the tire again.

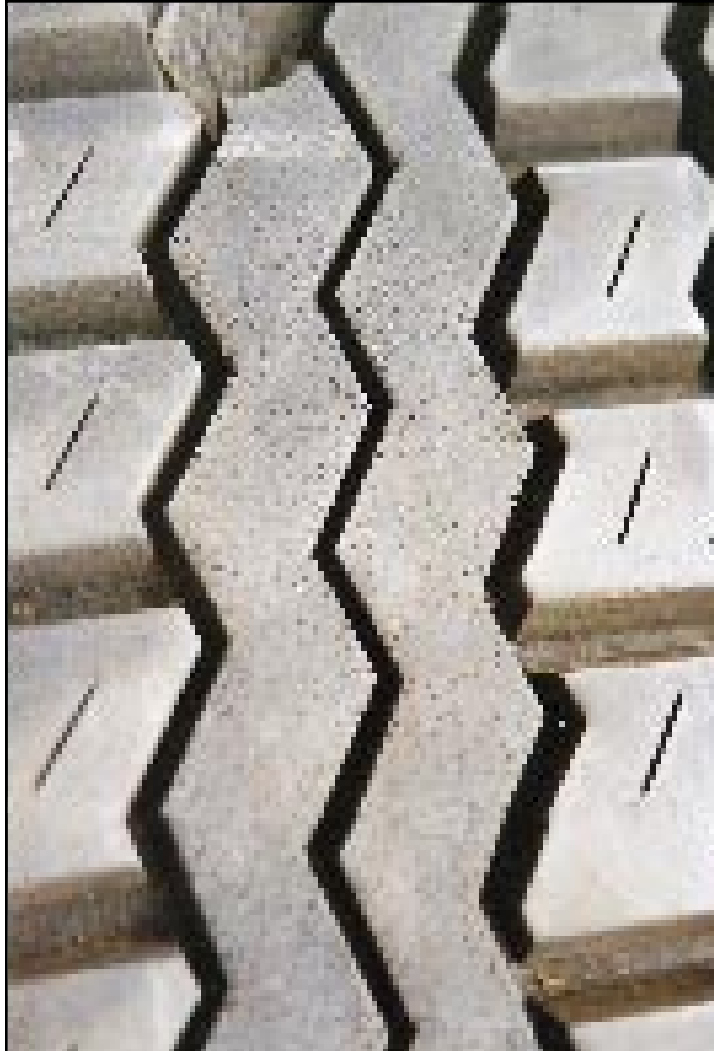
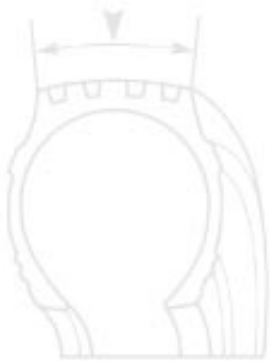
APPEARANCE	A spongy appearance in the surface of the tread. Portions of the tread may be missing.
PROBABLE CAUSE(S)	Insufficient tread rubber, improper cure, or poor mold fitment.

TIRE	The tread can be run out if the tread adhesion to the casing is adequate, however, tread wear may be poor. If the adhesion is poor, consult your retreader for possible warranty adjustment, and retread the tire again.
VEHICLE	None
OPERATIONS	None

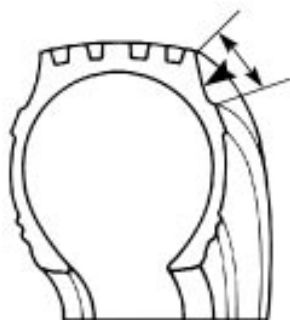
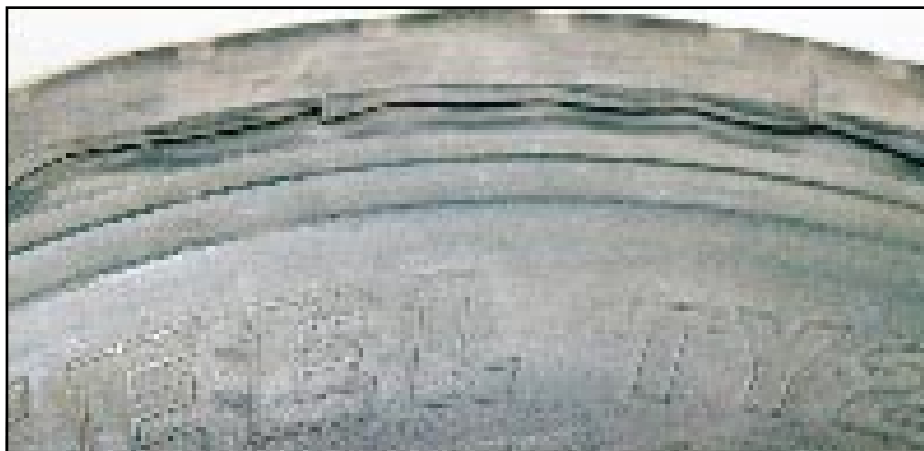
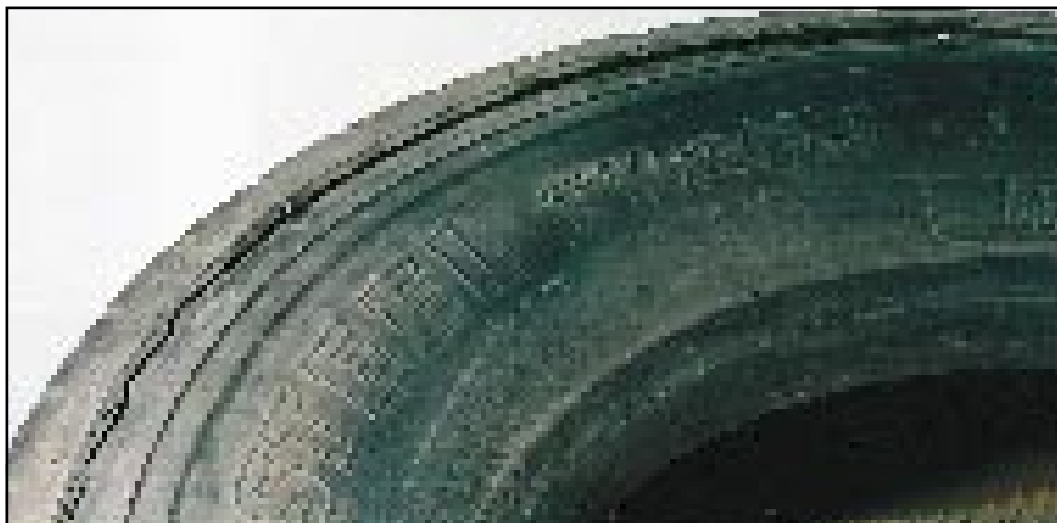
The sidewall shoulder rubber of the retread is loose.

Lack of shoulder buff or poor mold fitment (mold cure), poor tread building, scorched or contaminated buffed surface and/or improper crown radius.

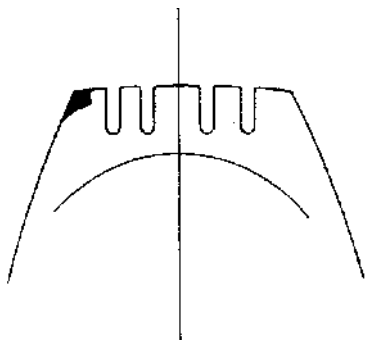
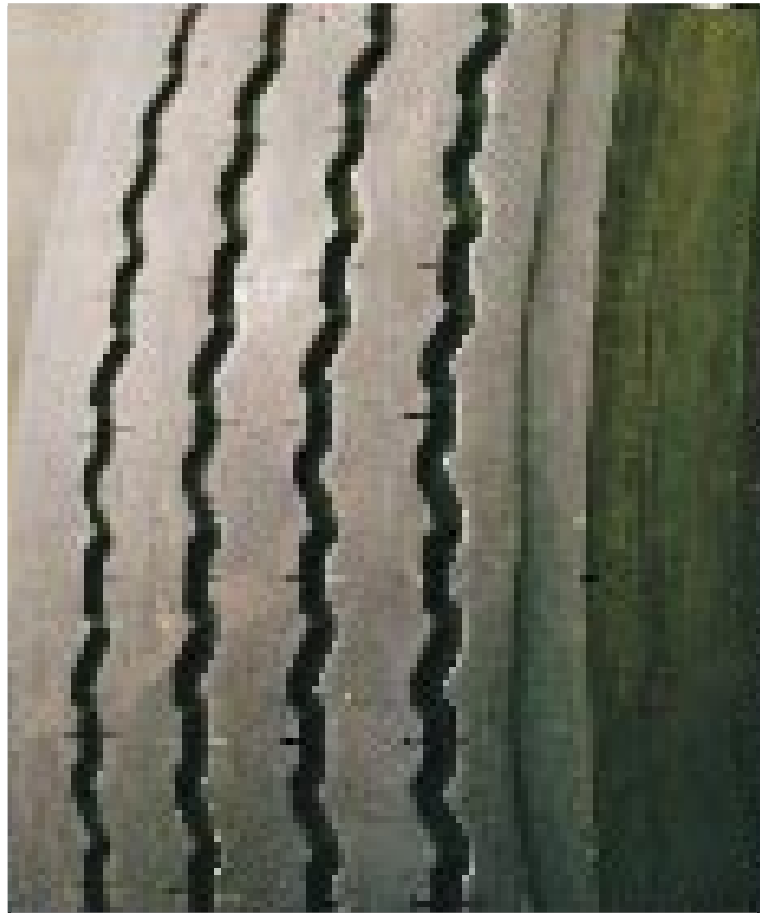
Shoulder Step/Chamfer Wear

Even tread wear in center with steps worn in shoulders. This is confined to the outer portion of the shoulder rib. Can be wider on one shoulder than the other.

Typical of radial tires in slow wearing operations. May vary with tread design and service application.

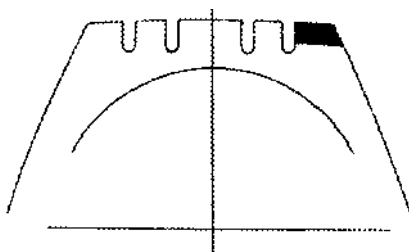
Full Shoulder Wear

APPEARANCE	Excessive wear extending across entire shoulder rib to a major tread groove, usually on one side of tire only.
PROBABLE CAUSE(S)	<p>Result of side scrubbing and generally is caused by either improper toe condition or drive axle misalignment.</p> <p>In case of toe in, the outside shoulders of both steer tires will be worn, while in the case of toe out, the inside shoulders of both steers will be worn. Drive axle misalignment wears the inside shoulder of one tire and the outside shoulder of the other steer tire. Poorly maintained suspension components (e.g. torque rods, springs, and spring bushings) can produce the same results.</p>

TIRE	If wear is severe, tires can be rotated to another position or reversed on the wheel.
VEHICLE	Diagnose misalignment, check suspension components, and correct as required.
OPERATIONS	None

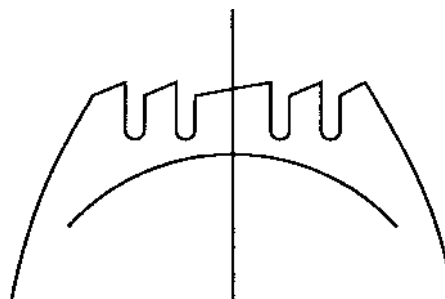
Feather Wear

APPEARANCE	Tread ribs worn so that one side of rib is higher than the other resulting in step-offs across the tread face. Generally, all ribs exhibit this wear.
PROBABLE CAUSE(S)	Excessive side force scrubbing, resulting from severe conditions of misalignment such as excessive toe, severe drive axle misalignment, worn, missing or damaged suspension components, bent tie rod or other chassis misalignment.

TIRE	If feather wear is severe, tires can be rotated to another axle for maximum utilization of remaining tread.
VEHICLE	Diagnose and correct misalignment condition as required. If feather wear on both steer tires is in the same direction, drive axle or other chassis misalignment is indicated. If steer tire feathers are in opposite directions, a toe condition is indicated.
OPERATIONS	None

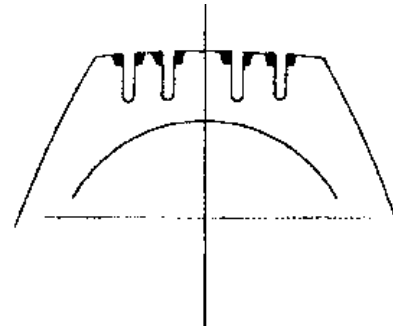
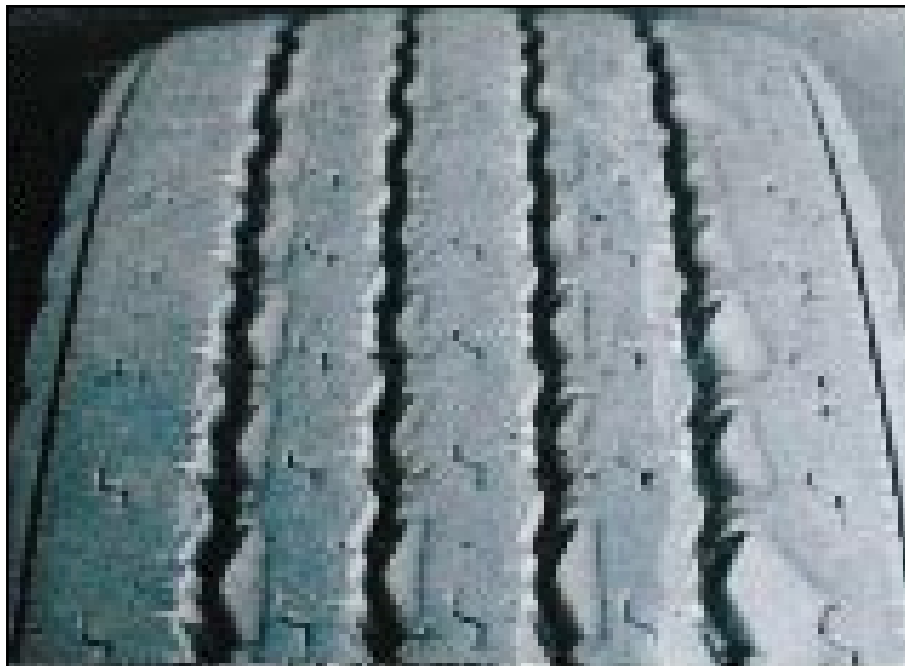
Erosion/River/Channel Wear

APPEARANCE	Circumferential wear along rib edges next to major tread grooves may be wavy in appearance and vary in width around tire.
PROBABLE CAUSE(S)	Characteristic of slow wear rate of radial tires on free rolling axles. May vary with individual tire tread design and construction. Common in line haul operations in which loads are light and turning is frequent.

TIRE	Erosion wear should not be of concern.
VEHICLE	None
OPERATIONS	None

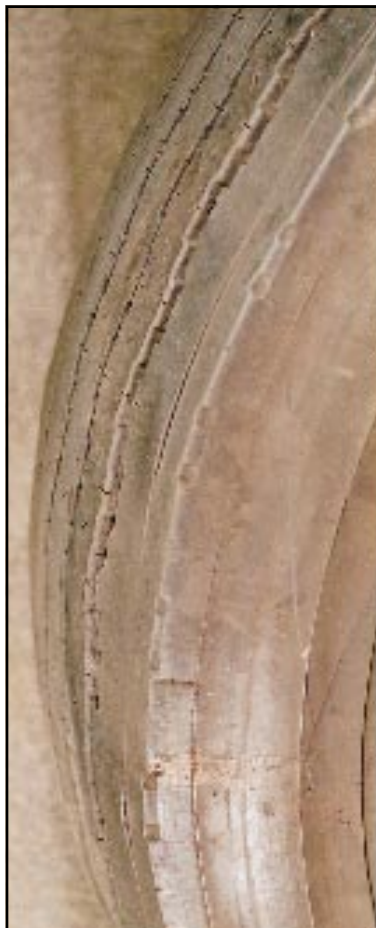
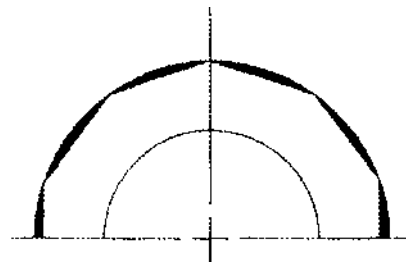
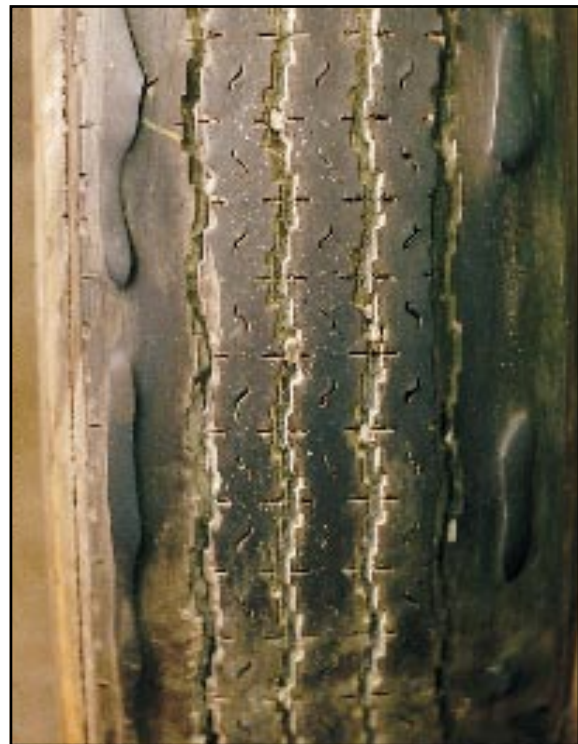
Cupping/Scallop Wear

APPEARANCE	Localized dished out areas of fast wear creating a scalloped appearance around tire. Appears around the tire on the shoulder ribs. May progress to adjoining ribs.
PROBABLE CAUSE(S)	Usually a result of moderate to severe assembly out of balance condition, improper rim/wheel mounting or other assembly non-uniformity. Can also be due to lack of shock absorber control on some suspension types.

TIRE	If ride complaints arise, tires may be rotated to drive axle.
VEHICLE	Diagnose imbalance condition, i.e., wheel, rim, hub, brake drum. Correct as necessary.
OPERATIONS	None

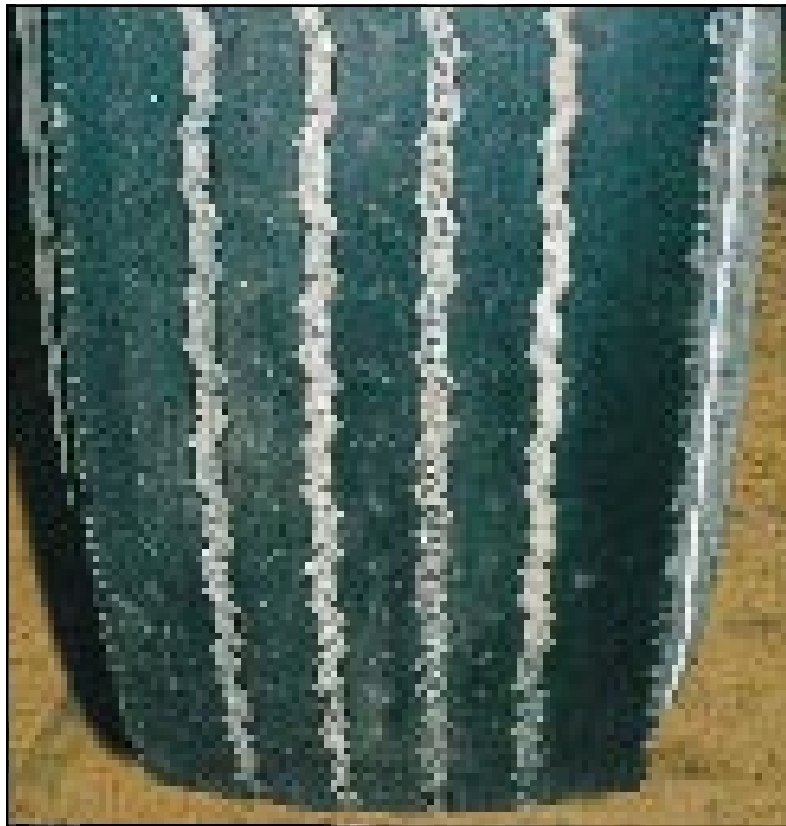
One-Sided Wear

APPEARANCE	Excessive wear on one side of tire extending from the shoulder towards the center of the tread.
PROBABLE CAUSE(S)	Improper alignment, worn king pins, loose front wheel bearings, excessive axle loads.

TIRE	Depending on severity of wear, tires may be rotated to drive axle or, if worn to minimum tread depths on shoulder, submit for possible retreading.
VEHICLE	Diagnose mechanical problem and correct.
OPERATIONS	None

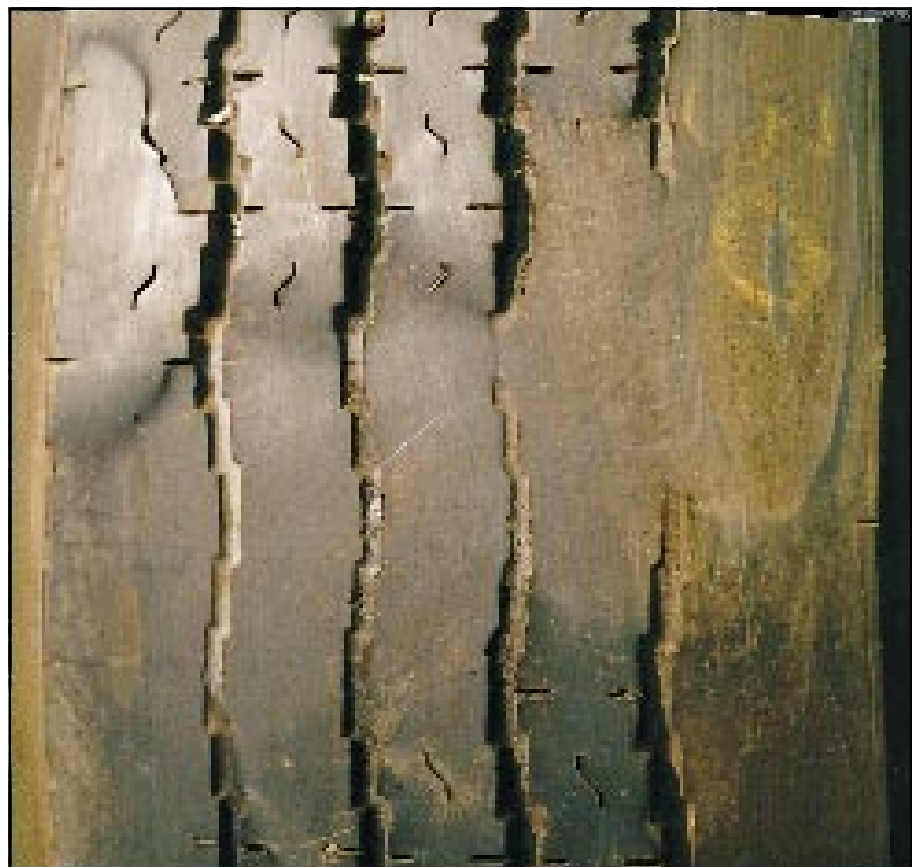
Diagonal Wear

APPEARANCE	Localized flat spots worn diagonally across the tread, often repeating around tread circumference.
PROBABLE CAUSE(S)	Runout and/or out of balance in conjunction with a slow rate of wear. Can develop from a brake skid, spot wear, shoulder wear, or other advanced wear conditions. Can also be caused by loose wheel bearings and is aggravated by misalignment.

TIRE	The tire may be rotated to the outside drive dual position with change in rotation of the tire. If wear is excessive, submit to retreader for further options.
VEHICLE	Diagnose cause and correct.
OPERATIONS	None

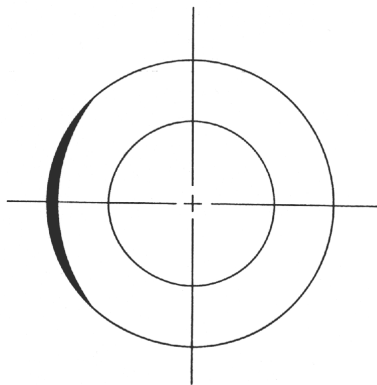
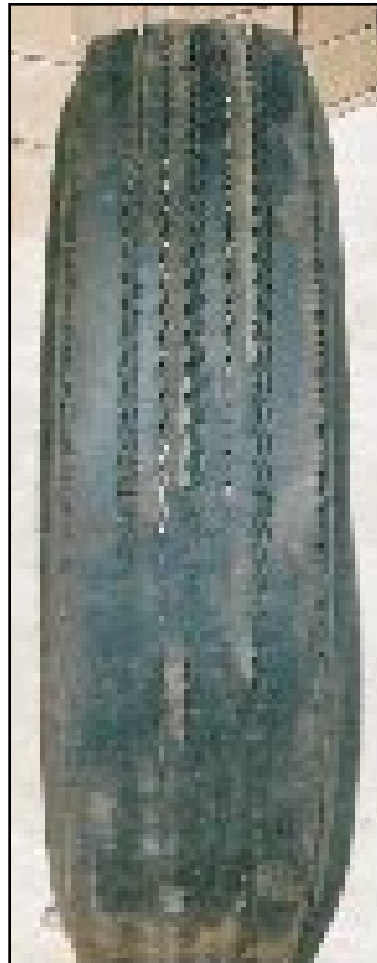
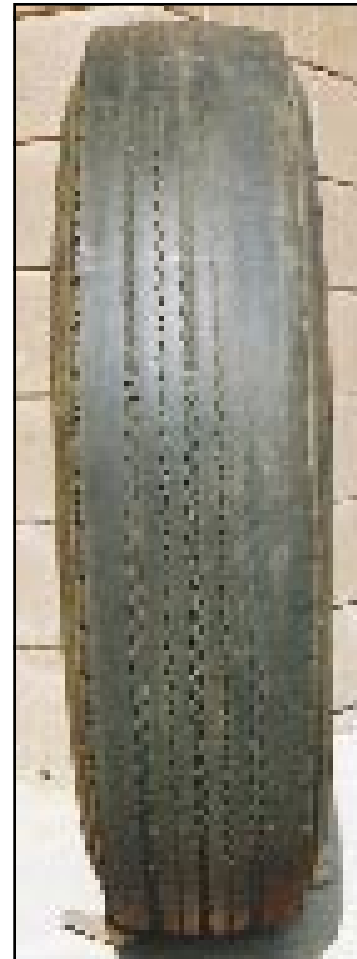
Eccentric/Out-Of-Round Wear

APPEARANCE	Considerable difference in tread depth between 90° and 180° apart.
PROBABLE CAUSE(S)	Usually a result of excessive radial runout or other non-uniformity in the rotating assembly, e.g. hub, stud circle, wheel/rim, tire and/or improper bead seating of tire on rim. May also be caused by dragging or distorted brake drums and drums with excessive wall thickness variation. May be accompanied by, or develop into, a vibration complaint.

TIRE	Tire may be rotated to the trailer dual. If wear is excessive on worn side, submit to retreader for further options.
VEHICLE	Diagnose problem components/parts. Replace or correct as necessary.
OPERATIONS	None

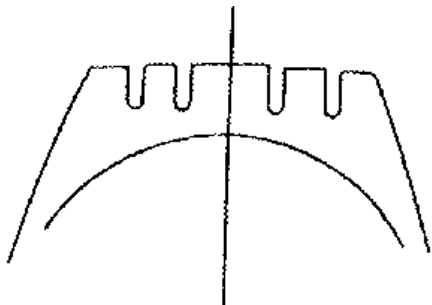
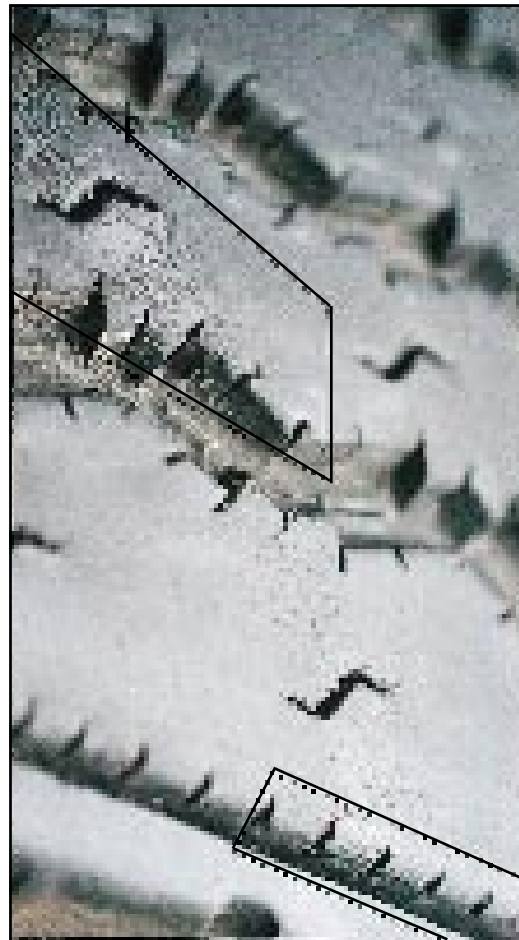
Overall Fast Wear

APPEARANCE	Good wear pattern but fast rate of wear.
PROBABLE CAUSE(S)	Can be caused by service conditions such as mountainous terrain, frequency and severity of turning, abrasive road surfaces in combination with vehicle configurations and their attributes such as power steering, heavy axle loads, high wheel cuts, setback axles, short wheel base tractors, long wheel base straight trucks.

TIRE	None
VEHICLE	Consult vehicle and tire manufacturers when specing equipment or replacing tires.
OPERATIONS	None

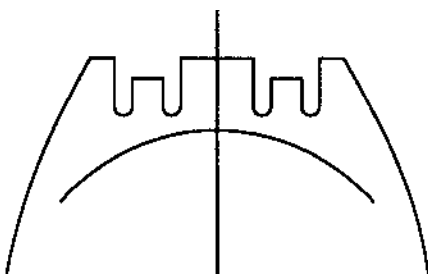
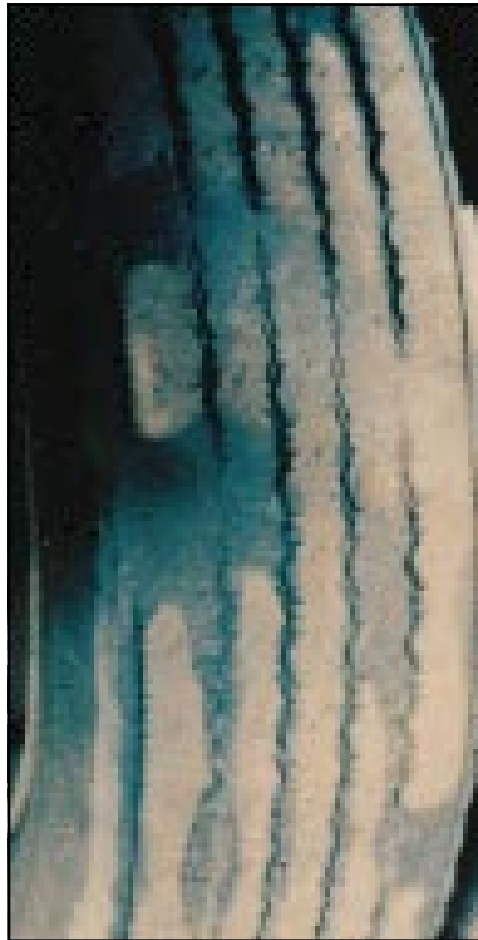
Rib Depression/Punch Wear

APPEARANCE	One or more inner ribs worn below the level of the adjacent ribs circumferentially around the tire.
PROBABLE CAUSE(S)	Lack of shock absorber control in some suspension types, improper inflation pressures, loose or worn wheel bearings, assembly non-uniformity such as improper bead seating and out-of-balance condition, aggravated by high speed empty hauls.

TIRE	If not worn excessively, continue to run. If wear is excessive, retread.
VEHICLE	Diagnose mechanical problem and correct.
OPERATIONS	None

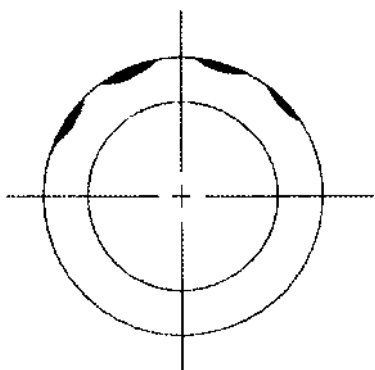
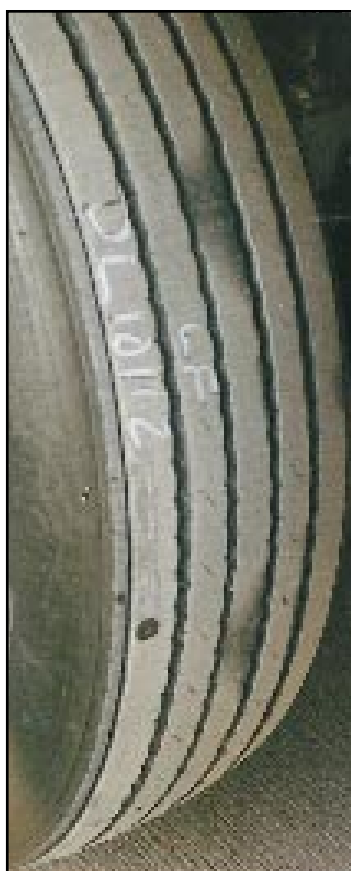
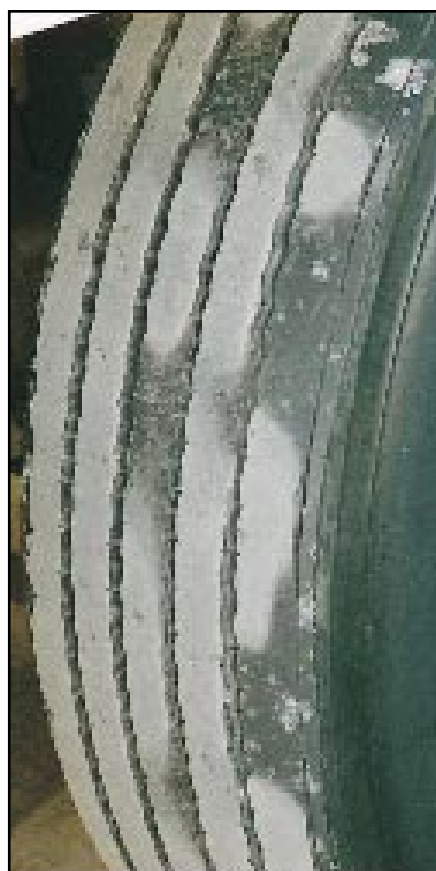
Erratic Depression Wear

Random, erratic wear around tire circumference.

Lack of shock absorber control in some suspension types. Loose or worn wheel bearings, assembly non-uniformity such as improper bead seating and out-of-balance condition, aggravated by high speed empty hauls.

If not worn excessively, continue to run. If wear is excessive, retread.

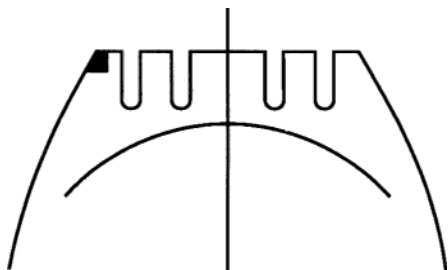
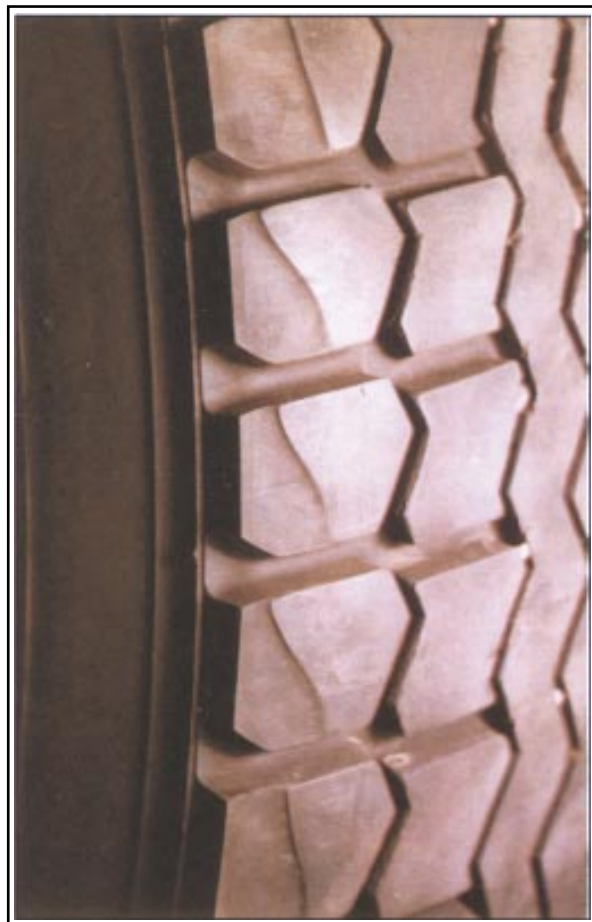
Shoulder Step/Chamfer Wear

APPEARANCE	Tire worn on edge of shoulder. This is confined to the outer portion of the shoulder. Can be wider on one shoulder than the other. This condition usually appears first on the inside shoulder of the inside dual of the front drive axle.
PROBABLE CAUSE(S)	Typical of radial tire construction and slow rates of tread wear. May vary with tread design and service application. Can be aggravated by axle deflection, road conditions, and worn or damaged suspension parts.

TIRE	Consider rotating tire among drive axles. Does not adversely affect overall tread life.
VEHICLE	Inspect for worn or damage suspension parts.
OPERATIONS	None

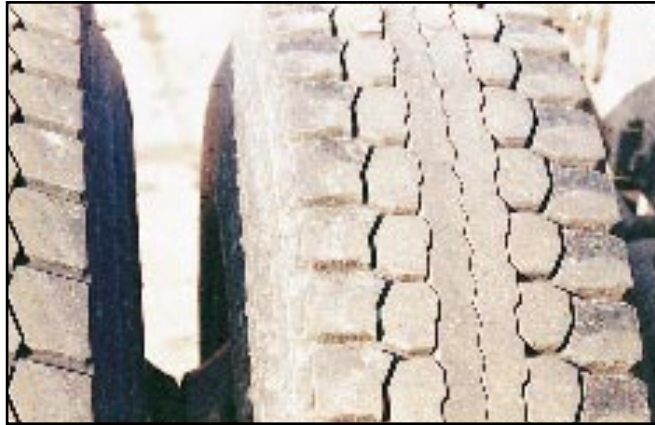
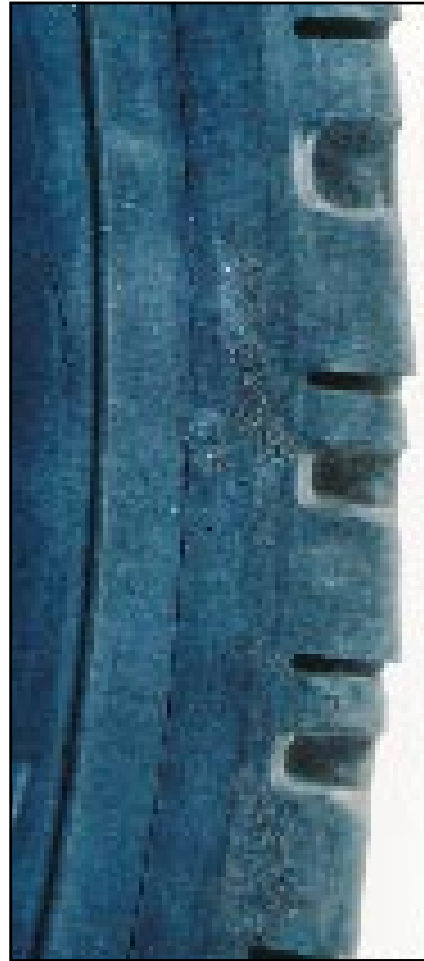
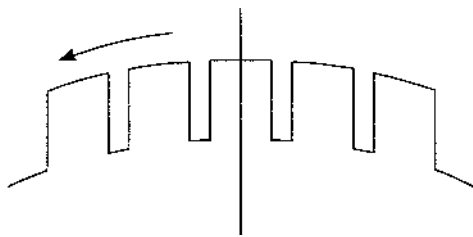
Heel/Toe Wear

APPEARANCE	Each lug around tire worn high to low from front to back edge.
PROBABLE CAUSE(S)	Most often caused by mismatched inflation pressures or tire diameter in a dual assembly and certain conditions such as P&D operations, mountainous terrains, etc.

TIRE	Run out on drive axle. If severe, change direction of rotation until tread is worn to point of retread.
VEHICLE	Review tire maintenance practices and tread design selection.
OPERATIONS	None

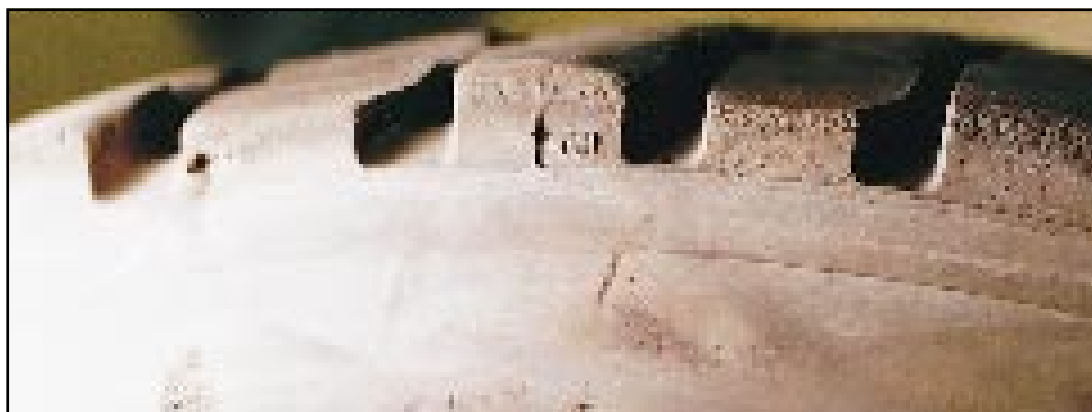
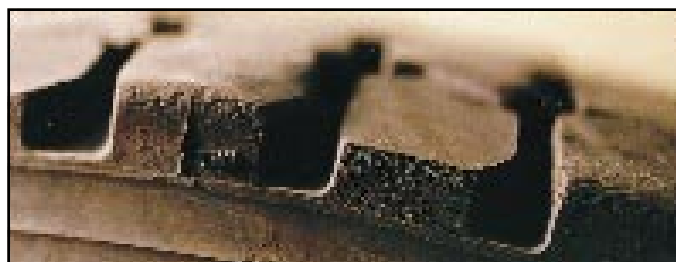
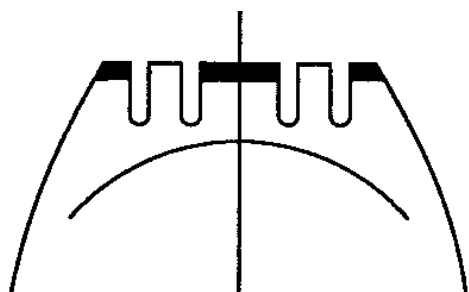
Alternate Lug Wear

APPEARANCE	Alternate lugs worn to different tread depths around tire circumference. May be every second lug, every third, etc... or a combination thereof.
PROBABLE CAUSE(S)	Mismatched inflation pressures or tire diameters in a dual assembly and certain conditions such as pick up and delivery operations and variations in loads. Is accentuated by slow rate of tire wear and by worn or poorly maintained suspension components or axle misalignment.

TIRE	Continue to run out unless tread depth variations become severe. Rotate to faster wearing position, i.e., single screw tractor or rear drive axle.
VEHICLE	Check for worn or damaged components and axle misalignment.
OPERATIONS	Review tire maintenance practices and tread design selection.
