RADIAL TIRE CONDITIONS ANALYSIS GUIDE

**A Comprehensive
Review of Tread Wear
And Tire Conditions**

© Copyright 1994 The Maintenance Council
Printed in U.S.A.

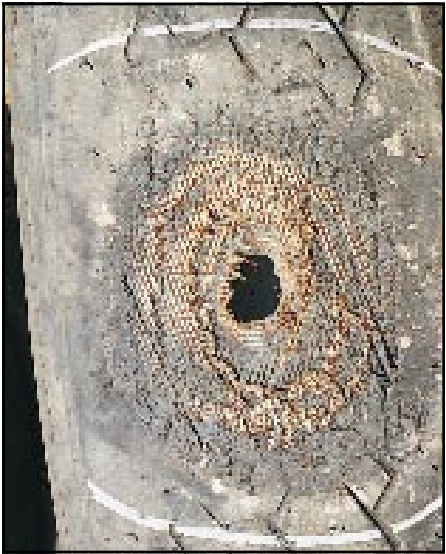
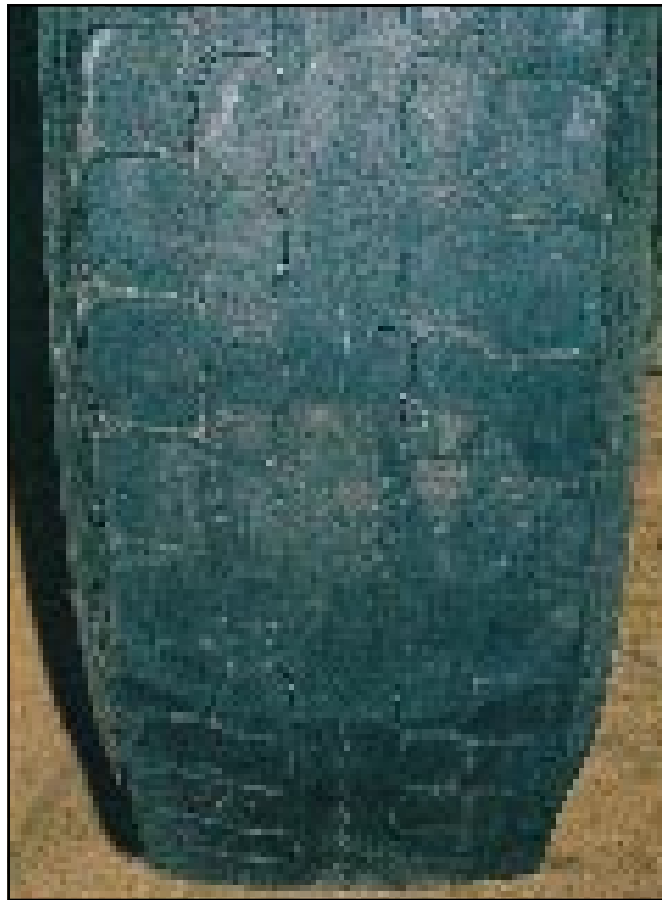
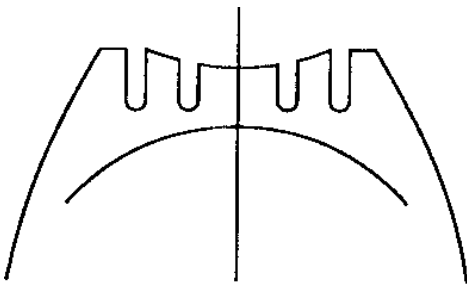
Brake Skid/Flat Spot Wear

APPEARANCE	Flat spot on tread surface. Surface texture may show abrasion marks from tread sliding on road surface, but surface may have since worn smooth. Often exhibited on more than one tire position on an axle.
PROBABLE CAUSE(S)	Aggravated by new brakes (high friction, not worn in), unbalanced brake system, aggressive use of brakes and driver abuse. Sometimes seen on new vehicle drive-aways.

TIRE	If condition is not excessive, duals can be rematched to position flat spots 180° from each other. If more severe, the tire can be repaired or retreaded if damage is not into the belts. If skid damage is into the tire belts, it may be possible to remove the top belt and/or rebelt and then retread the tire. Consult your retreader. If damage is excessive, scrap tire.
VEHICLE	Check brake material and brake balance.
OPERATIONS	Review driver training program.

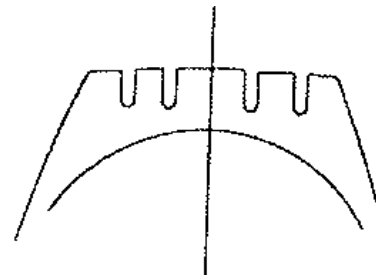
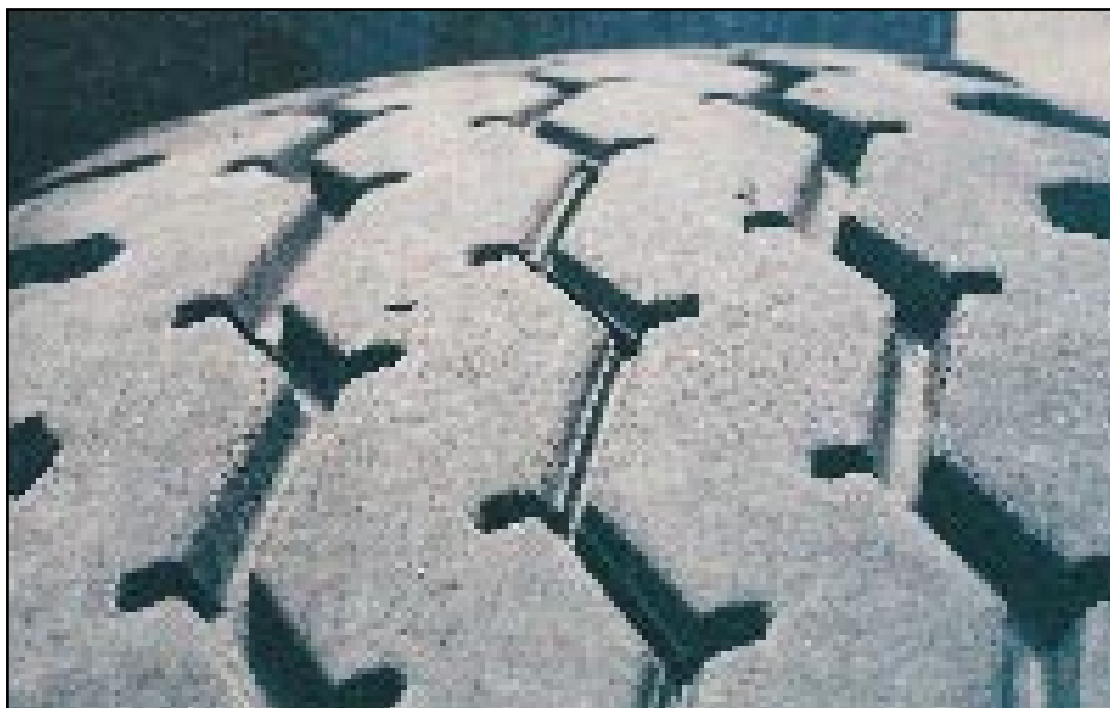
Overall Fast Wear

APPEARANCE	Uniform wear pattern, but fast rate of wear.
PROBABLE CAUSE(S)	Can be caused by service conditions such as mountainous terrain, frequency and severity of turning, abrasive road surfaces and equipment such as single axle drive, long wheel base straight trucks, heavy axle loads, high horsepower engines, or mismatched drive train components.

TIRE	Continue to run and retread. If condition continues, consult tire manufacturer
VEHICLE	Review tire design selection. Carefully match equipment with service requirements. Consult vehicle and tire manufacturer when specing equipment or replacing tires.
OPERATIONS	None

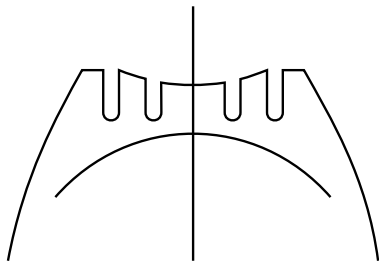
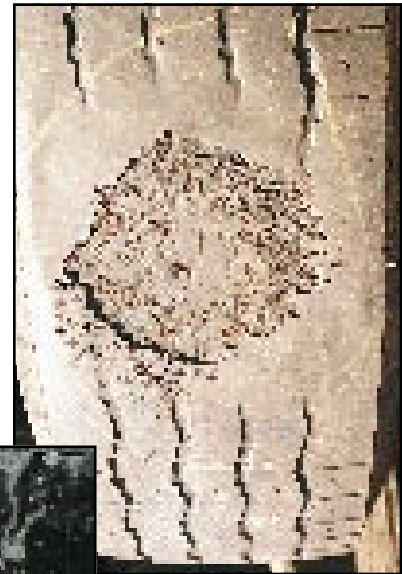
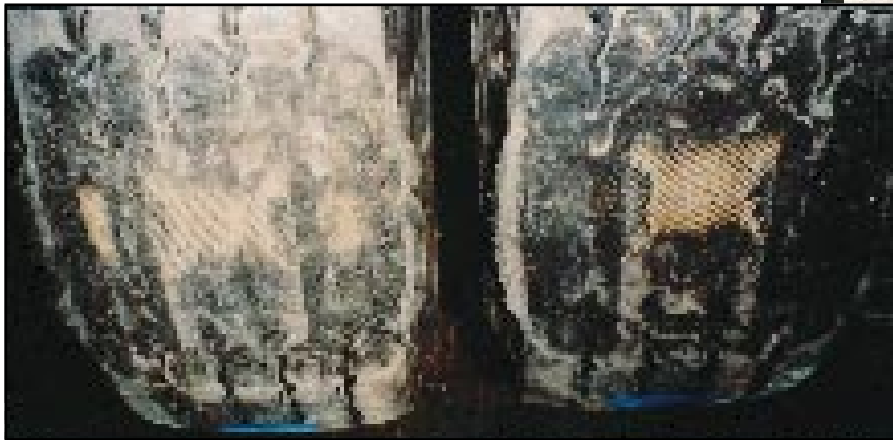
Brake Skid/Flat Spot Wear

Localized spot of excessive wear across the tread face. Surface texture may show circumferential abrasion marks from tread sliding on road surface, but surface may have since worn smooth. Usually exhibited on both tires in a dual assembly.

Brake skid occurs most often on dolly, trailer and drive tires. Aggravated by new brakes (high friction, not worn in), unbalanced brake system, aggressive use of brakes, frozen brakes and driver abuse such as the use of only trailer brakes to stop a vehicle. Sometimes seen on new vehicle drive-aways.

If condition is not excessive, duals can be rematched to position flat spots 180° from each other. If more severe, the tire can be repaired or retreaded if damage is not into the belts. If skid damage is into the tire belts, it may be possible to remove the top belt and/or rebelt the tire. Consult your retreader. If damage is excessive, scrap tire.

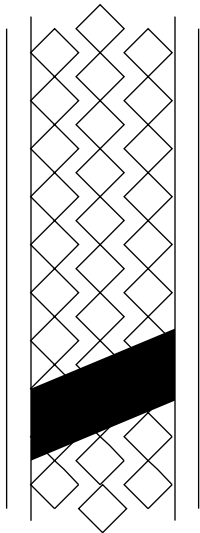
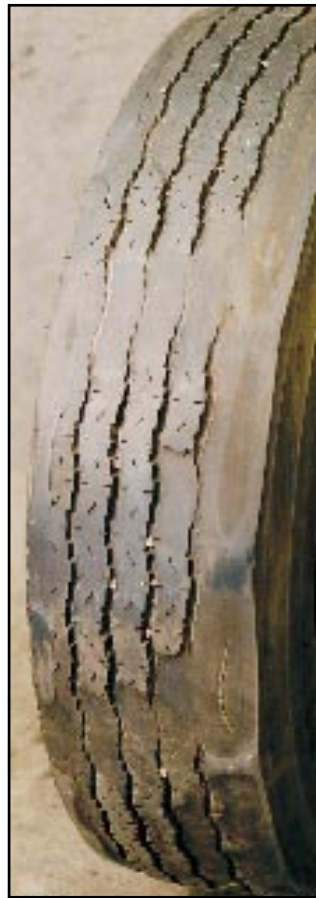
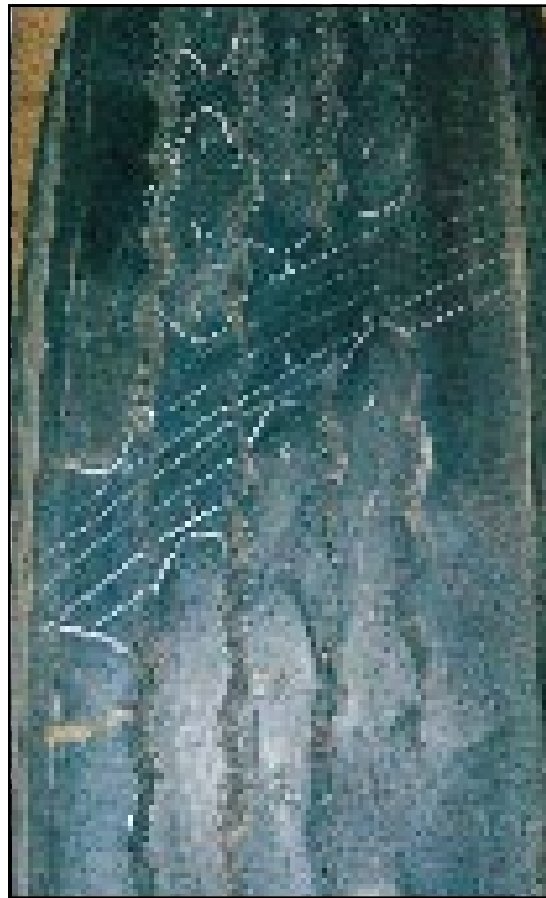
Diagonal Wear

APPEARANCE	Localized flat spots worn diagonally across the tread at approximately 25°-35° angles often repeating around tread circumference.
PROBABLE CAUSE(S)	Bad wheel bearings, toe out, mismounting of tire and wheel assembly to trailer, mismatched duals for size and/or inflation pressures; may start as brake skid. Aggravated by high speed empty or light load hauls.

TIRE	Reverse direction of rotation of the tire. If wear is excessive, true or retread
VEHICLE	Diagnose cause and correct.
OPERATIONS	None

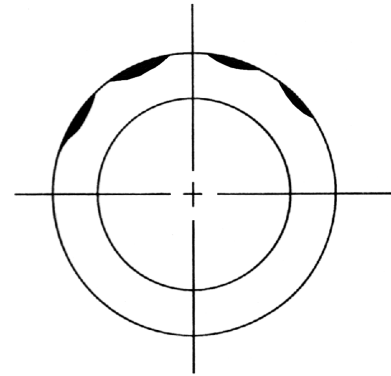
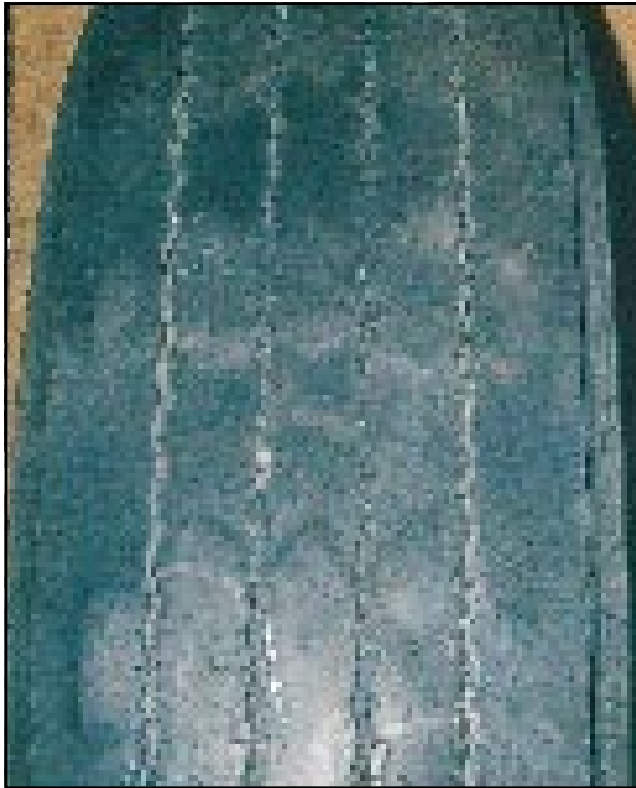
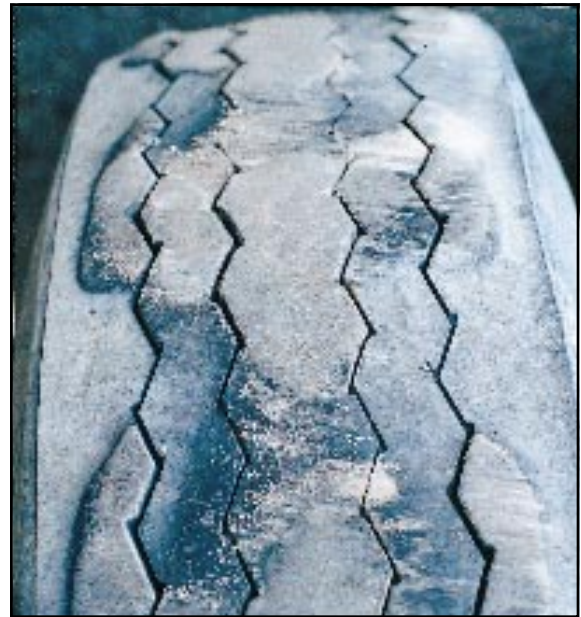
Multiple Flat Spotting Wear

Numerous areas worn flat around circumference or tread.

Uneven dual loading due to mismatched inflation pressures or tire sizes, worn wheel bearings, imbalance, air suspensions with bad shocks, driver abuse of trailer brakes; aggravated by high speed empty hauls.

If not worn excessively, run tires out. If remaining tread at worn spots is $2/32$ " or less, retread tire.

Diagnose cause and correct.

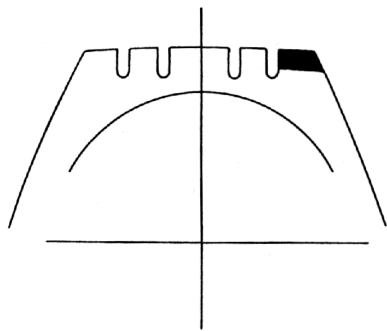
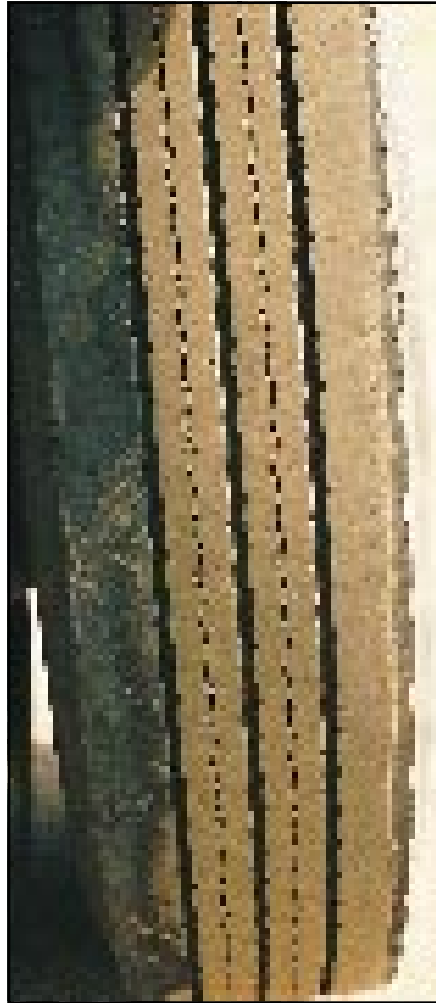
Rapid Shoulder Wear - One Shoulder

APPEARANCE	Tire worn on edge of one shoulder sometimes extending to inner ribs. Can progress to diagonal wipeout.
PROBABLE CAUSE(S)	Excessive toe, excessive camber. These conditions can be created by a misaligned or bent axle and can also be caused by loose or worn wheel bearings.

TIRE	Change direction of rotation of tire. If shoulder wear is severe, remove and retread.
VEHICLE	Diagnose misalignment and/or mechanical condition and correct.
OPERATIONS	None

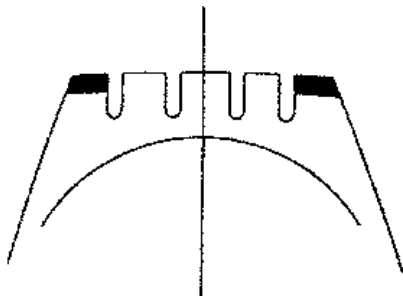
Rapid Shoulder Wear - Both Shoulders

APPEARANCE	Full rib wear on both shoulders.
PROBABLE CAUSE(S)	Frequently found on spread axles as a result of normal service conditions. Also found on dolly axles as a result of the push/pull action of that operation.

TIRE	If shoulder wear is severe, remove and retread.
VEHICLE	None
OPERATIONS	Review tire application with tire manufacturer.

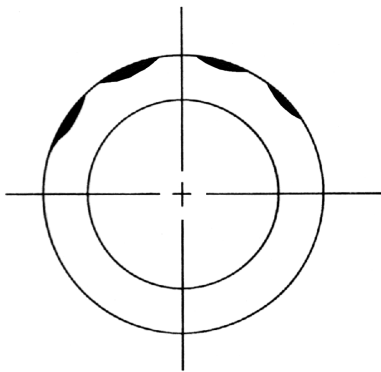
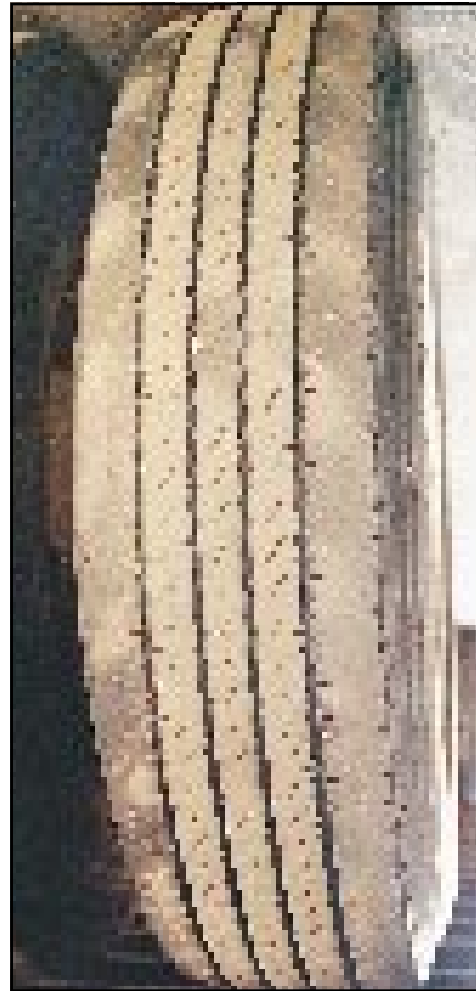
Erratic Depression Wear

APPEARANCE	Random, erratic wear around tire circumference.
PROBABLE CAUSE(S)	Lack of shock absorber control in some suspension types, mismatched tire sizes and/or inflation pressures between duals, loose or worn wheel bearings, assembly non-uniformity such as improper bead seating and out-of-balance condition, aggravated by high speed empty hauls.

TIRE	If not worn excessively, continue to run. If wear is excessive, retread.
VEHICLE	Diagnose mechanical problem and correct.
OPERATIONS	None

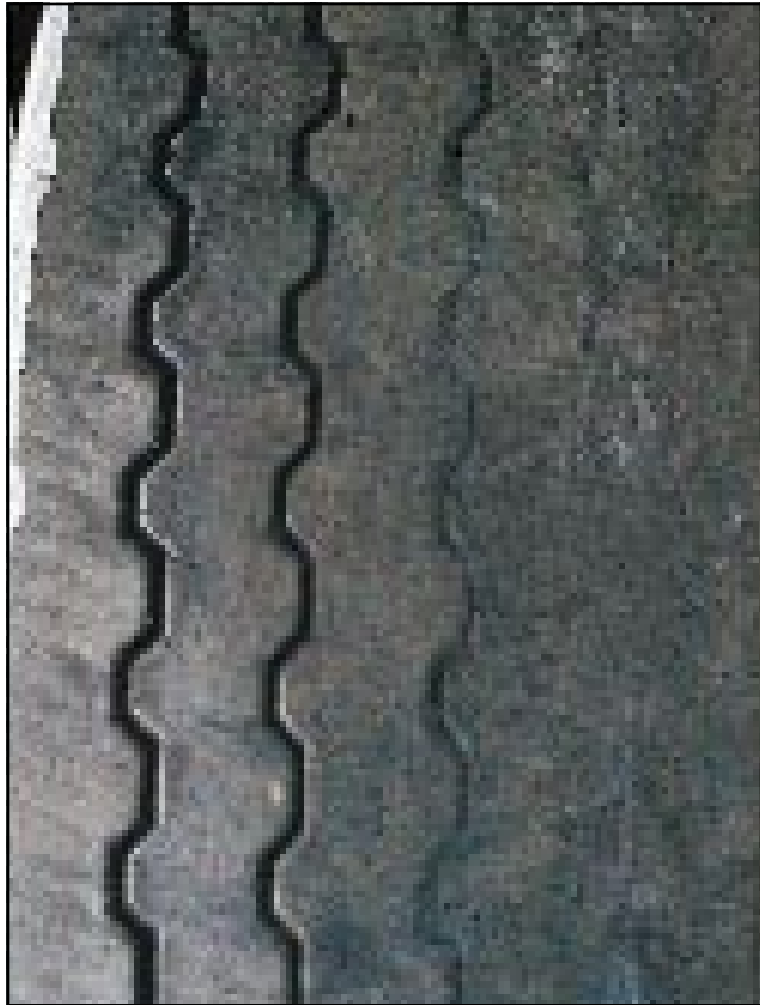
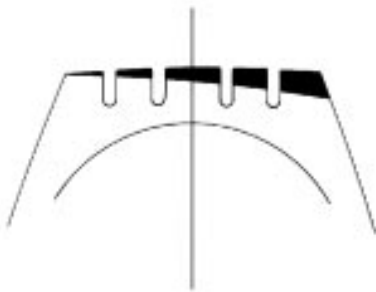
One Sided Wear

APPEARANCE	Excessive wear on one side of tire.
PROBABLE CAUSE(S)	Excessive toe, excessive axle camber, non-parallel axles, non-uniform tire and wheel assembly caused by improper bead seating or a bent wheel.

TIRE	Change tire position on trailer. If excessive, retread.
VEHICLE	Isolate and correct cause.
OPERATIONS	None

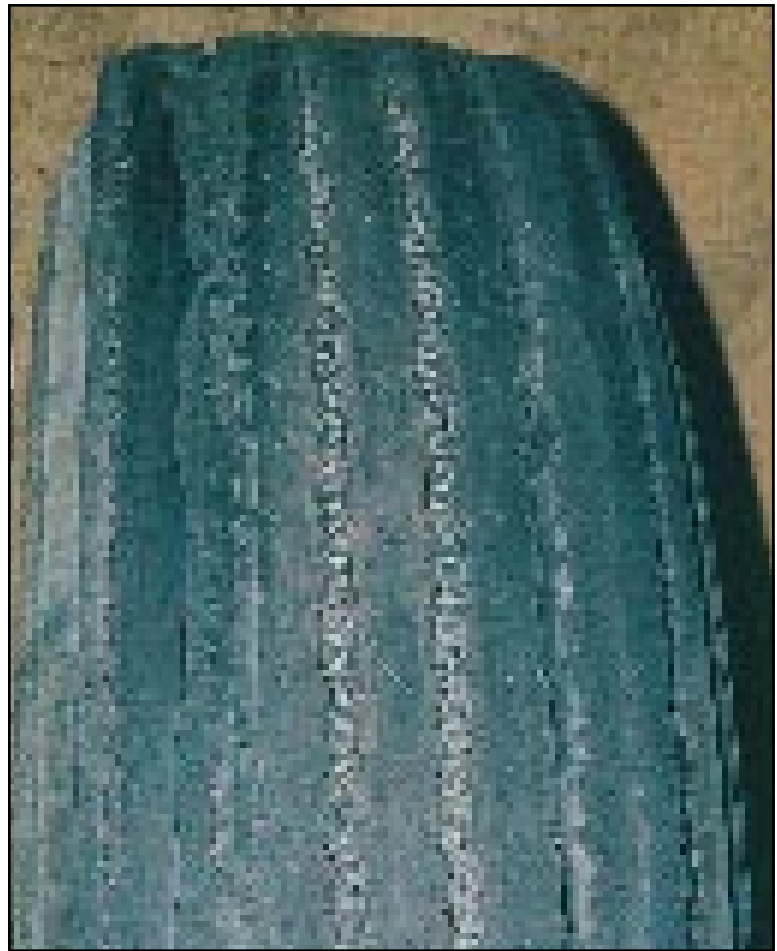
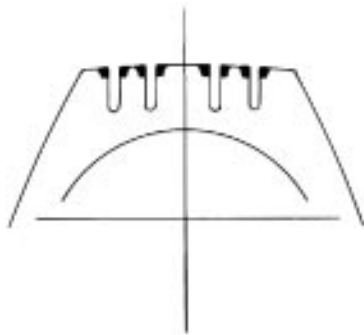
Erosion/River/Channel Wear

Localized wear along inside edges of tread ribs which may be wavy in appearance and vary in width around the tire.

Characteristic of slow wear rate of radial tires on free rolling axles. May vary with individual tire tread design and construction.

Erosion wear should not be of concern.

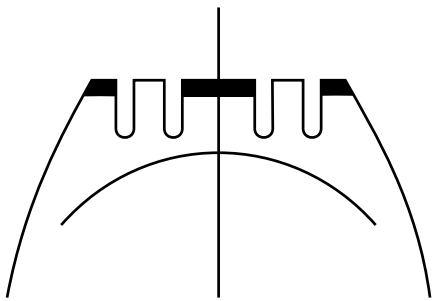
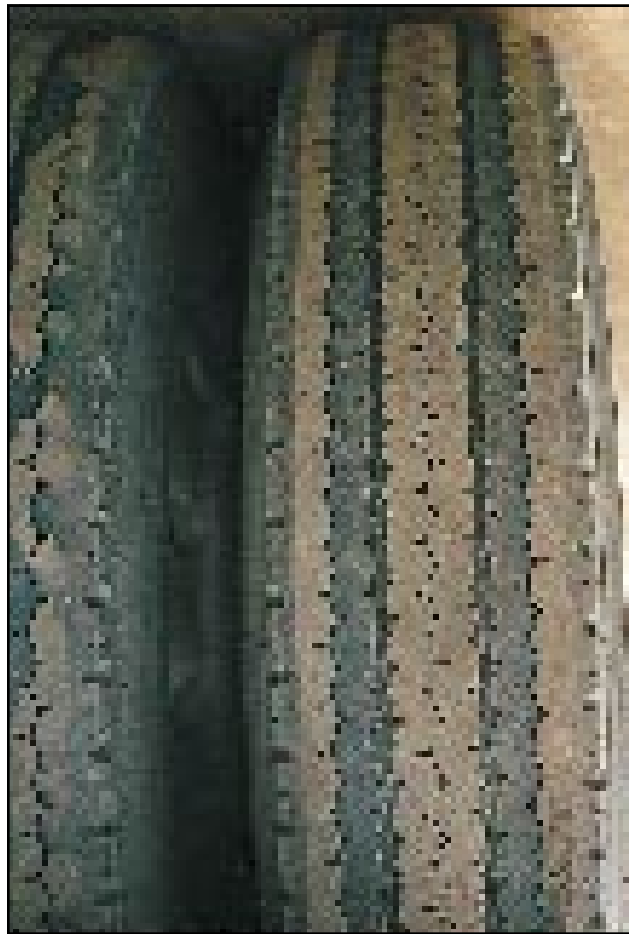
Rib Depression/Punch Wear

APPEARANCE	One or more inner ribs worn below the level of the adjacent rib around the tire's circumference.
PROBABLE CAUSE(S)	Lack of shock absorber control in some suspension types, mismatched tire sizes and/or inflation pressures between duals, loose or worn wheel bearings, assembly non-uniformity such as improper bead seating and out-of-balance condition, aggravated by high speed empty hauls.

TIRE	If not worn excessively, continue to run. If wear is excessive, retread.
VEHICLE	Diagnose mechanical problem and correct.
OPERATIONS	None
